**COSSACK**

**DRAFT** Conservation Management Plan

Volume 2: Appendices

## **Building Condition Assessments Report**

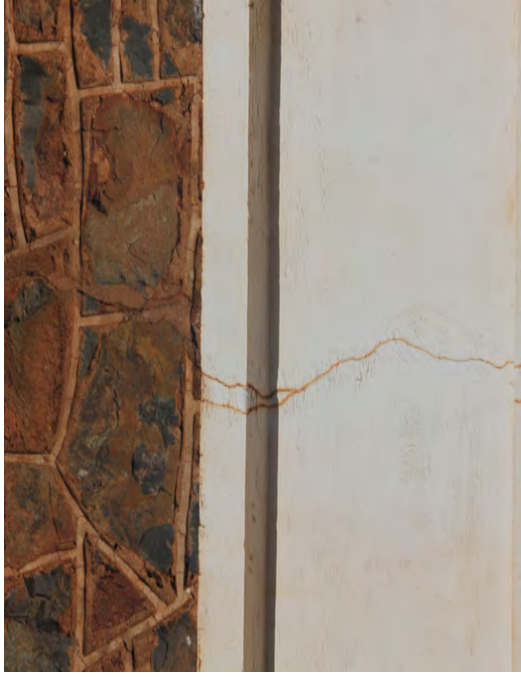
*Hairline cracks throughout the walls. Source: TPG+PM 2017*

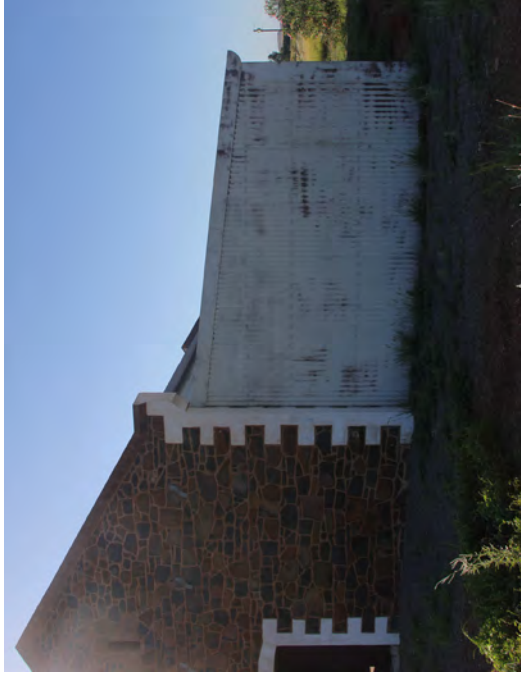
*Galvanised iron lean-to annex. General rust and loose paint. Source: TPG+PM 2017*

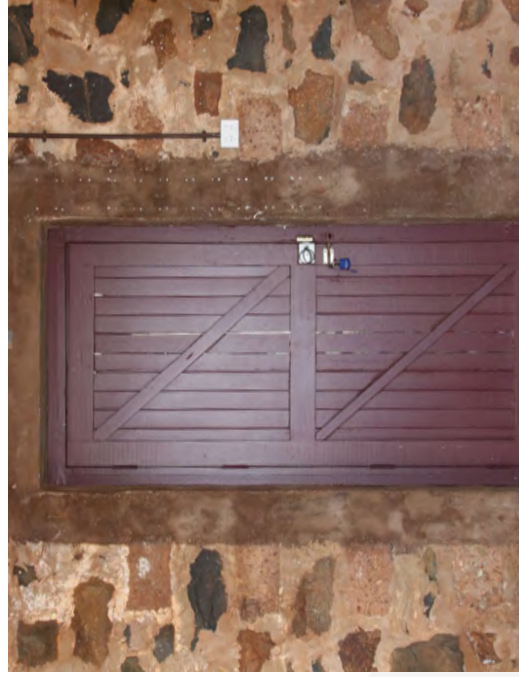
*Efflorescence of salts due to cement mortar and the use of concrete to tie beams. Source: TPG+PM 2017*

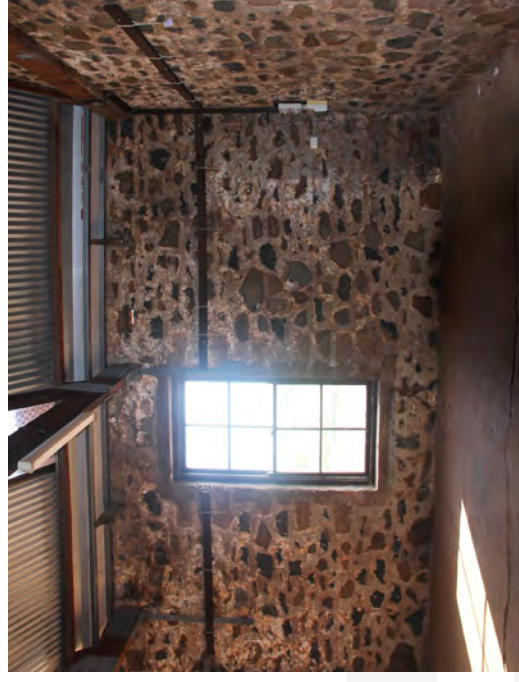
*Store interiors with salts' efflorescence and cement mortar to bluestone walls. Source: TPG+PM 2017*

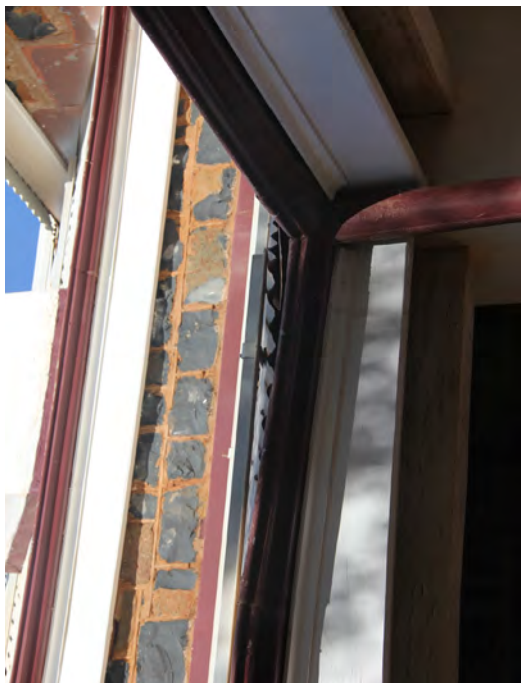
Rainwater system is collapsing, with dismantled downpipes. Source: TPG+PM 2017

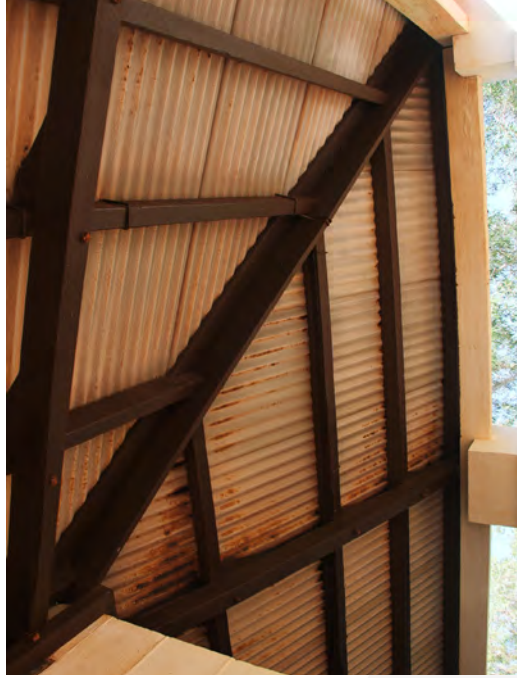
General rust on metal roof sheets. Source: TPG+PM 2017

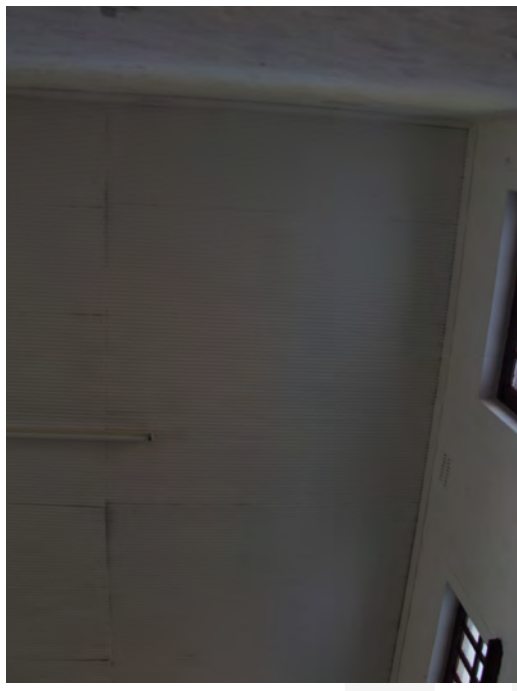
Pressed galvanised iron ceiling with loose sheets and signs of rust. Source: TPG+PM 2017

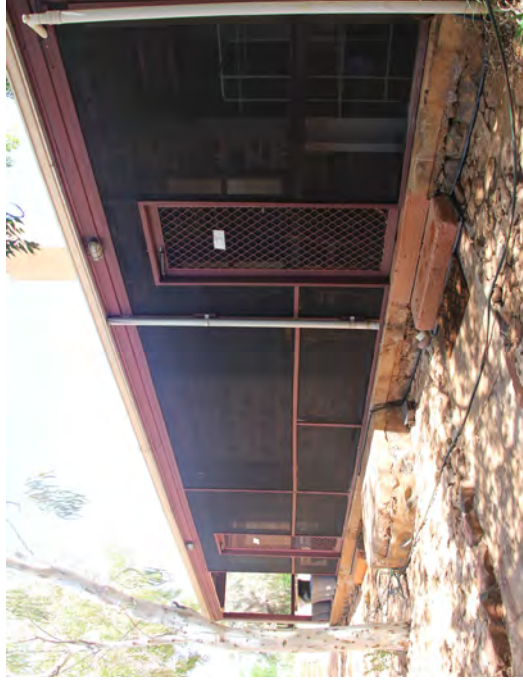
The existent black flyscreen is easily removable if necessary, so it remains in situ. Source: TPG+PM 2017

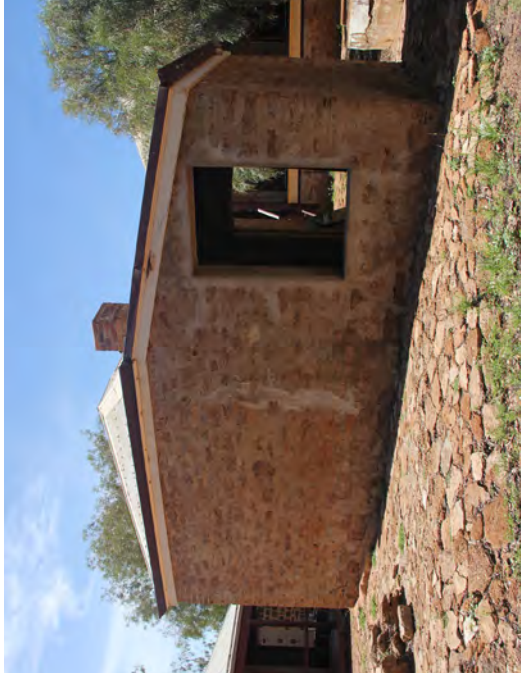
Major vertical crack. Source: TPG+PM 2017

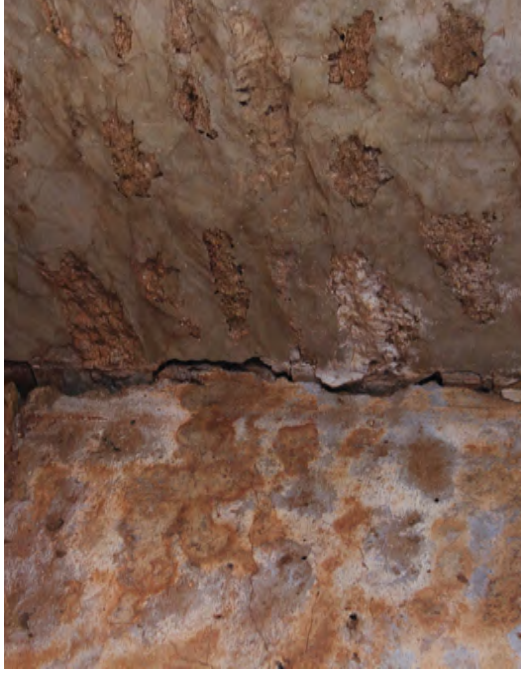
Major vertical crack from inside. Source: TPG+PM 2017

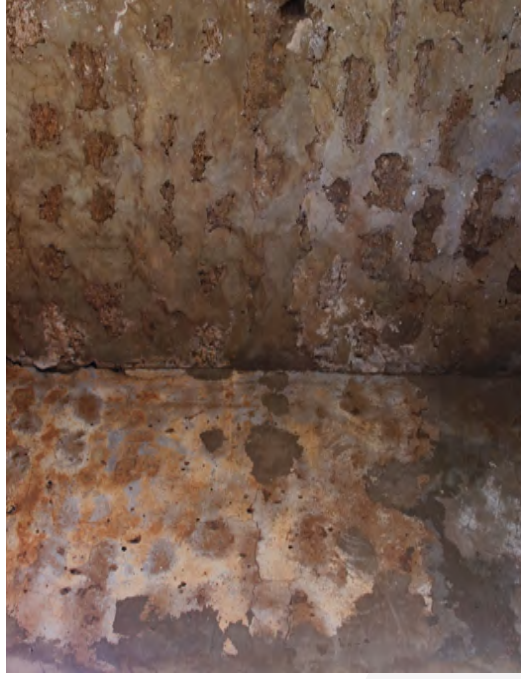
Efflorescence of salts due to cement mortar. Source: TPG+PM 2017

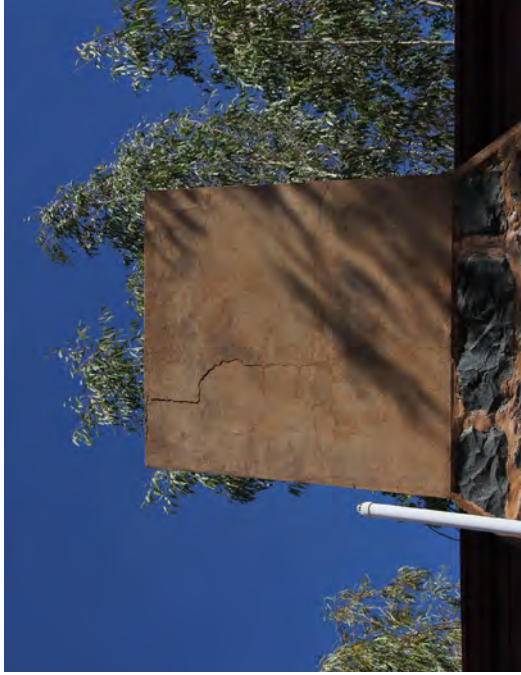
Major cracks to the chimney. Source: TPG+PM 2017

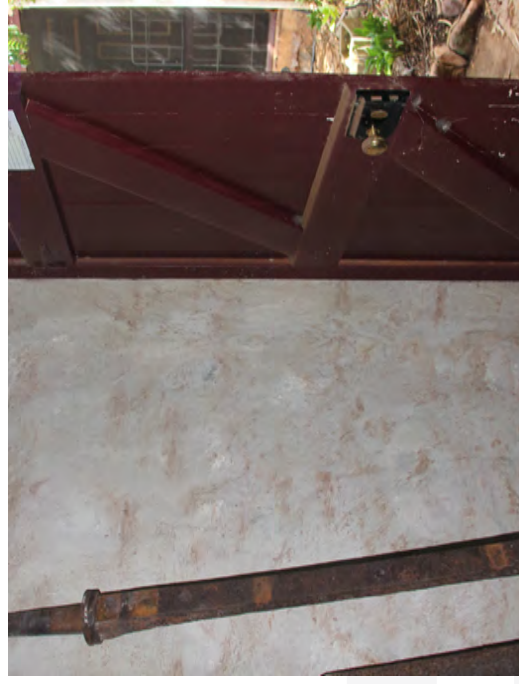
Interiors need to be cleaned from leaves and general rubbish. Source: TPG+PM 2017

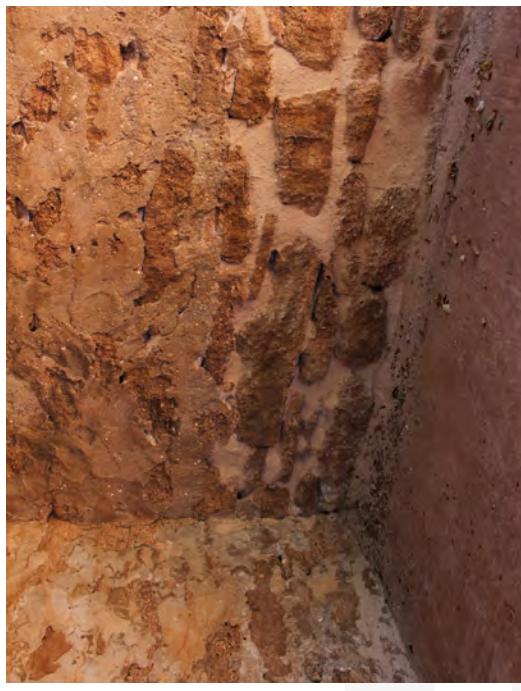
Friable original mortar on the wall base. Source: TPG+PM 2017

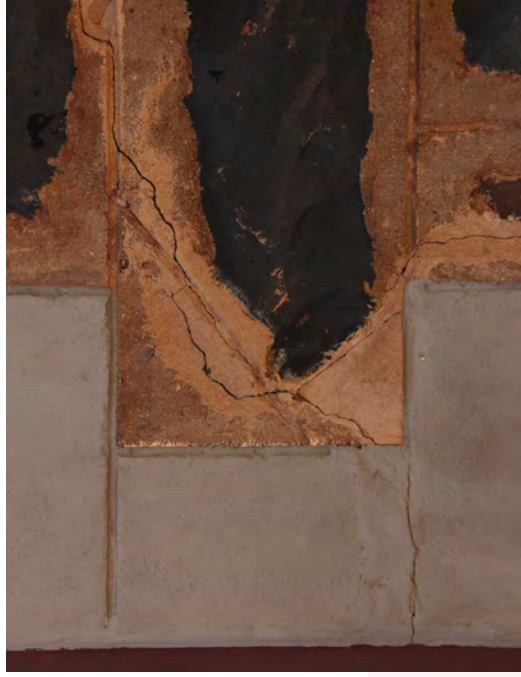
Hairline cracks throughout. Source: TPG+PM 2017

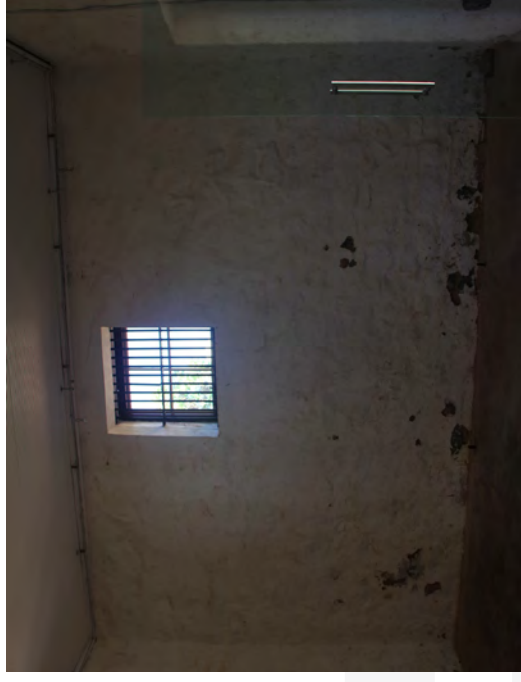
Painting peeling from wall, possible from cement pointing causing efflorescence of salts. Source: TPG+PM 2017

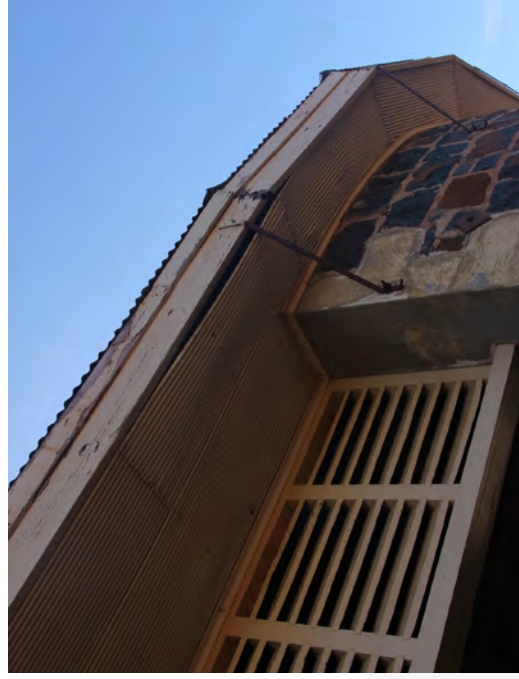
Damaged eaves and soffit. Source: TPG+PM 2017

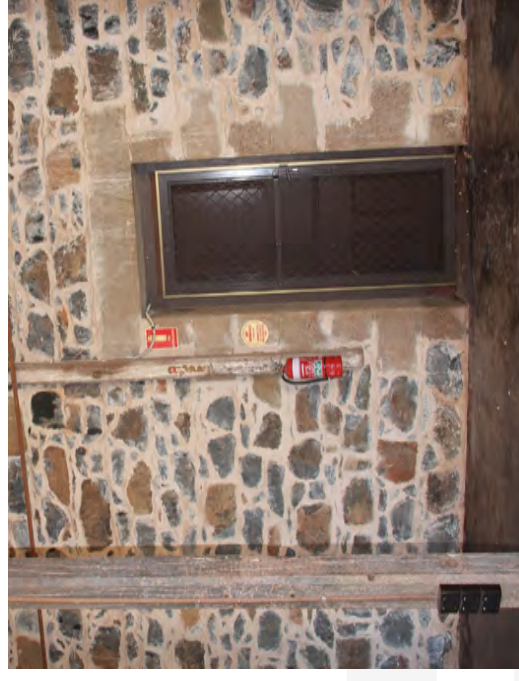
Cement pointing causing efflorescence of salts. Humidity patch over door.  
Source: TPG+PM 2017

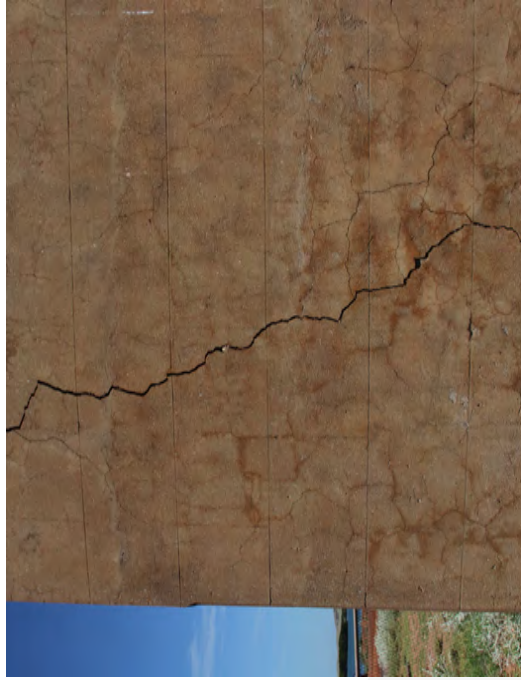
Major vertical crack. Source: TPG+PM 2017
