## Place No. 27 Karratha Homestead Group

LOCATION	
Name of Place	Karratha Station Homestead Group
Other Name (1)	Maitland Station
Other Name (2)	Maitland River
Location/Address	
Street Number	
Street Name	North West Coastal Highway
Suburb/Town	Maitland
Other Locational descriptor (text)	South of North West Coastal Highway, 25 km from Karratha mE465765 mN 7690566 Longitude: 11.6708 Latitude: -20.8848

## KARRATHA HEAD STATION (2012)

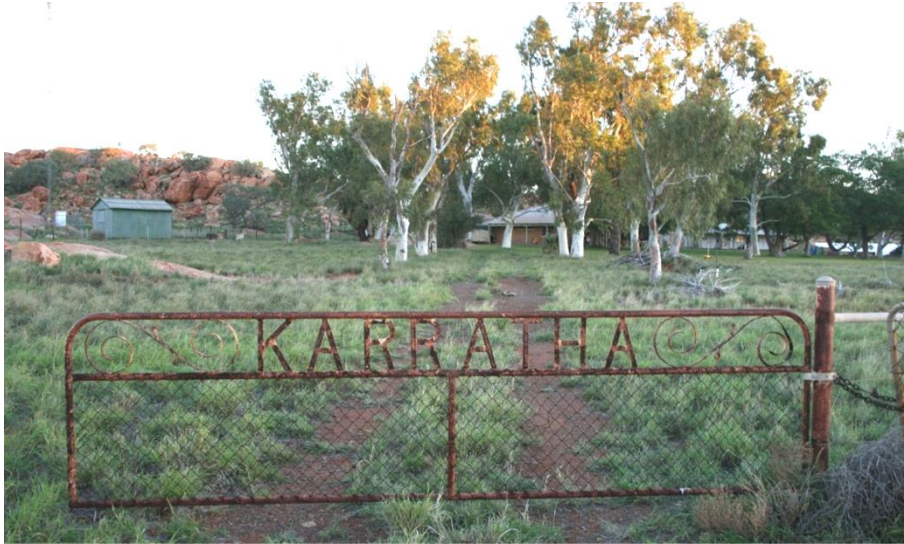
Karratha Station gates 2012

An earlier tree lined driveway entrance to the station complex is evident with earlier iron gated entrance with the name ‘Karratha’ in moulded metal.

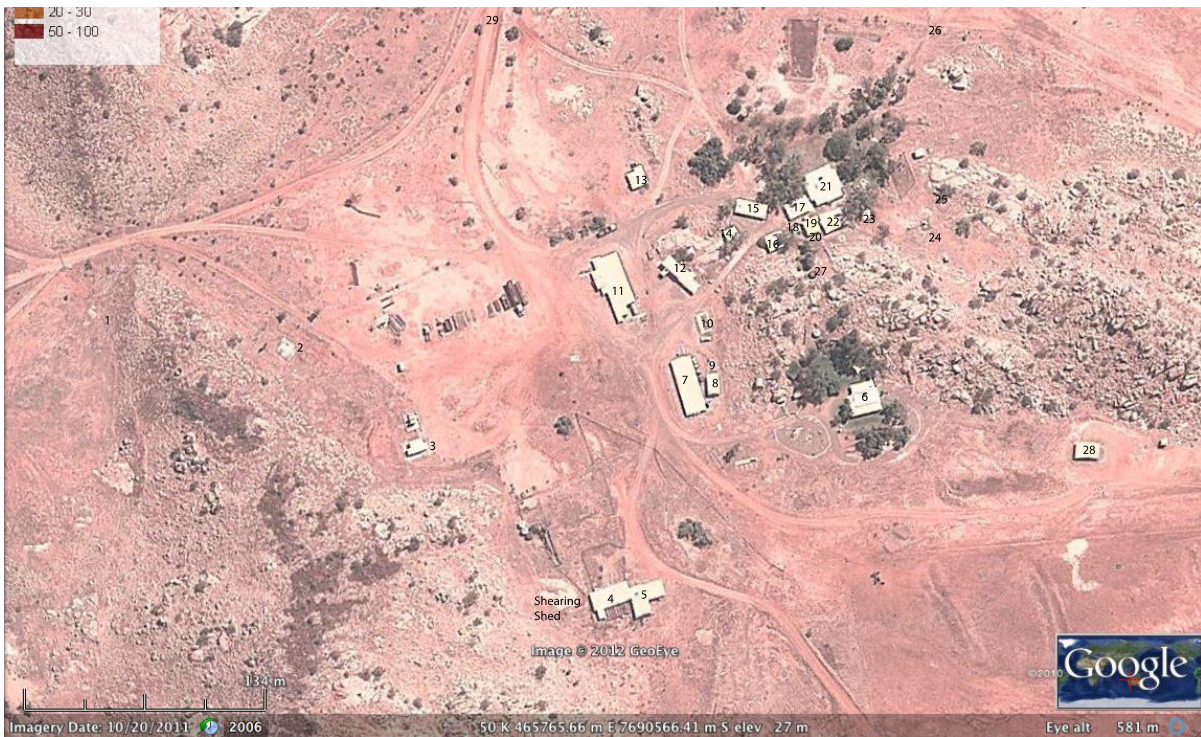
1. Aboriginal camp (floors visible)
2. House base (concrete floor)
3. Generator shed (modern)
4. Shearing shed (converted to stables: wooden frame and CI walls and roof) with remnants of yards to south

5. Storage shed attached to shearing shed (CI walls and roof with wooden frame; concrete floor)
6. Overseer's residence (modern, not visited)
7. Worker's quarters (CI walls and roof; internal brick walls; concrete floor)

8. Stone building (converted to internal brick laundry: CI roof; walls rendered except original stone)
9. Wall footings of stone building (originally part of building 8)

10. Footing of worker's mess (concrete wall footings)
11. Work shops (metal and wooden frame; CI walls and roof; concrete floor)
12. Complex: hut (CI walls and roof; concrete floor); 2 open vehicle sheds (CI roof)

13. Shed (used as stables in past: wooden and metal framed; CI walls and roof; concrete floor)
14. Building (2 rooms and 2 verandahs: concrete floor, walls, verandah posts; metal roof)

15. Metal prefabricated building (relatively modern)
16. Garage (modern: metal roof)
17. Quarters (CI roof and walls; wooden frame; concrete floor) with awning

18. Stone building (possible coolroom, now cyclone shelter: CI roof; stone walls painted white; cement floor)
19. Saltroom (CI roof; railway sleeper frame; brick walls)

20. Workshop (CI roof; CI walls; pipe and railway sleeper frame; concrete floor)
21. Homestead (CI roof; brick construction; original metal verandah posts)

22. Residence (CI roof; panel walls; concrete floors; use of original metal verandah posts)
23. Stone wall housing cast iron heater (presumably building remnant)

24. Wall footings (stone) of structure (min. 29 x 15m); Toilet (CI walls and roof); Microwave tower
25. Ruin: stone walled structure 3 x 2 m.
26. Earlier tree-lined entrance and metal gate

27. Water tank
28. Hanger (modern)
29. To north: stock yards and race track location

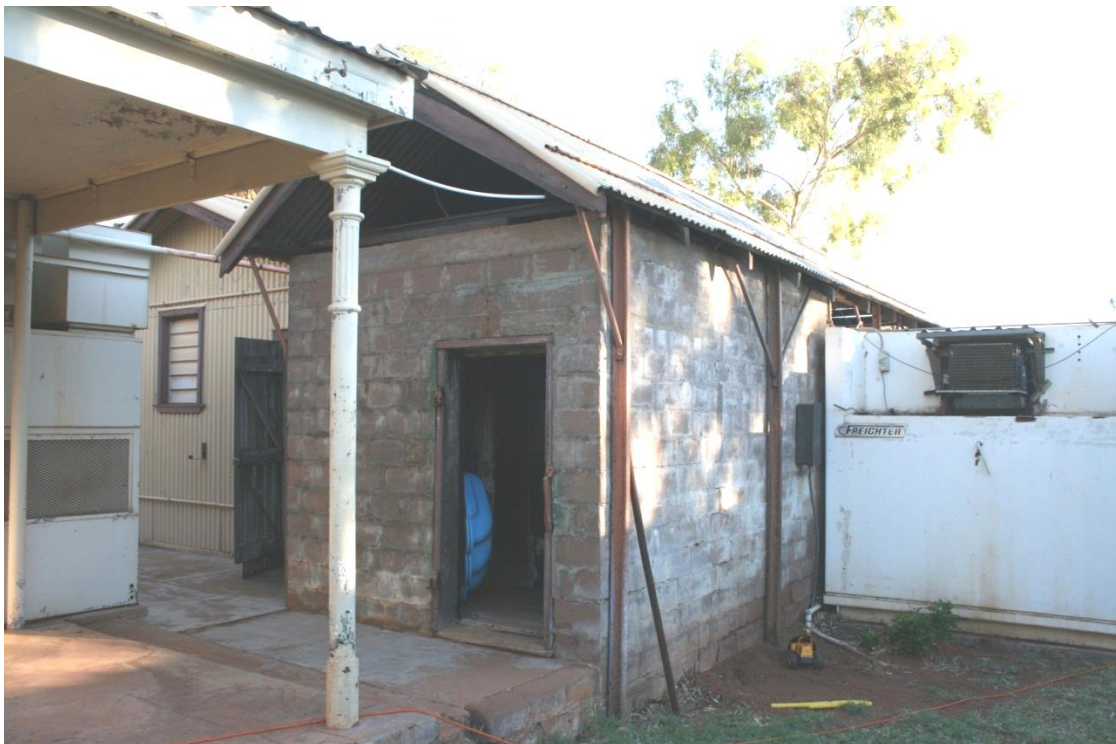
**Saltroom at Karratha Station, 2012**

Workshop (20) and salt store (19) – These were built adjacent to each other by Charles Thompson for Bill Leslie in 1935. Both buildings use railway sleepers and steel pipe as framing and each has a vaulted corrugated iron roof. The workshop has corrugated iron cladding walls and the salt store is made of brick with one wall removed. The salt store housed salt that Leslie gathered from locations near Dampier. Dampier Salt later adopted this enterprise a commercial scale.

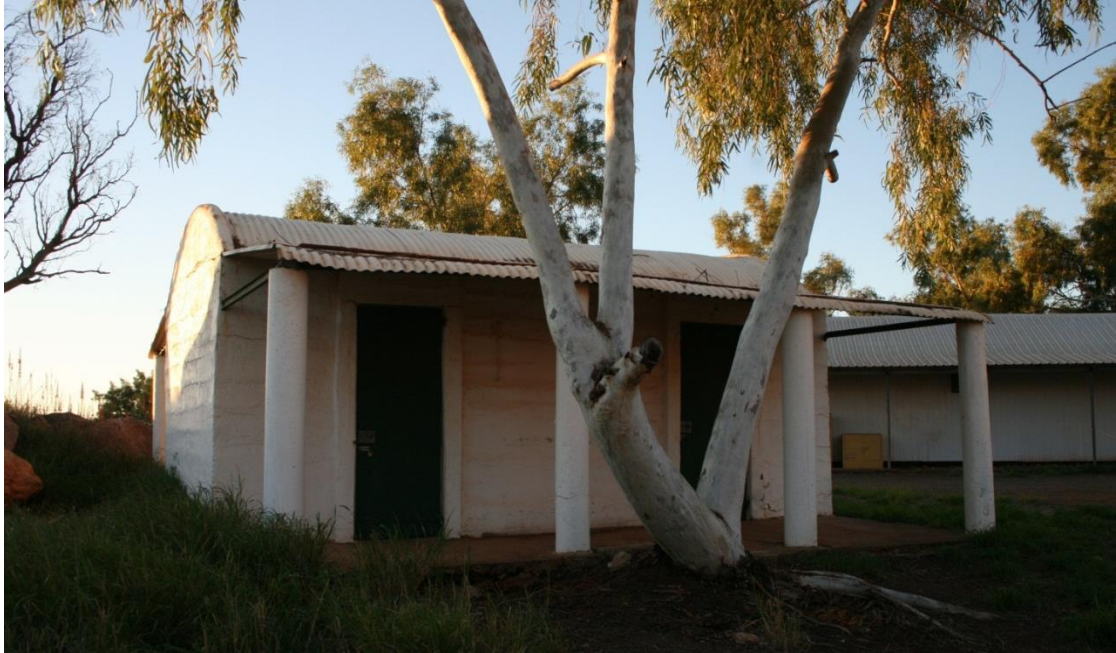
Residence (Plan: Building number 14) 2012

Building (14) – This is a small two roomed concrete structure (concrete poured between sheltered framework), with a concrete floor, distinctive round concrete verandah posts, a corrugated iron vaulted roof and a lean-to verandah front and back. This building may have been the overseers cottages and has been described as the ‘willy willy shelter’. It was built by the Withnells between 1910 and 1920.
