COSSACK

DRAFT Volume 1: Conservation Management Plan
February 2018

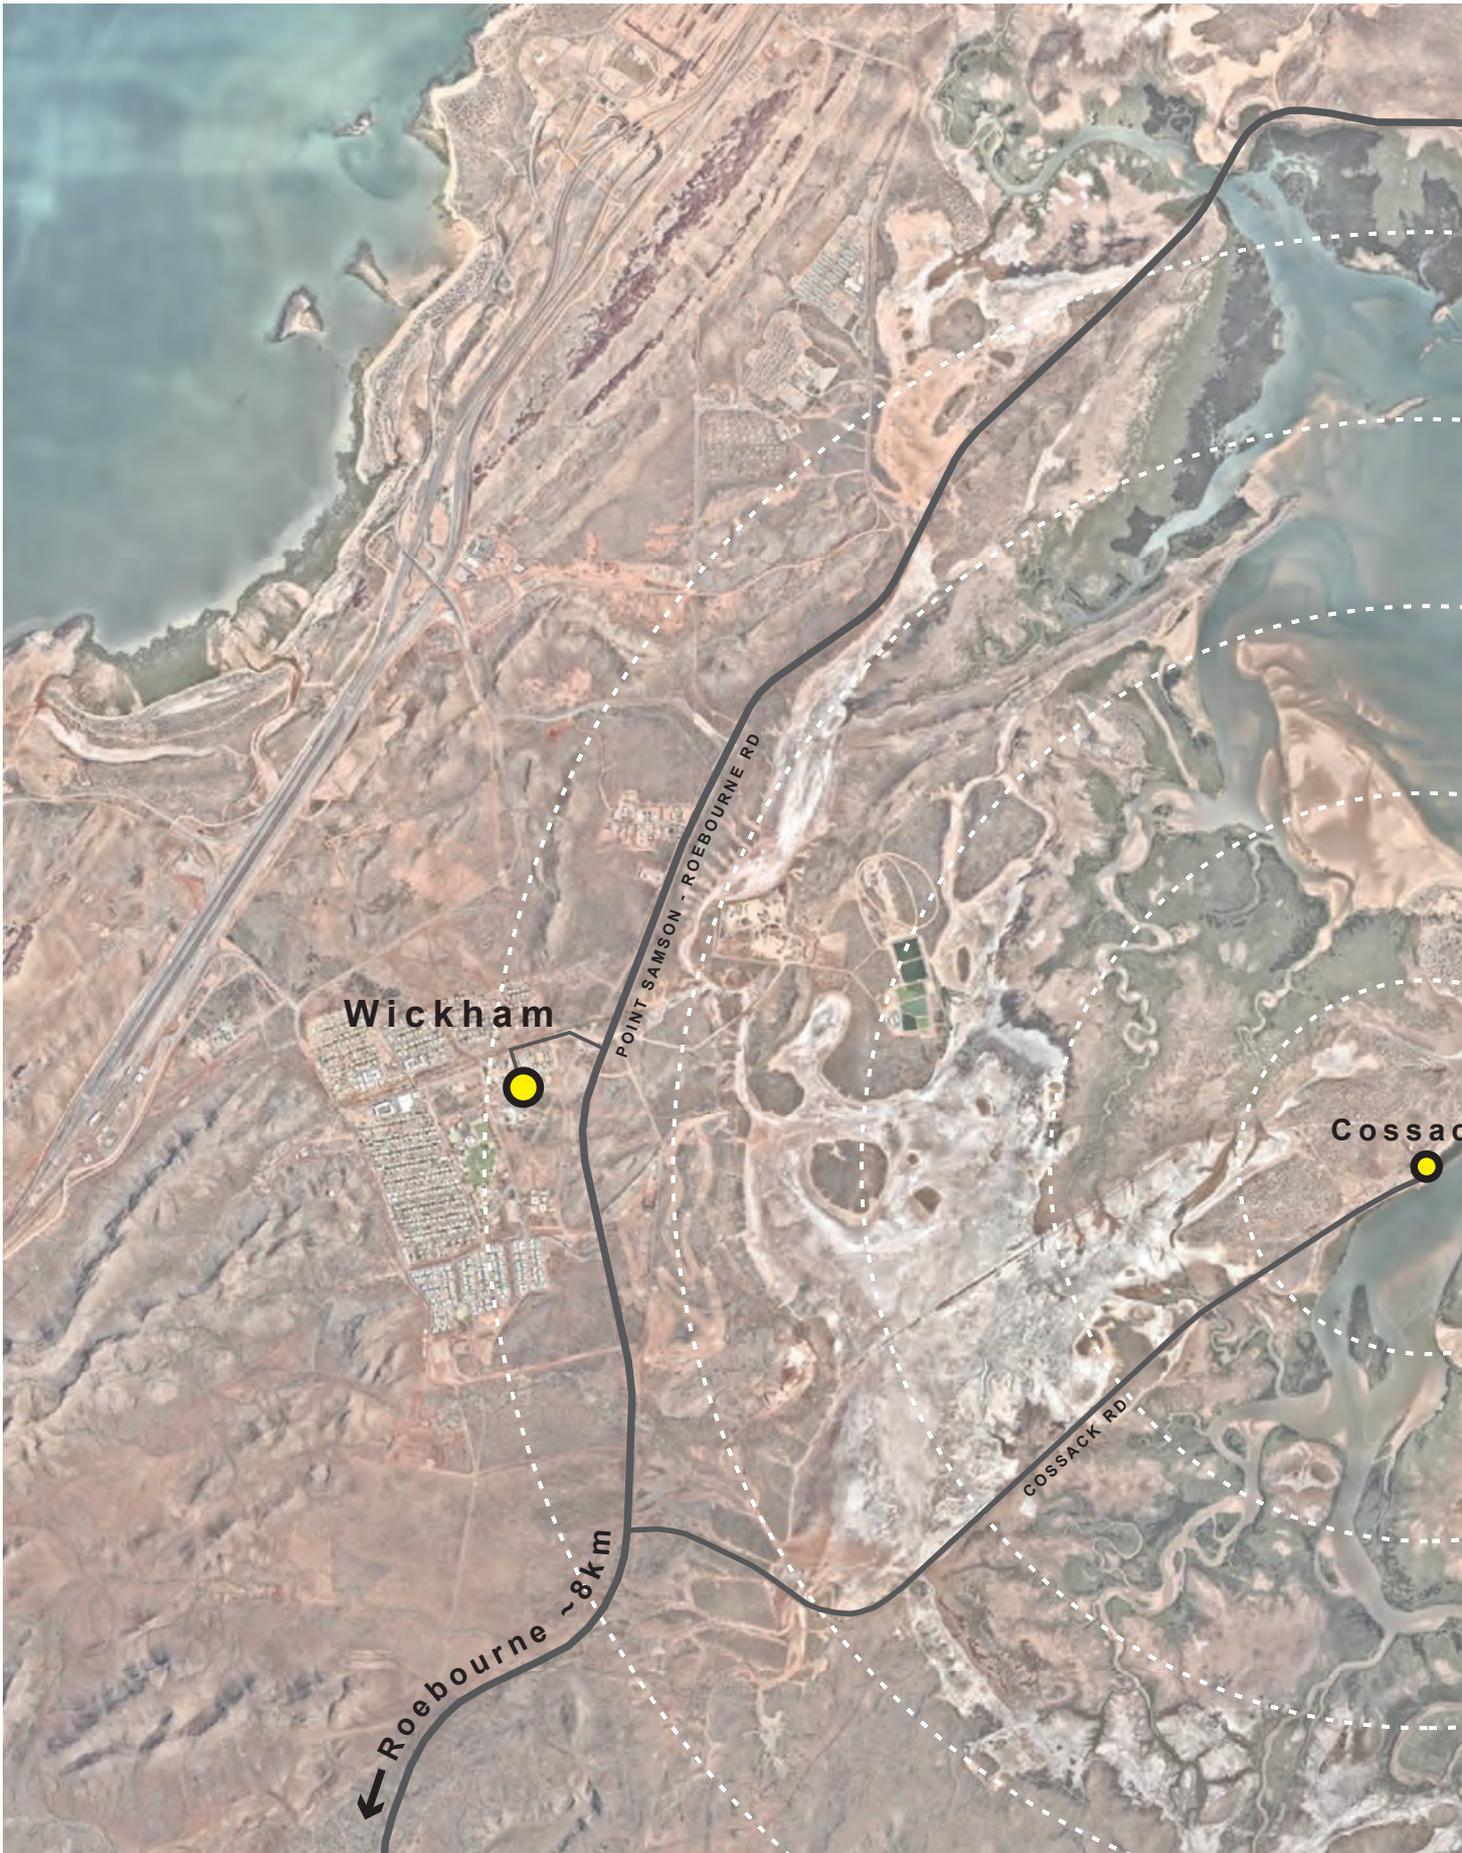
Figure 1. Location Plan The Department of Housing and Works, the Shire of Roebourne and the Heritage Council of WA, 2006, Draft Master Plan Concept Stage, page 29.

The area subject to this CMP encompasses the area of land identified within the HCWA's Cossack Town Site Precinct which is generally bound by Wickham Street, Dampier Street, Pearl Street, Ward Street, Pilot Street, Perseverance Street, Settlers Beach Road, Cossack Road to the Cemetery at Lots 422 and 433, and the foreshore to the high-water mark (including the Land Backed Wharf), as illustrated in Figure 1.

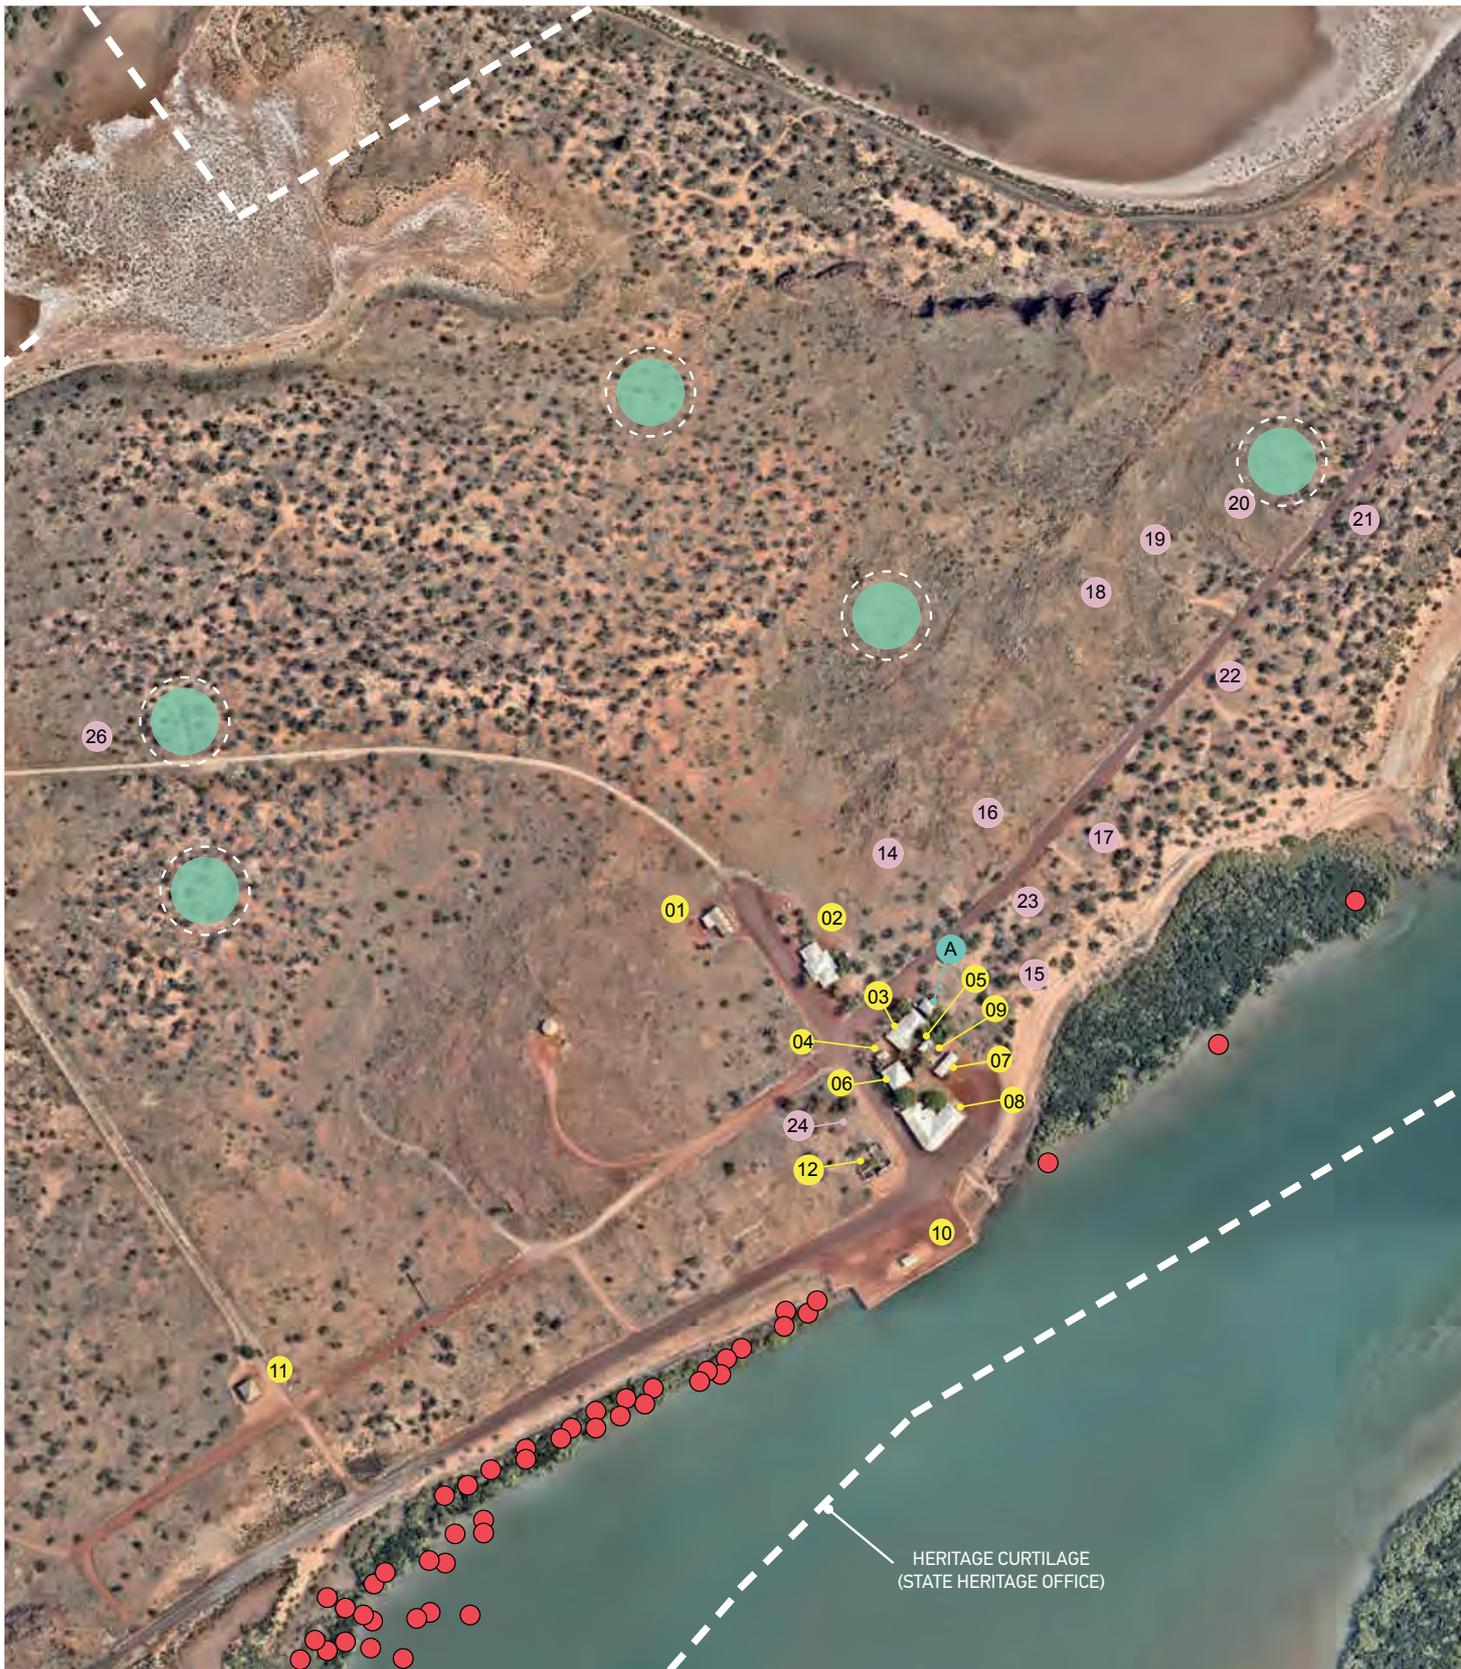
Figure 2. Site Context. Source: Nearthmaps.com.au (TPG artwork over Nearthmaps image, 2017).

In addition to the places listed above, a number of historical, Aboriginal and maritime archaeological sites also contribute to the evolution and significance of Cossack. These sites are indicated in Figure 2 overleaf.

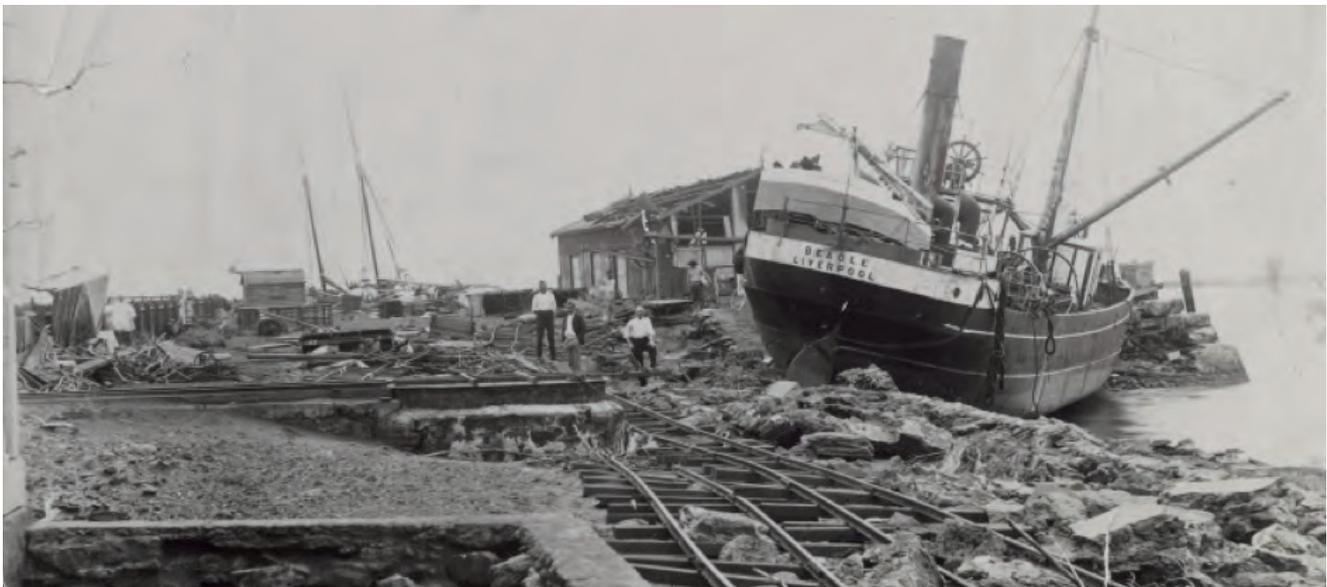
Figure 8. Cyclone damage at Cossack Wharf in 1898 (Source: State Library of Western Australia).

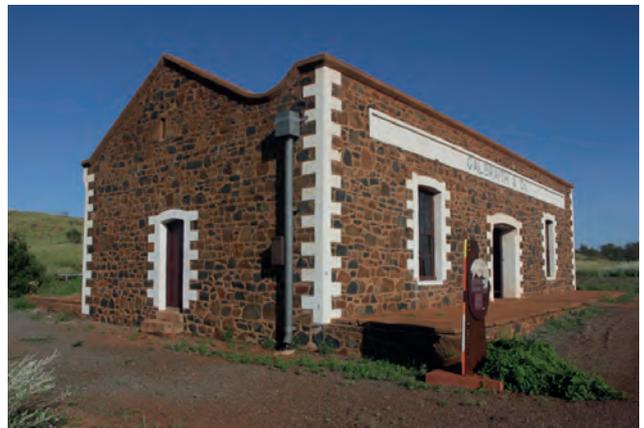
Figure 12. Galbraith's Store in 2017 (Source: TPG, 2017).

Galbraith's Store was constructed from local bluestone (ironstone) rock rubble walls with some bastard tuck pointing and rendered quoining at door and window openings, with a custom orb zincalume roof. The use of stone in solid foundations during this time was suggested to be an indication of status which was almost exclusive to the province of the pearling and trading elites, and the government that supported them.

Galbraith's Store is currently used for purposes of a shop and art gallery under a commercial lease and remains in poor to good condition.

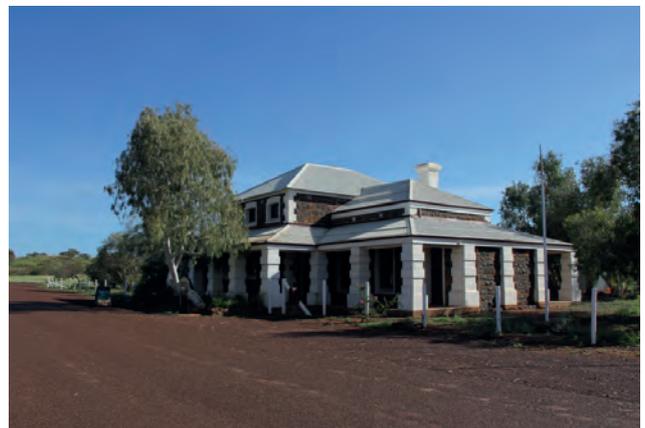
Figure 17. Court House in 2017 (Source: TPG, 2017).

The Old Court House is the second largest building in the Cossack Town Site and its style and materials, particularly its wide verandahs and rusticated pillars, demonstrates an intention of grandeur and prestige, befitting an important administrative building of law and order for the town and region. It is suggested that a contract was let in 1895 for the construction, for the price of 2058 pounds, which is substantially lower compared to the price of construction for the Police Quarters, and the Customs House and Bond Store (HCWA 2006).

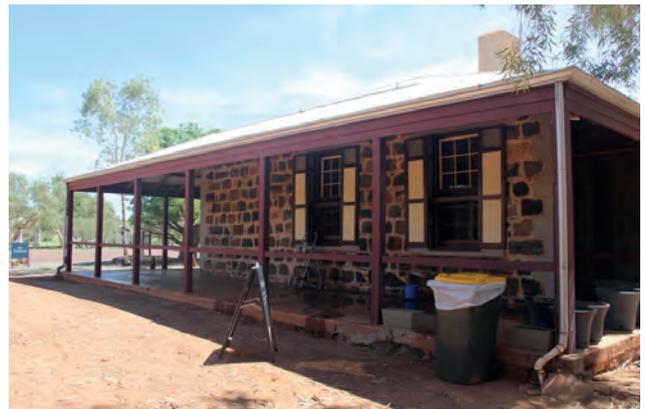
Figure 20. Police Quarters in 2017 (Source: TPG, 2017).

The Police Quarters building was built in 1890 and occupies a corner site at the Cossack Town Site's central intersection. The Police Quarters is constructed of coursed random rubble bluestone; with rendered quoining at door and window openings.

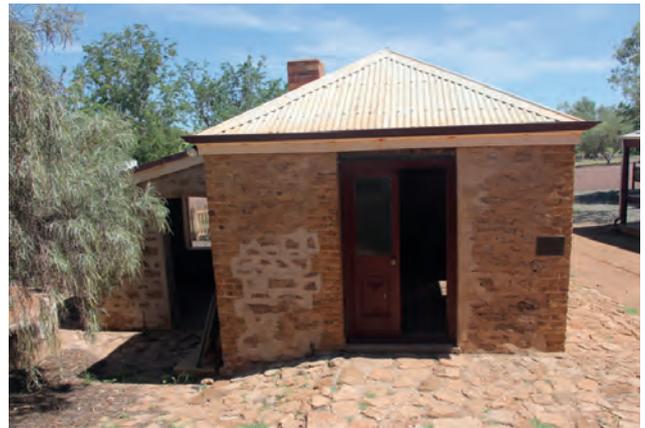
Figure 21. Western elevation of the Bakehouse in 2017 (Source: TPG, 2017).

The original ovens and equipment have been removed from the building, which has hindered its authenticity and material integrity. The building has also been subject to refurbishment works which were carried out in 1993. These works included repair works to its walls, and the replacement to its windows and its roof (HCWA, 1996).

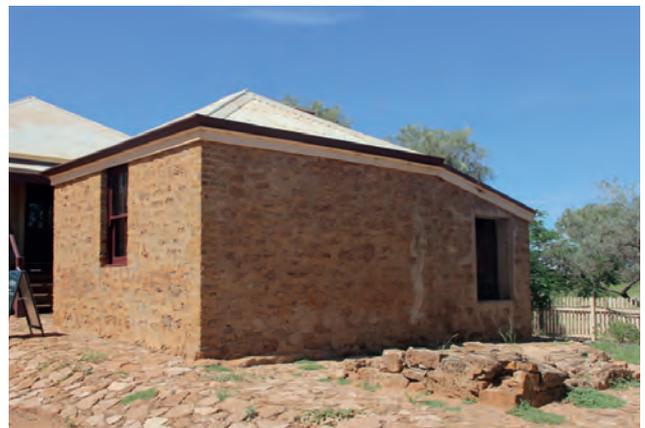
Figure 23. Northeast elevations of the Bakehouse in 2017 (Source: TPG, 2017).

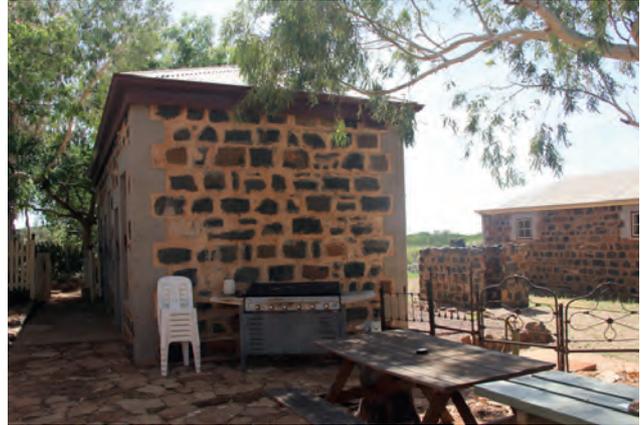
Figure 24. Cookhouse building in 2017 (Source: TPG, 2017).

The Cookhouse is now essentially a shell as all its fittings and equipment have been removed. The Cookhouse has also been subject to insensitive works which have now diminished its overall authenticity such as the roof which was reconstructed in 1984 and some other minor remedial repair works.

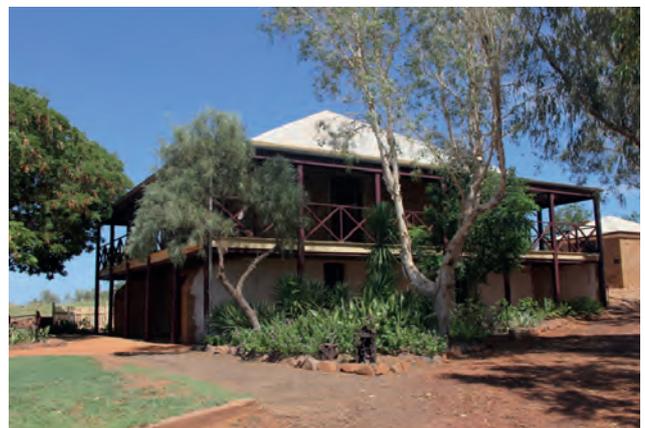
Figure 28. Post Office in 2017 with reconstructed roof (Source: TPG, 2017).

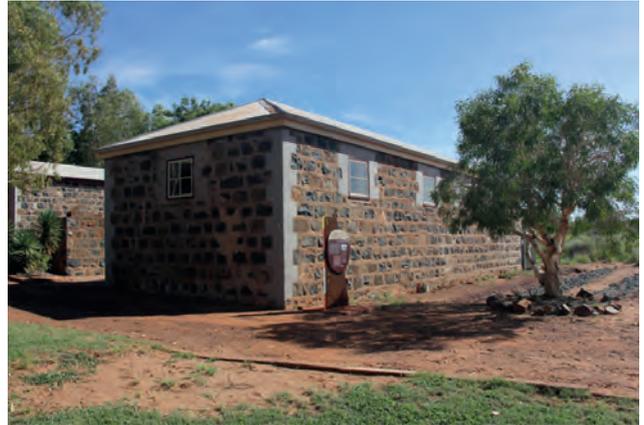
Figure 29. Southwest elevations of the Lockup building in 2017 (Source: TPG, 2017).

The Lockup building is considered to have a diminished level of authenticity given the reinstatement works to its roof and windows, and is nowadays used as a museum.

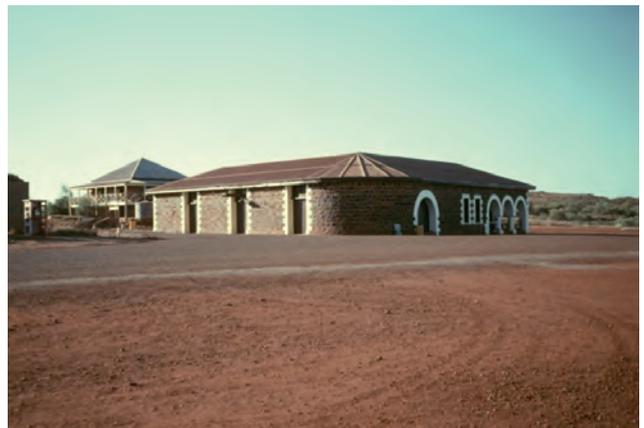
Figure 33. South and west elevation of Customs House and Bonds Store 1994 with new reinstated roof (Source: State Library of Western Australia).

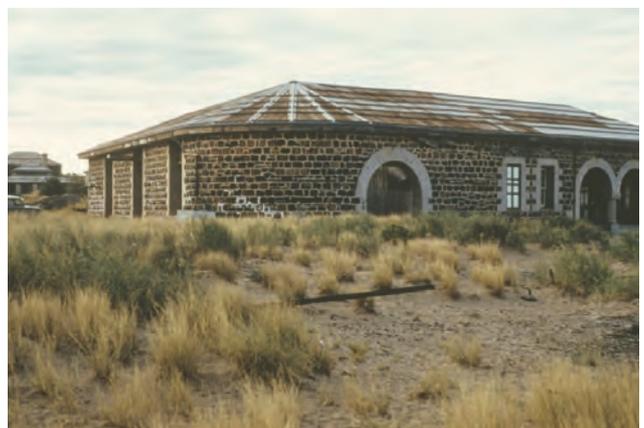
Figure 34. South and west elevation of the Customs House and Bonds Store in 2017 (Source: TPG, 2017).

The Customs House and Bond Store is the largest and most complex building in Cossack Town Site. It is sited on a high-profile corner at the beginning of the Pearl Street axis and visually commands the southern end of the historic town centre as the only building with a curved corner wall and arched major openings and an arched colonnade. It makes a substantial contribution to the townscape. Its proximity to the wharf reinforces the port function of the building and town and its heavy design style gives the impression of permanence and strength (HCWA, 1996).

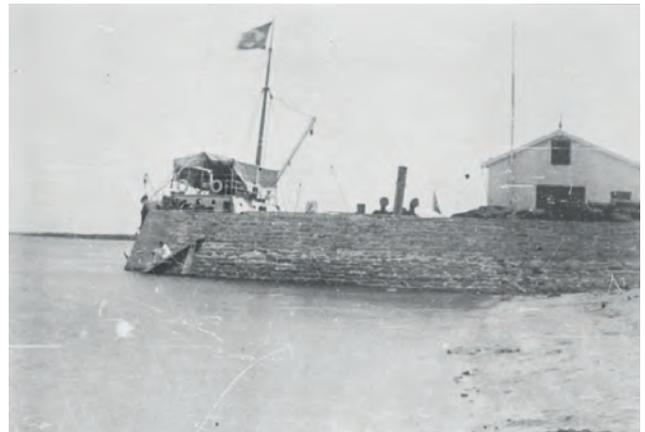
Figure 43. Northeast elevation of Wharf wall in 1895 (Source: State Library of Western Australia).

The Landbacked Wharf was the centre of Cossack's port functions and is constructed of a stone and concrete wharf (originally with a timber deck) and covers the site of two former timber pile jetties. The wharf has a concrete face wall, with stone pitch end walls however has recently been damaged in 2017, presenting a settlement on the north-eastern corner.

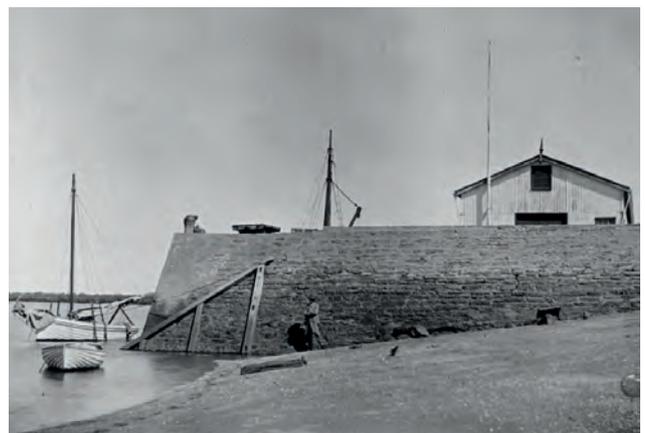
Figure 44. Northeast elevation of Wharf wall in 1910 (Source: State Library of Western Australia).

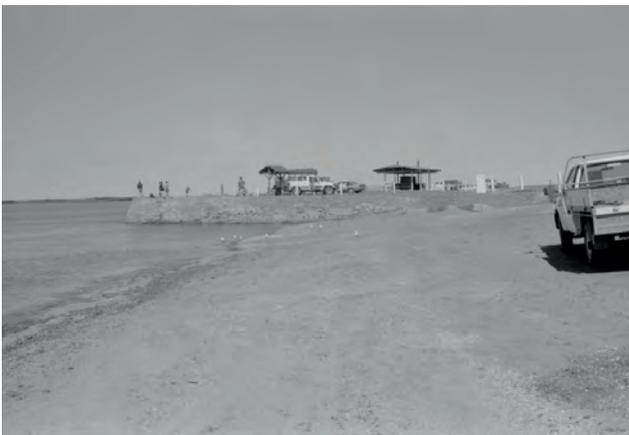
Figure 46. Northeast elevation of Wharf wall in 1994 (Source: State Library of Western Australia).t

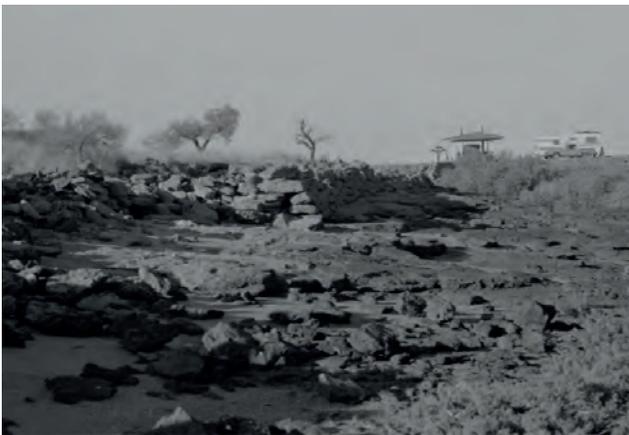
Figure 47. Remains of wharf retaining wall, north past railway station in 1994 (Source: State Library of Western Australia).

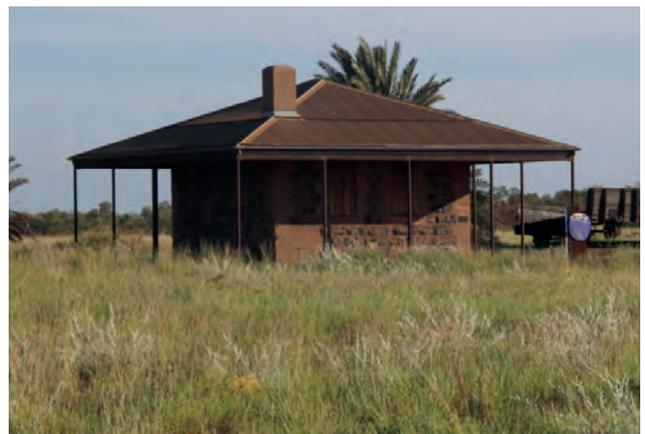
Figure 49. Cossack School in 2017 (Source: TPG).

The Cossack School building was built in 1896/97 to replace an earlier building that was destroyed by a cyclone in 1894. Cossack School is constructed of local bluestone walls with lime mortar and quoining to corners and is the only extant building remote from the town core. It is situated on Perseverance Street, adjacent to the tramway alignment. As part of the conservation works that were carried out in 2000, extensive restoration and reconstruction works were completed.

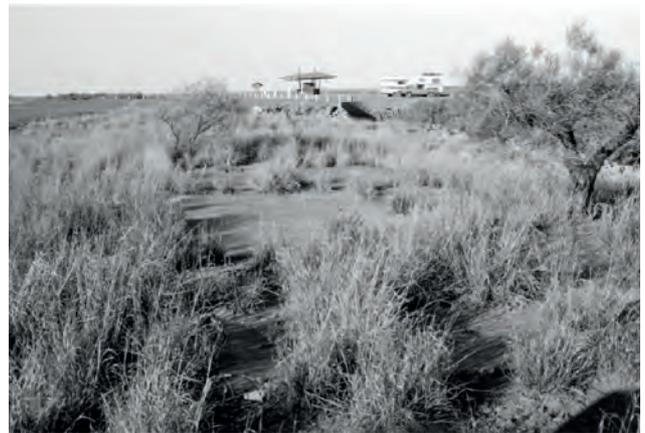
Figure 51. Floor slab and remains of Cossack Railway Station in 1994 (Source: State Library of Western Australia).

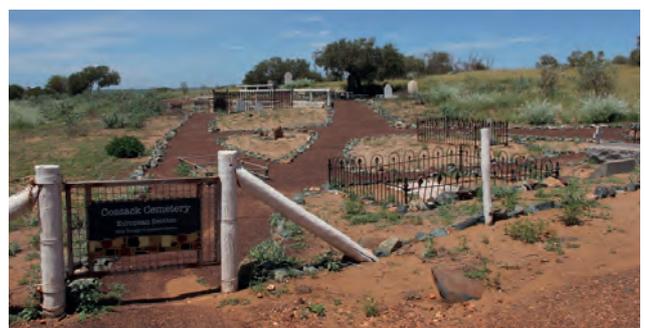
Figure 53. European Section of Cossack Cemetery in 2017 (Source: TPG, 2017).

The place remains in poor condition and many graves have no markers due to shifting in sand, cyclone damage and natural deterioration. The place was classified by the National Trust on 7 June 1977.

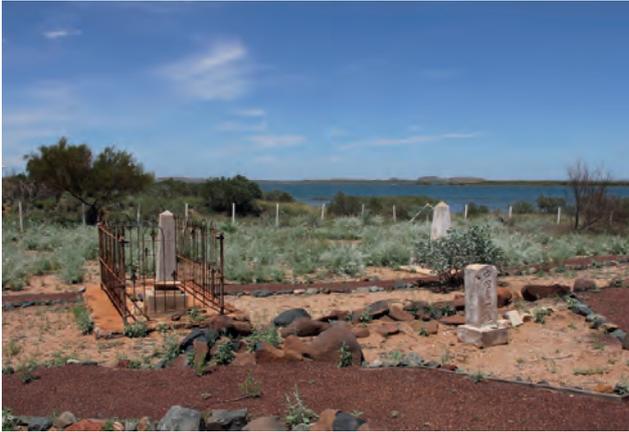
Figure 54. Japanese Section of Cossack Cemetery in 2017 (Source: TPG, 2017).

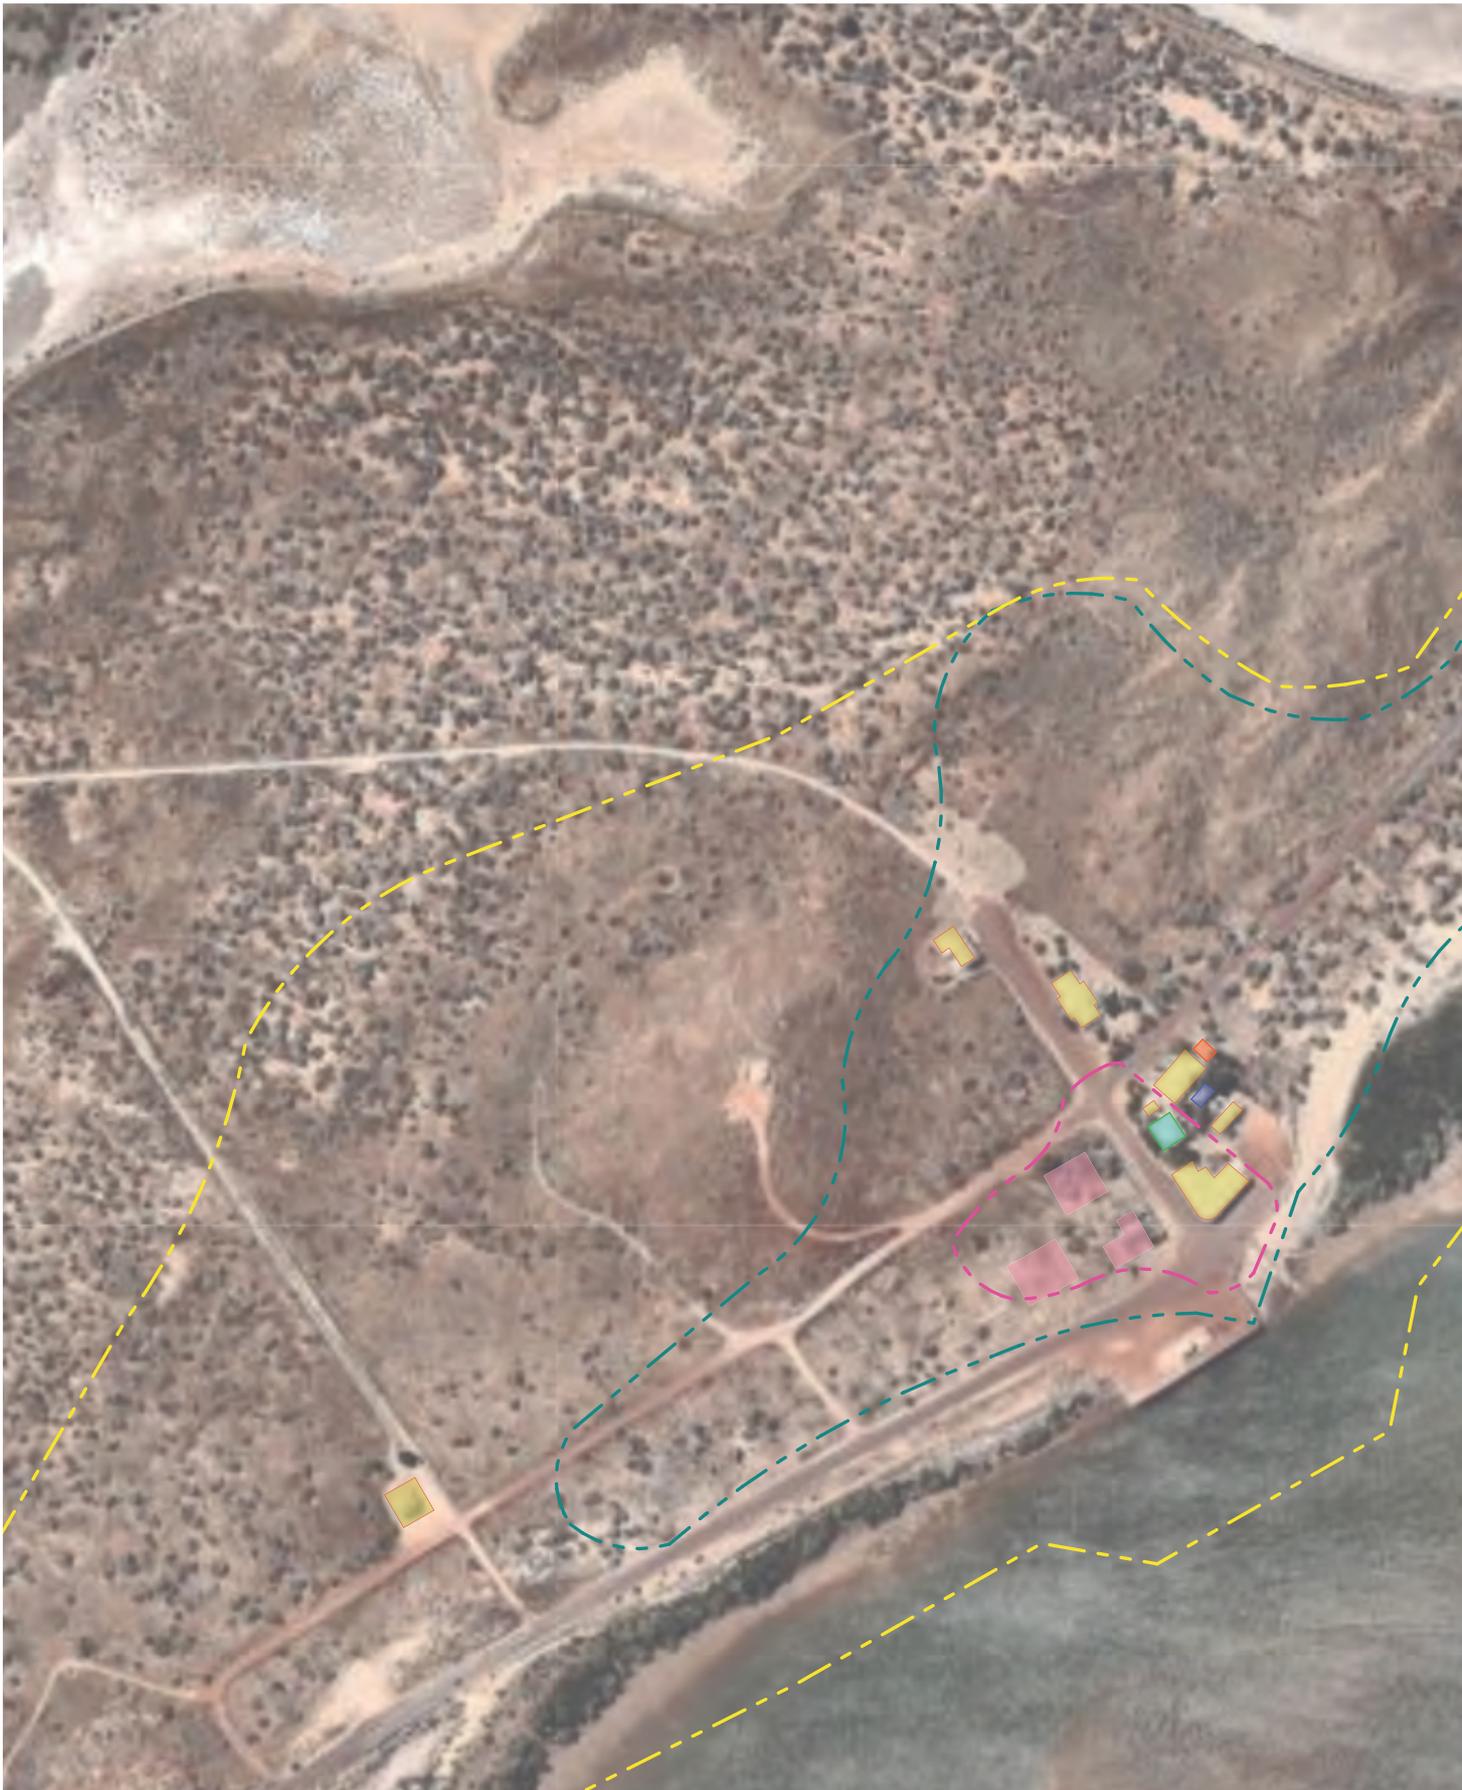
Figure 55. Chronological Sequence, according to Nayton, 1990 (TPG artwork over Nearmaps image, 2017).

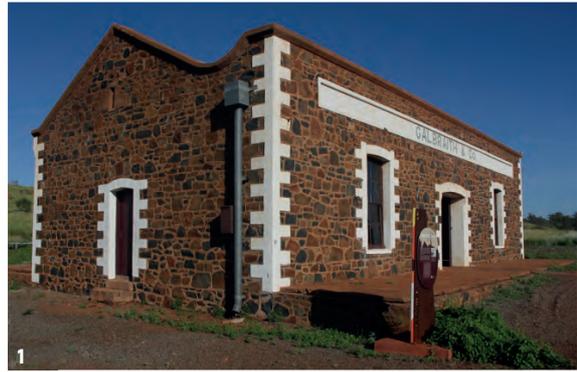
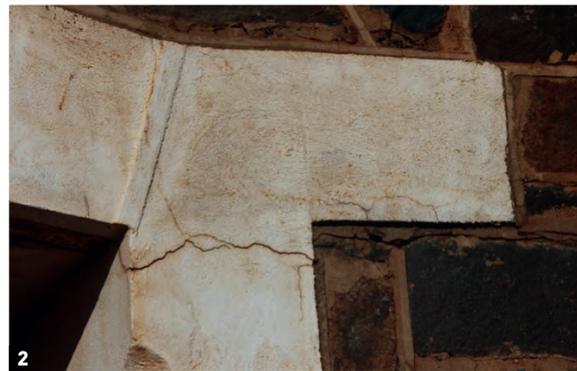
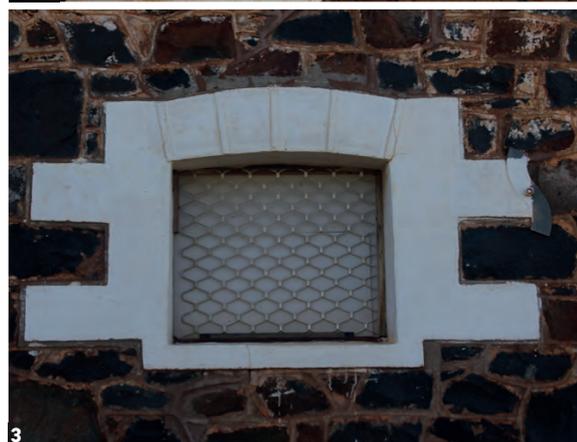
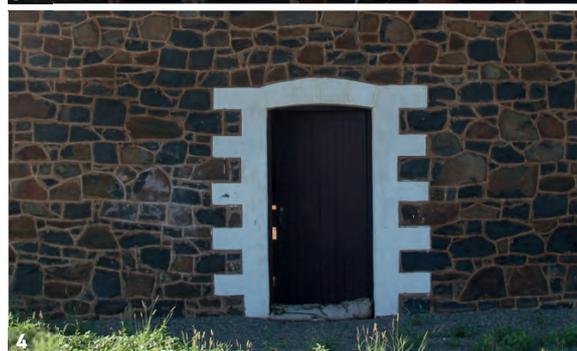
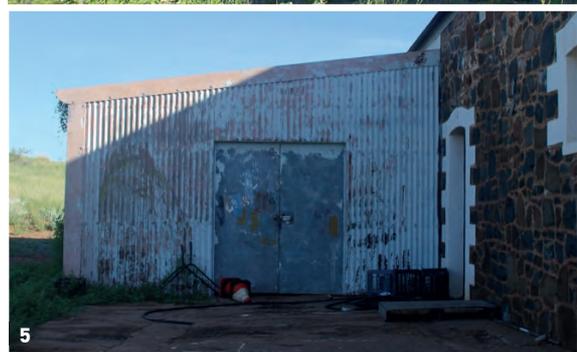
Galbraith's Store	
External	
Roof	Corrugated metal roof sheeting
Battens	New battens
Rafters and Purlins	New timber king post trusses. Purlins with trip-l-grips to both sides
Gutters	New PGI box gutter
Downpipes	New PGI downpipe
Fascia's and Scotia	Rendered masonry frieze panel with Galbreith's Store logo
Bargeboards	N/A
Eaves	N/A
Soffits	N/A
Eaves Brackets	N/A
Ceiling Joists	N/A
Walls	Bluestone random rubble with some bastard tuck pointing
Openings	Openings with aluminum screening, and two double hung timber windows with four clear glazed panels each sash. Three single leaf panelled timber door and one double sliding timber panelled door
Ground	Cement topping on bluestone foundation to match existing façade
Electrics	N/A
Others	Corrugated metal sheeting lean-to annexe attached to portion of wall
Internal	
Ceiling/Roof	Exposed timber king post trusses
Walls	Reconstructed bluestone random rubble with some bastard tuck pointing

Openings	Two openings with aluminum screening, and two double hung timber windows with four clear glazed panels each sash
Floors	Concrete floors
Fixtures and Fittings	Picture railings
Electrics	Six florescent light and six ceiling fans and switchboard
Others	Fire extinguisher
Condition	
<p>Generally, the place is in a fair condition. Areas that require attention include:</p> <ul style="list-style-type: none"> • Perform suggested maintenance works as per Item 9 of the CWS • Remove all redundant electrical wires • Test existent mortar composition and paint scrapes investigation on lean-to annexe and to quoining's • Engage a heritage structural engineer for structural report before fixing major cracks • Treat efflorescence accordingly to Item 11 of the CWS • Manually rake out all cement pointing and repair with traditional mortar • Reinstate windows as per CWS • Paint scrapes investigation to quoining, depending on existing integrity of cement render consider leaving it natural, otherwise paint with Bauwerk paint • Rust treat and paint lean-to annexe accordingly to paint scrapes result • All works to be performed accordingly to Section 11 of CWS <p><i>Note: Please refer to Conservation Works Schedule 2017</i></p>

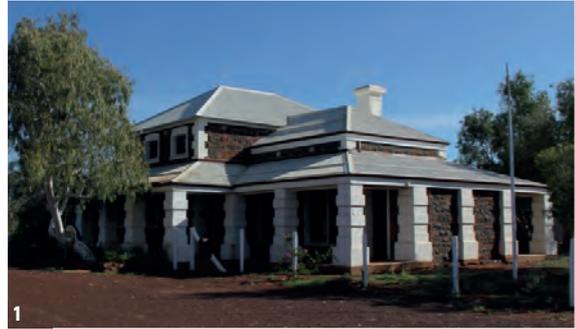
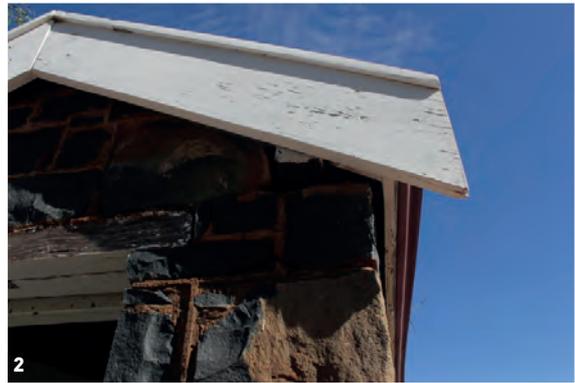
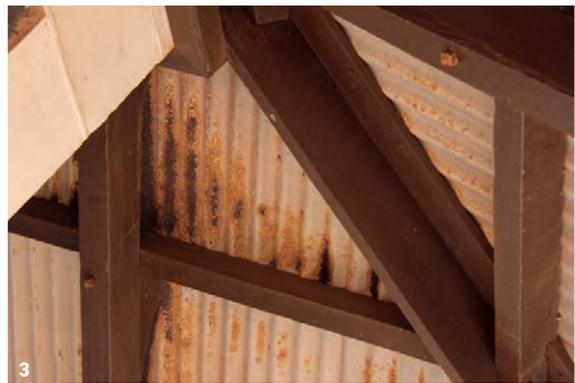
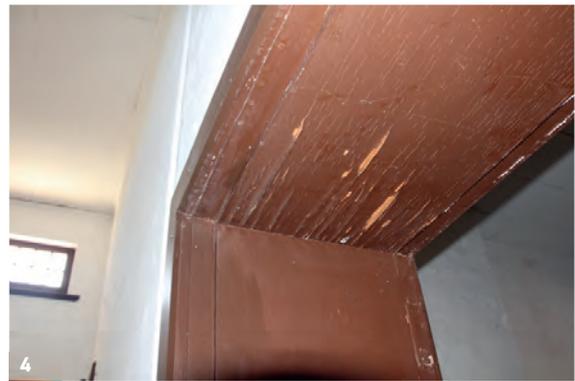
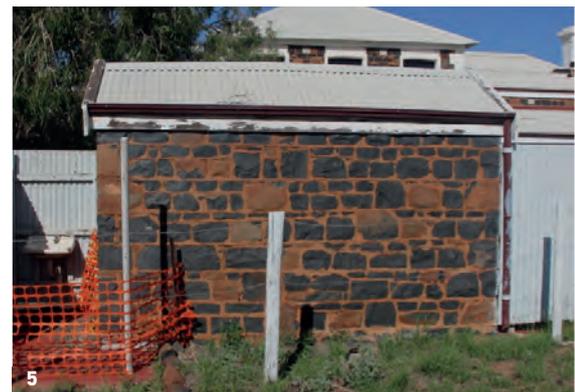
The Old Court House	
External	
Roof	Corrugated metal roof sheeting, Cyclone tie downs
Battens	N/A
Rafters and Purlins	Timber verandah beams
Gutters	PGI ovolo gutter
Downpipes	PVC downpipe
Fascia's and Scotia	Scotia under PGI ovolo gutter
Bargeboards	N/A
Eaves	N/A
Soffits	Mortar soffit to chimney
Eaves Brackets	N/A
Ceiling Joists	N/A
Walls	Bluestone random ashlar with rendered quoining at corners and rendered window reveals
Openings	Timber French glazed windows and paneled timber windows Three paneled timber door
Ground	Cement topping to verandah floor
Electrics	Florescent lighting, CCTV, infra-red motion sensor and wiring
Others	Painted tendered chimney to northeast of building. Rendered stonework verandah columns with alternate banding
Internal	
Ceiling/Roof	PGI ripple iron painted ceiling
Walls	Rendered dado and rough rendered stonework
Openings	Timber French glazed windows and paneled timber windows. Three paneled timber door

Floors	Concrete floors
Fixtures and Fittings	Various display cabinets, benches and internal fittings
Electrics	CCTV and florescent lighting
Others	Fireplace with timber mantle
Toilets	
Custom orb galvanised iron with timber fascia, bluestone wall, ledged and braced timber door to each toilet, no privacy latch, cement topping to verandah floor severely cracks at re-entrant angles, remnants of original cover remain	
Condition	
Generally, the place is in a fair condition. Areas that require attention include:	
<ul style="list-style-type: none"> • Perform suggested maintenance works on Item 9 of CWS • Remove all redundant electrical wires • Test existent mortar composition and investigate paint scrapes • Engage a heritage structural engineer for structural report before fixing major cracks • Manually rake out all cement pointing and repair with traditional mortar and limewash • Roof structure not inspected • Repair roof sheeting • Repair rainwater system • Repair all bargeboards, eaves and so its • Repair loose roof sheeting • Repair all metal ceilings, paint finish • Run new underground power supply, internal conduit vertical drops from ceiling, use galvanised metal conduit and industrial GPO's/switches. GPO's to be surface mounted galvanised boxes and face panels. All metal fittings to be earthed to code • Repair toilets and toilet roof structure • Repair joinery doors and windows • All works to be performed accordingly to Section 11 of CWS

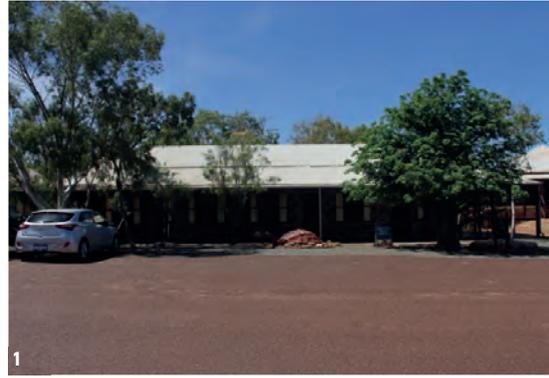
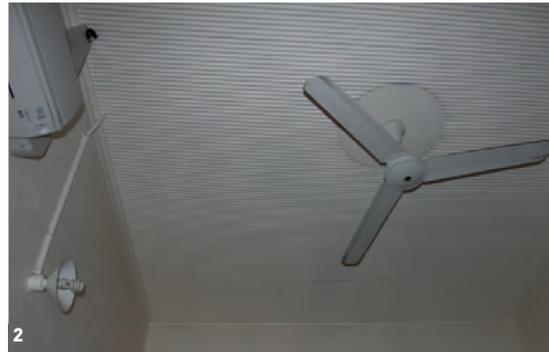
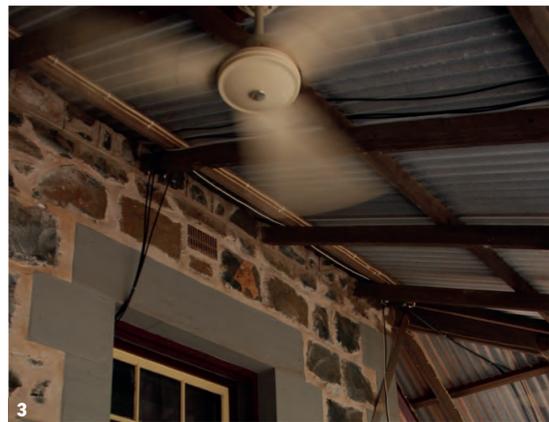
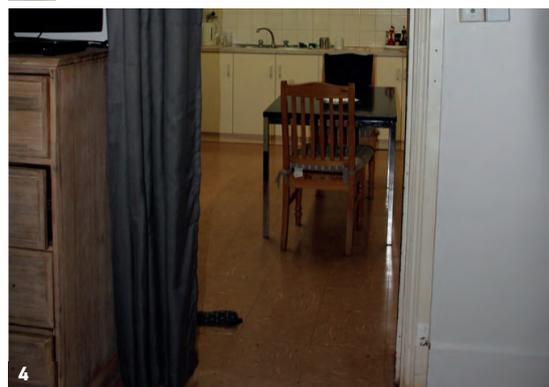
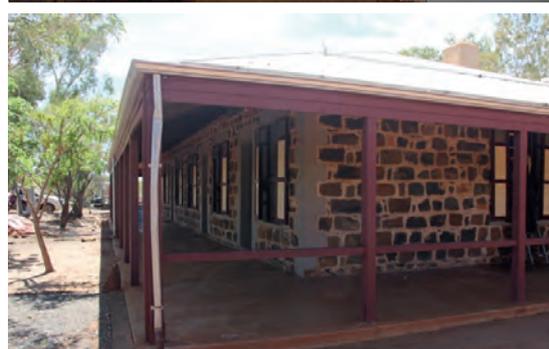
Police Quarters	
External	
Roof	Custom orb fixed with cyclonic fixings and mini corrugated metal roof sheeting to toilet
Battens	N/A
Rafters and Purlins	Centres connected to beam and nailed to rafters
Gutters	Ovolo gutter
Downpipes	Circular aluminum downpipes
Fascia's and Scotia	Timber fascia
Bargeboards	N/A
Eaves	N/A
Soffits	Mortar soffit to chimney
Eaves Brackets	N/A
Ceiling Joists	Beam connected to post
Walls	Coursed random rubble bluestone and corrugated metal sheeting to form laundry, shower and toilet addition
Openings	Double hung windows with fixed fly screen, Timber cyclone shutters with glazed pane over hinged to stonework. four panel windows, timber panel door and timber framed fly screen door. Rendered quoining at door and window openings.
Ground	Polished decorative floor finish, cement and tiles
Electrics	Aerial over ridge, ceiling fan, outdoor light. television antennae and cables, electric wiring, switchboard and electric power points throughout

Others	Concrete chimney
Internal	
Ceiling/Roof	Ripple iron ceiling
Walls	Gloss paint finish, rendered wall, timber rail to wall
Openings	Timber French glazed windows and paneled timber windows. Three paneled timber door
Floors	Vinyl floor
Fixtures and Fittings	Sink, bench top with cupboards under, cupboards over and stove
Electrics	Two hanging florescent tubes on chains, ceiling ran and power points, air conditioning, light and GPO's
Others	Fireplace with timber mantle
Condition	
<p>Generally, the place is in a fair condition. Areas that require attention include:</p> <ul style="list-style-type: none"> • Perform suggested maintenance works on Item 9 of CWS • Run new underground power supply, internal conduit vertical drops from ceiling, use galvanised metal conduit and industrial GPO's/switches. GPO's to be surface mounted galvanised boxes and face panels. All metal fittings to be earthed to code • Inspect what is under vinyl floors, and depending on the integrity of existing floor below it leave original floor exposed (eg. concrete floor), make good • Paint scrapes investigation to quoining, depending on existing integrity of cement render consider leaving it natural, otherwise paint with Bauwerk paint • Inspect roof structure and repair accordingly to section Recommended Building Works of this report • Reinstate 02 doors to room 11 and 4 to match existing timber panelled doors • All works to be performed accordingly to Section 11 of CWS <p><i>Note: Please refer to Conservation Works Schedule 2017</i></p>

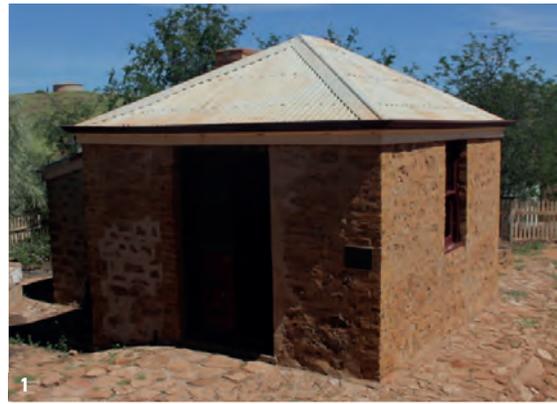
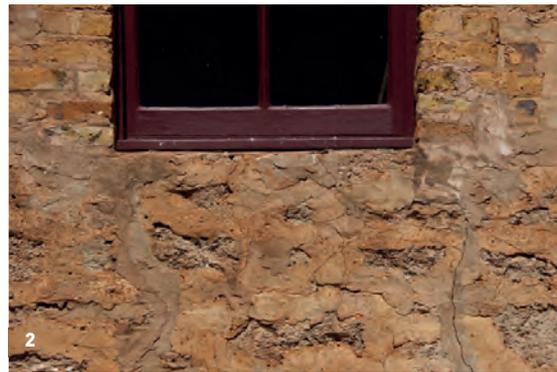
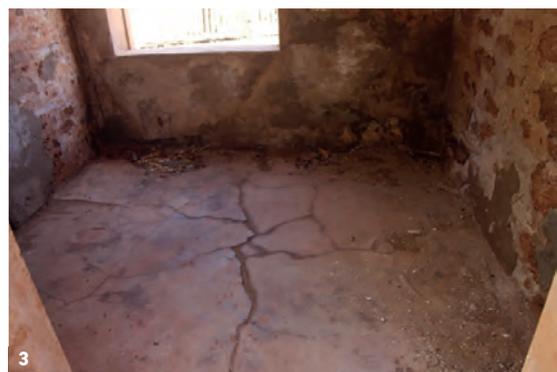
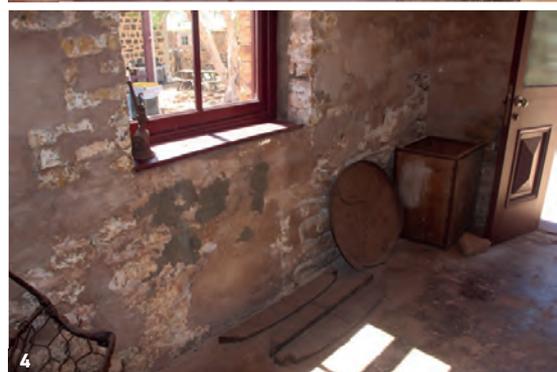
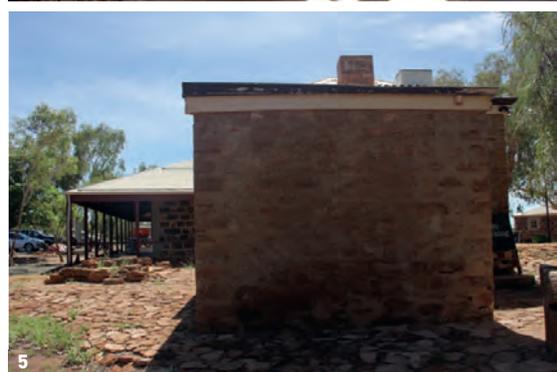
<i>The Bakehouse</i>	
External	
Roof	Corrugated roof sheeting and cyclone fixings
Battens	Hardwood battens
Rafters and Purlins	Hardwood rafters
Gutters	Ogee gutter
Downpipes	Circular downpipes
Fascia's and Scotia	Hardwood fascia
Bargeboards	Hardwood bargeboards
Eaves	N/A
Soffits	N/A
Eaves Brackets	N/A
Ceiling Joists	Timber joist
Walls	Friable limestone walls
Openings	Timber window frame, double side hung timber door
Ground	Friable limestone floor random
Electrics	Security light
Others	Bluestone and cement tank stand
Internal	
Ceiling/Roof	Painted corrugated metal sheeting with timber cornice painted
Walls	Rough cement render
Openings	Timber window frame, double side hung timber door
Floors	Concrete
Fixtures and Fittings	Fluorescent light
Electrics	Switchboard and power point
Others	Brickwork fireplace
Condition	
<p>Generally, the place is in a fair condition. Areas that require attention include:</p> <ul style="list-style-type: none"> • Perform suggested maintenance works on Item 9 of CWS • Test existent mortar composition and investigate paint scrapes • Engage a heritage structural engineer for structural report before fixing major cracks • Manually rake out all cement pointing and repair with traditional mortar • Replace bargeboards where deteriorated beyond repair, prepare and repaint • Repair major crack North-western external wall • All works to be performed accordingly to Section 11 of CWS <p><i>Note: Please refer to Conservation Works Schedule 2017</i></p>

Photographs	
<ol style="list-style-type: none"> 1 View of southwest elevation looking northeast from Pearl Street 2 Detail of mortar composition 3 Detail of floor composition 4 Detail of mortar composition and timber window frame 5 View of northwestern elevation
