COSSACK

DRAFT Volume 1: Conservation Management Plan
February 2018

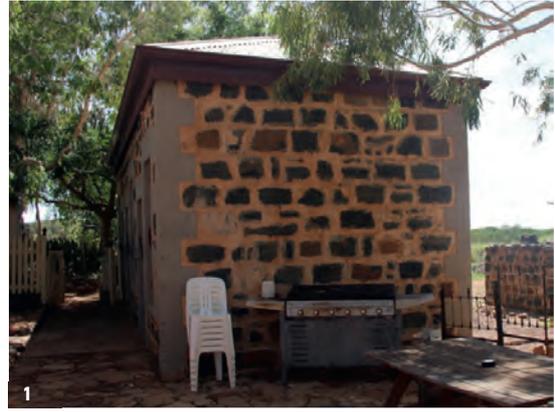
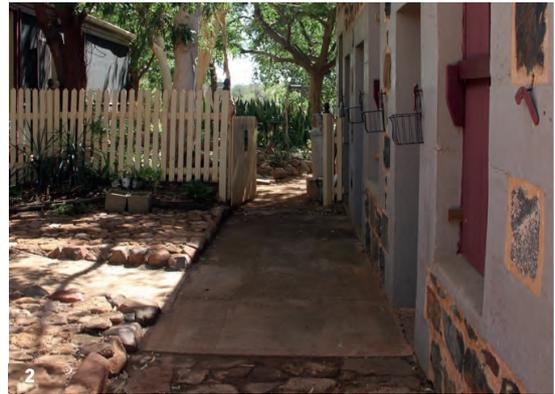
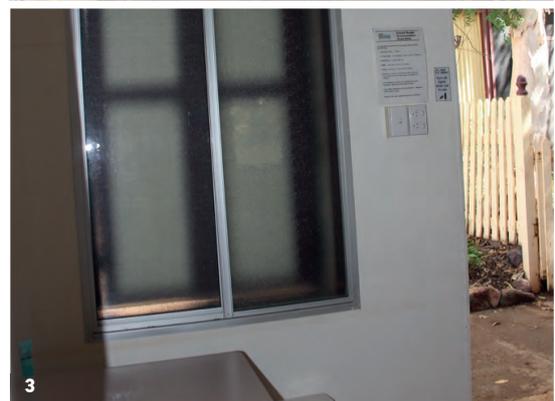
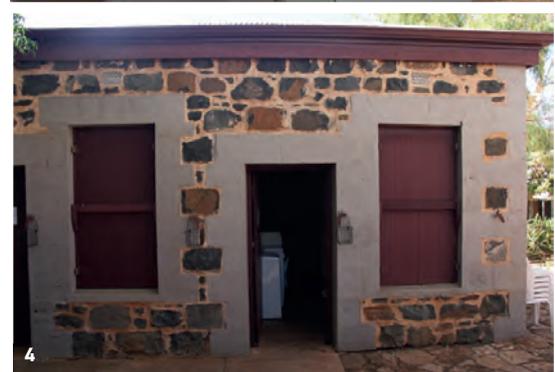
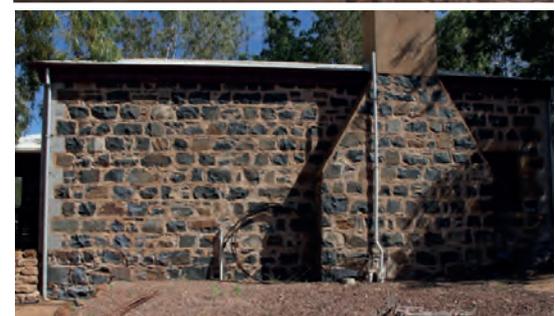
<i>The Cookhouse</i>	
External	
Roof	Corrugated roof sheeting
Battens	N/A
Rafters and Purlins	Purlins
Gutters	Ovolo gutter
Downpipes	Circular downpipe
Fascia's and Scotia	N/A
Bargeboards	timber mounding under gutter
Eaves	N/A
Soffits	N/A
Eaves Brackets	N/A
Ceiling Joists	MS angle roof trusses
Walls	Coursed bluestone in lime mortar, pointed with cement mortar. Rendered quoining at corners and around doors
Openings	Cyclone shutters to window opening, braced panel doors
Ground	Stone and cement floors
Electrics	Electrical conduit on wall
Others	Rendered chimney, and gas bottle connections
Internal	
Ceiling/Roof	Corrugated metal roof. One florescent tube lighting
Walls	Rendered and tiled walls
Openings	Shutters only and timber door frame with ledge and braced door with rim lock
Floors	Concrete and ceramic tiles
Fixtures and Fittings	Fluorescent light and vanity, shower, sink, toilet fixtures
Electrics	Light switch
Others	Fireplace

Condition	
<p>Generally, the place is in a fair condition. Areas that require attention include:</p> <ul style="list-style-type: none"> • Perform suggested maintenance works on Item 9 of CWS • Remove concrete floor front verandah, replace with limestone to match surroundings • Remove metal frame window from the bathroom, substitute for timber window, with glass panes, to match existing • Paint scrapes investigation to quoining, depending on existing integrity of cement render consider leaving it natural, otherwise paint with Bauwerk paint • Inspect and make good to rainwater system • All works to be performed accordingly to Section 11 of CWS <p><i>Note: Please refer to Conservation Works Schedule 2017</i></p>	
Photographs	
<ol style="list-style-type: none"> 1 View of southwest elevation looking northeast 2 Detail of floor composition 3 Detail of aluminum window frame and glazing 4 Detail of quoining on façade and timber panel windows 5 View of mortar composition of southeast elevation

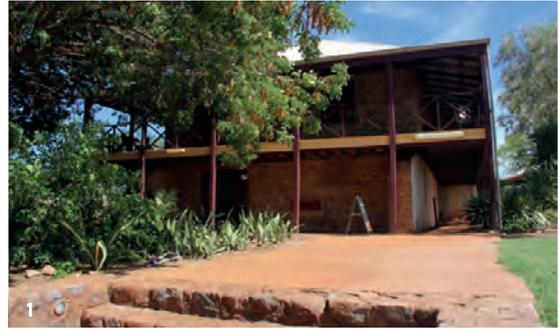
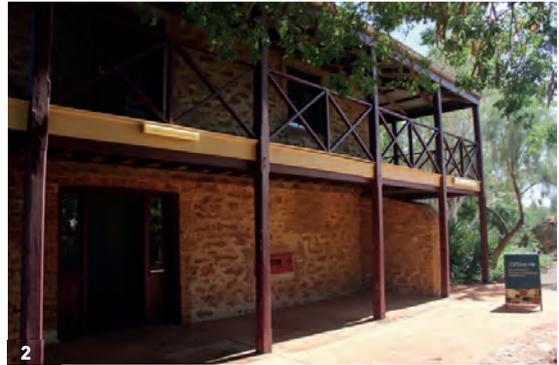
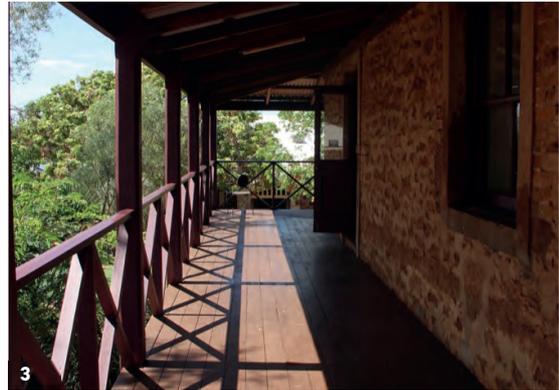
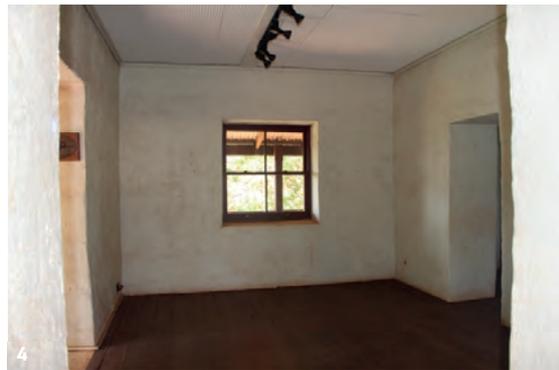
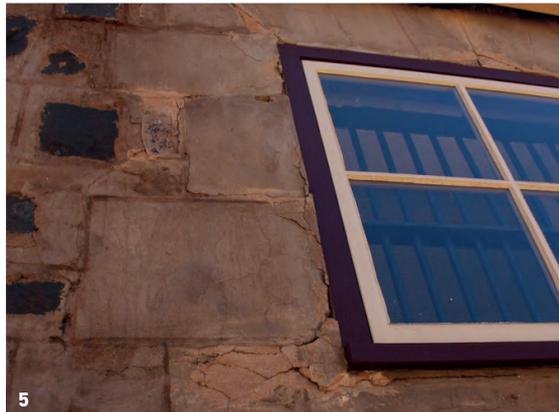
Post and Telegraph Office	
External	
Roof	Corrugated roof sheeting
Battens	Battens with screw to each rafter
Rafters and Purlins	Rafters at centres
Gutters	Ogee gutter
Downpipes	N/A
Fascia's and Scotia	Fascia board and scotia mounding
Bargeboards	N/A
Eaves	N/A
Soffits	N/A
Eaves Brackets	N/A
Ceiling Joists	N/A
Walls	Friable limestone walls, ballast brick quoining to corners and window opening
Openings	Reconstructed double hung timber window frames and half glazed double French doors
Ground	Cement finish and steep timber steps and railing to verandah
Electrics	N/A
Others	Verandah posts, handrail and beams and stone base with existing tank stand
Internal	
Ceiling/Roof	Corrugated metal ceiling with timber scotia
Walls	Whitewashed walls and hardwash plaster finish
Openings	Reconstructed double hung timber window frames and half glazed double French doors
Floors	Concrete and timber boards
Fixtures and Fittings	Telephone and power sockets

Electrics	Mini spotlights recessed to ceiling, fixtures and fittings, telephone and power sockets
Others	N/A
Condition	
<p>Generally, the place is in a fair condition. Areas that require attention include:</p> <ul style="list-style-type: none"> • Perform suggested maintenance works on Item 9 of CWS • Test existent mortar composition and investigate paint scrapes • Engage a heritage structural engineer for structural report before fixing major cracks • Manually rake out all cement pointing and repair with traditional mortar • Repair with traditional mortar base wall • Remove all redundant electrical wires • Repair major cracks • All works to be performed accordingly to Section 11 of CWS <p><i>Note: Please refer to Conservation Works Schedule 2017</i></p>	
Photographs	
<ol style="list-style-type: none"> 1 View of southeast elevation looking northwest 2 Detail of mortar composition and timber posts of south western elevation 3 Detail of timber decking composition to first floor balcony 4 Typical internal room to first floor 5 Detail of quoining and mortar composition

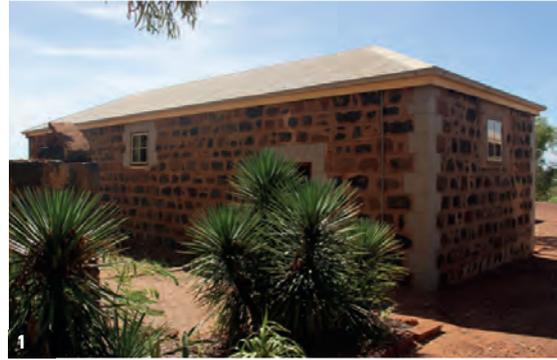
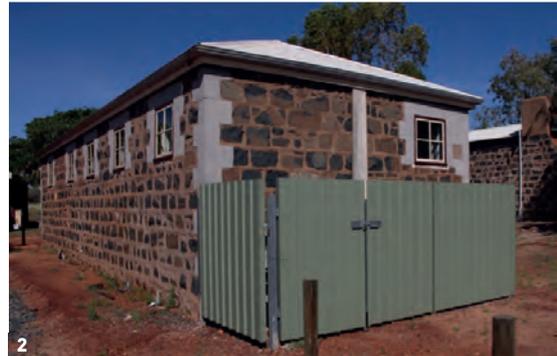
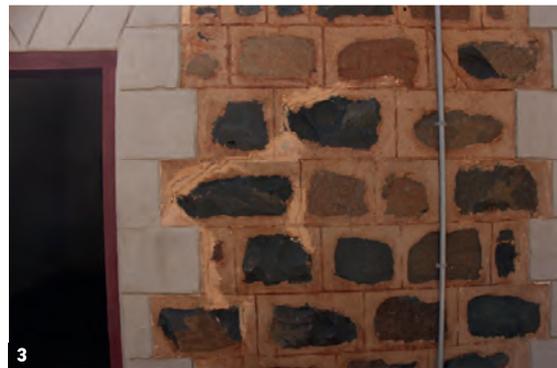
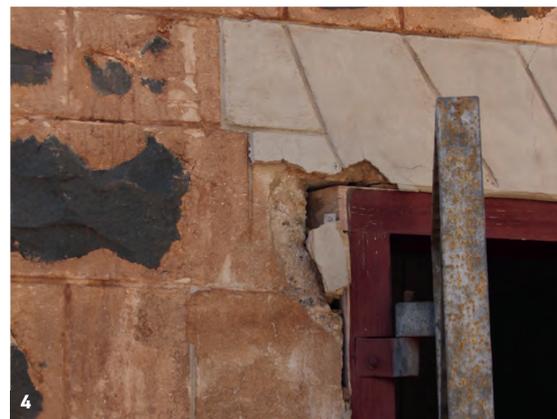
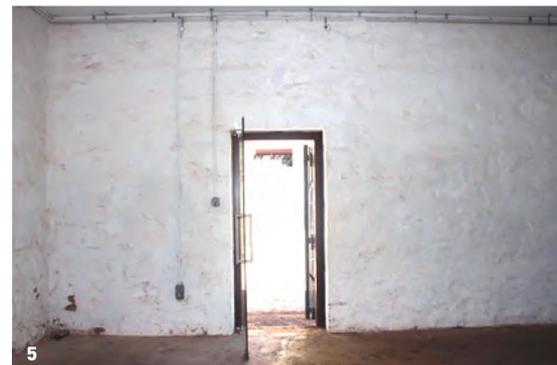
Gaol	
External	
Roof	Corrugated roof sheeting with ridge capping
Battens	N/A
Rafters and Purlins	Timber
Gutters	Ogee gutter
Downpipes	Circular downpipes
Fascia's and Scotia	Timber fascia
Bargeboards	N/A
Eaves	N/A
Soffits	N/A
Eaves Brackets	N/A
Ceiling Joists	N/A
Walls	Coursed bluestone, original lime mortar pointed over with cement render. Rendered quoining to corners
Openings	Reconstructed casement timber windows and restored steel bars, and steel door with bars and timber frame
Ground	N/A
Electrics	Affixed air conditioning unit to wall
Others	Custom orb fencing
Internal	
Ceiling/Roof	Corrugated metal, scotia architrave and fixings
Walls	Partially rendered stonework
Openings	Steel bars and hinged glass door
Floors	Concrete floors
Fixtures and Fittings	Picture railings at all walls
Electrics	Light switch to NW elevation
Others	Plaque on NE elevation
Condition	
<p>Generally, the place is in a fair condition. Areas that require attention include:</p> <ul style="list-style-type: none"> • Perform suggested maintenance works on Item 9 of CWS • Remove metal fence to power generator and add natural timber picket fence • Test existent mortar composition and investigate paint scrapes • Engage a heritage structural engineer for structural report before fixing major cracks • Repair rainwater system (100%) • Repair major cracks • Repair front door quoining with like to like mortar and paint • Manually rake out all cement pointing and repair with traditional mortar and limewash • Repair loose roof sheeting (50%) • Repair and paint metal ceilings (20%) • Paint scrapes investigation to quoining, depending on existing integrity of cement render consider leaving it natural, otherwise paint with Bauwerk paint • All works to be performed accordingly to Section 11 of CWS <p>Note: Please refer to Conservation Works Schedule 2017</p>

Photographs	
<ol style="list-style-type: none"> 1 View of northwest elevation looking southeast 2 Existing custom orb fencing to northeast elevation 3 Detail of quoining and mortar composition 4 Detail of timber frame and mortar composition to northwest elevation 5 Typical internal wall details

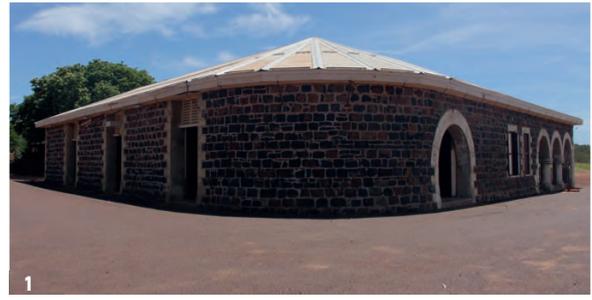
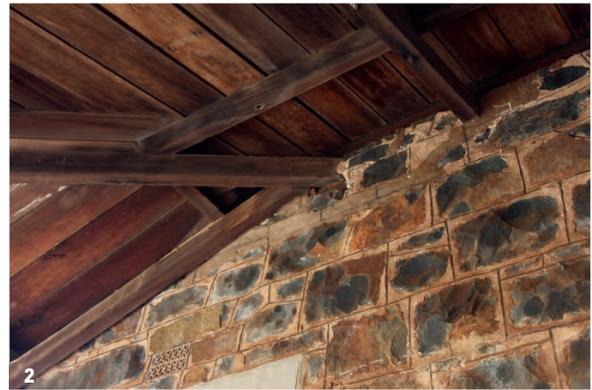
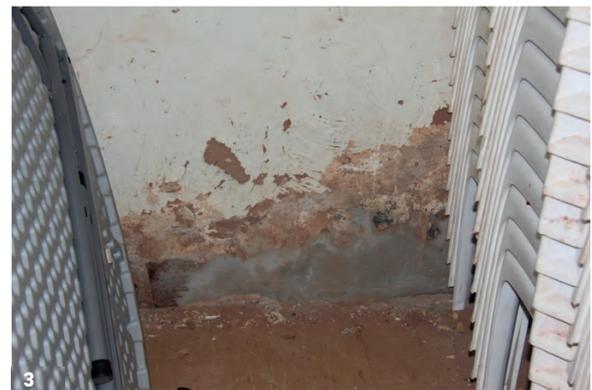
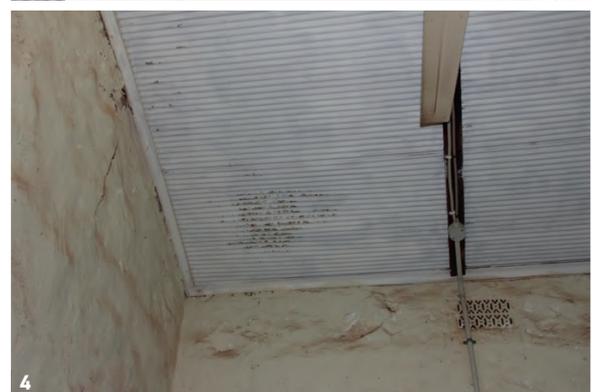
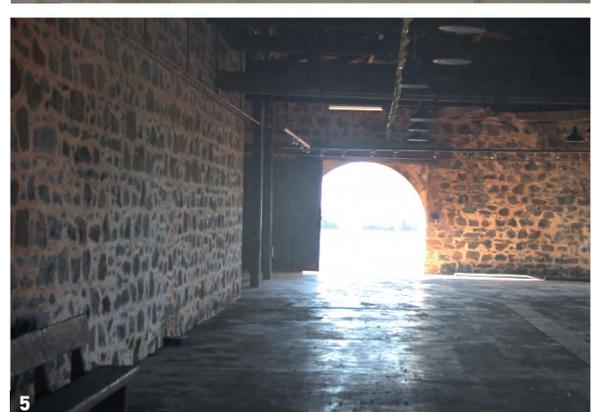
Customs House and Bond Store	
External	
Roof	Corrugated roof sheeting and cyclone fixings
Battens	Natural Jarrah
Rafters and Purlins	Natural Jarrah
Gutters	Valley gutter
Downpipes	N/A
Fascia's and Scotia	Jarrah painted, fixed to wall
Bargeboards	Jarrah painted, fixed to wall
Eaves	Eaves to Bonds Store
Soffits	Soffits to Bonds Store painted corrugated metal sheeting
Eaves Brackets	Painted metal
Ceiling Joists	N/A
Walls	Coursed bluestone, Repointed in lime mortar. Rendered quoining to corners. Rendered arches with quoining with pilasters. Metal balustrades
Openings	Double hung timber window and double casement timber framed shutters. Timber panelled sliding door
Ground	Red bitumen and jarrah boards with jarrah joists
Electrics	Air conditioning units and ducts. Various electrical and other telecommunications ducts
Others	Valance with corrugated metal sheets in timber frames, painted jarrah. Fluorescent lighting fittings. vent duct next to the male toilet entrance, painted

Internal	
Ceiling/Roof	Corrugated metal ceiling, painted
Walls	Coursed bluestone, original lime mortar. Rendered quoining, white tiles. Rendered plaster. Rustic limewash. Cast iron wall vent over all doors. Fireplace
Openings	Double hung timber window and double casement timber framed shutters. Timber panelled sliding door fixed louvered timber frame, double side hung door. Outer timber doors are of four panels, upper ones are black fly screen
Floors	Concrete floors
Fixtures and Fittings	Room adapted to Cafe use. Exhibition special lighting fitting. Picture railing
Electrics	Room adapted to Cafe use. General electrical wiring
Others	Gas bottles, air conditioning unit. Room adapted to cafe use
Condition	
<p>Generally, the place is in a fair condition. Areas that require attention include:</p> <ul style="list-style-type: none"> • Perform suggested maintenance works on Item 9 of CWS • Remove all redundant electrical wires • Test existent mortar composition • Manually rake out all cement pointing and repair with traditional mortar • Repair all metal ceilings, paint finish • Repair 01 door to room 5, 02 doors to Cafe • Repair all bargeboards, eaves and so its • Repair roof sheetings • Once defined use, repair cafe installations • Run new underground power supply, internal conduit vertical drops from ceiling, use galvanised metal conduit and industrial GPO's/switches. GPO's to be surface mounted galvanised boxes and face panels. All metal fittings to be earthed to code • Paint scrapes investigation to quoining, depending on existing integrity of cement render consider leaving it natural, otherwise paint with Bauwerk paint • All works to be performed accordingly to Section 11 of CWS <p>Note: Please refer to Conservation Works Schedule 2017</p>

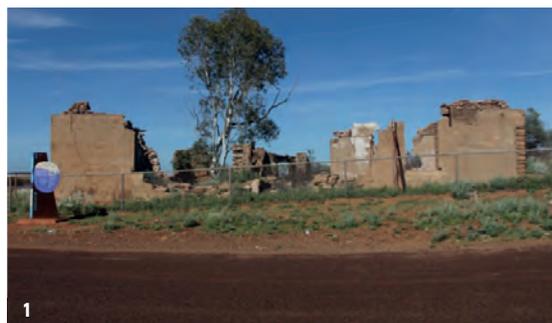
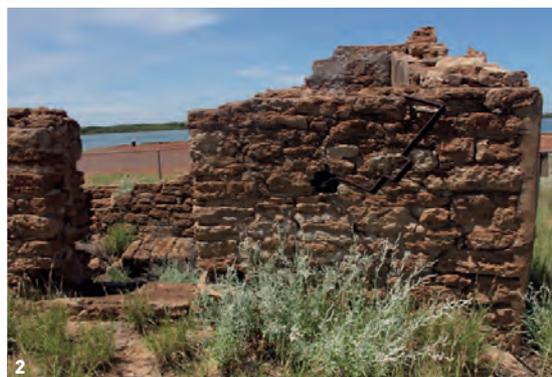
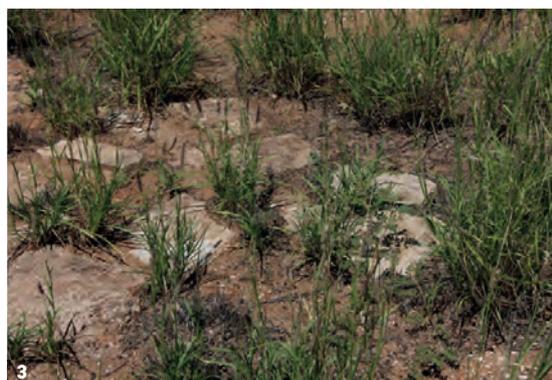
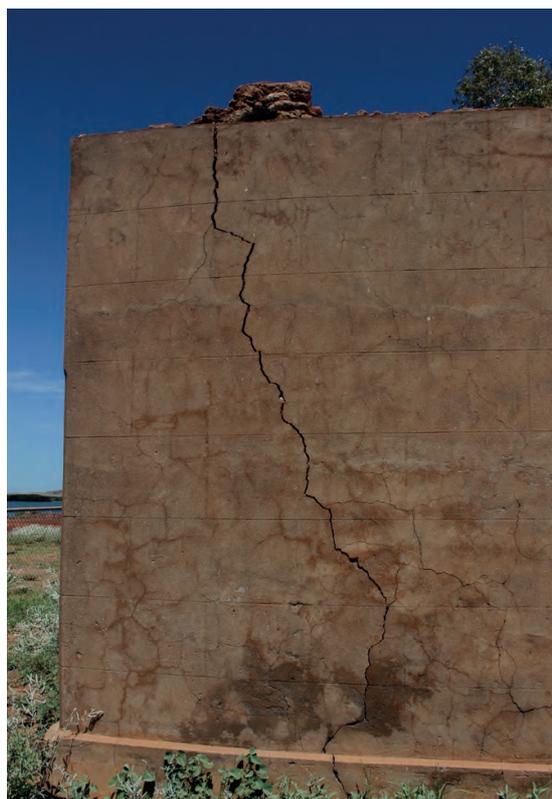
Registrar's Office (Mercantile Store)	
External	
Roof	N/A
Battens	N/A
Rafters and Purlins	N/A
Gutters	N/A
Downpipes	N/A
Fascia's and Scotia	N/A
Bargeboards	N/A
Eaves	N/A
Soffits	N/A
Eaves Brackets	N/A
Ceiling Joists	N/A
Walls	Remnants of original stone wall with cement render and cement plinth
Openings	N/A
Ground	Evidence of stone foundation
Electrics	N/A
Others	N/A
Internal	
Ceiling/Roof	N/A
Walls	Remnants of original stone wall with cement render and cement plinth
Openings	N/A
Floors	Evidence of stone foundation
Fixtures and Fittings	N/A
Electrics	N/A
Others	N/A
Condition	
<p>Generally, the place is in a fair condition. Areas that require attention include:</p> <ul style="list-style-type: none"> • Perform suggested maintenance works on Item 9 of CWS • Test existent mortar composition before repairs • Engage a heritage structural engineer for structural report before fixing major cracks • Repair major crack on the NE elevation with like to like mortar • All works to be performed accordingly to Section 11 of CWS <p>Note: Please refer to Conservation Works Schedule 2017</p>

Photographs	
<ol style="list-style-type: none"> 1 View of remains looking southwest 2 Detail of steel remains within wall 3 Evidence of stone foundation remains 4 Detail of cracking to northeast elevation

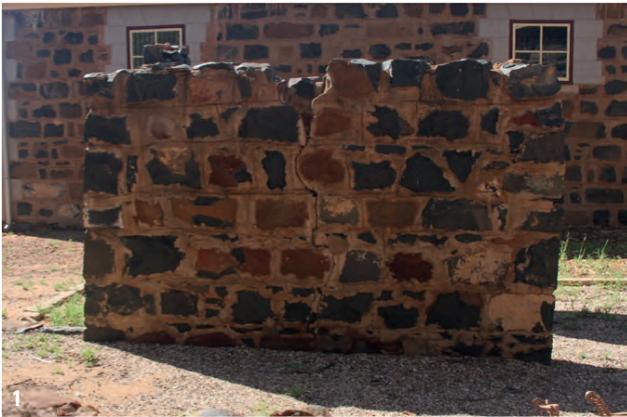
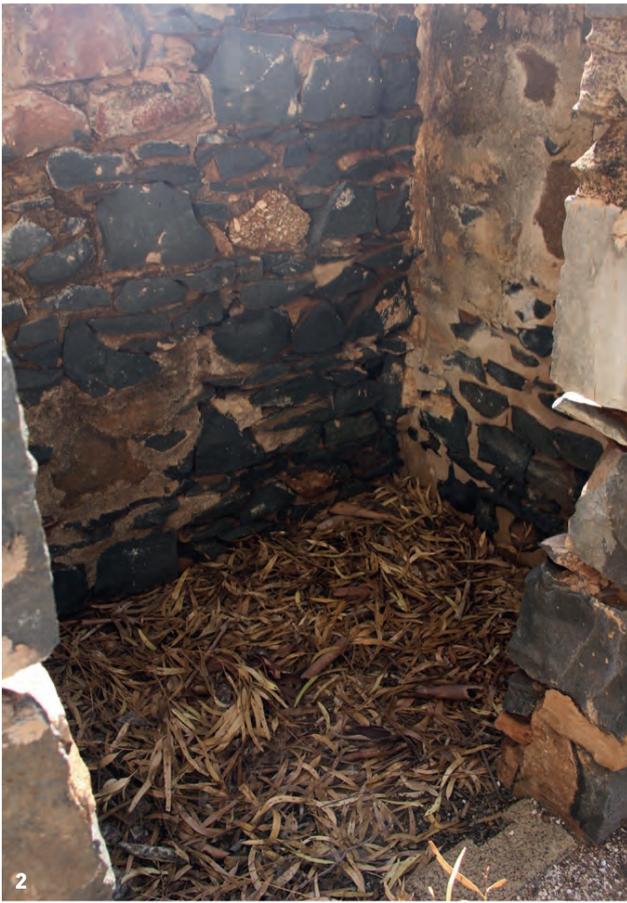
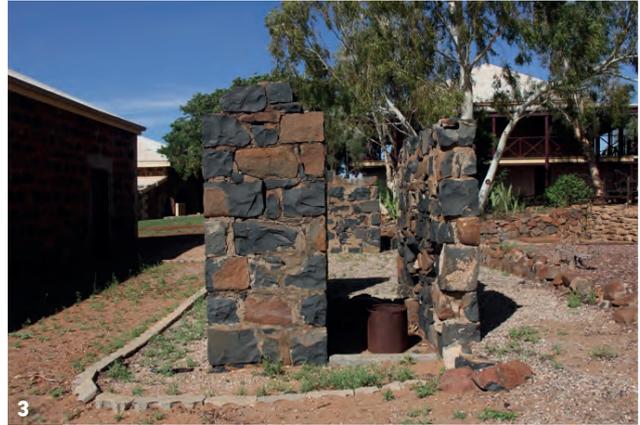
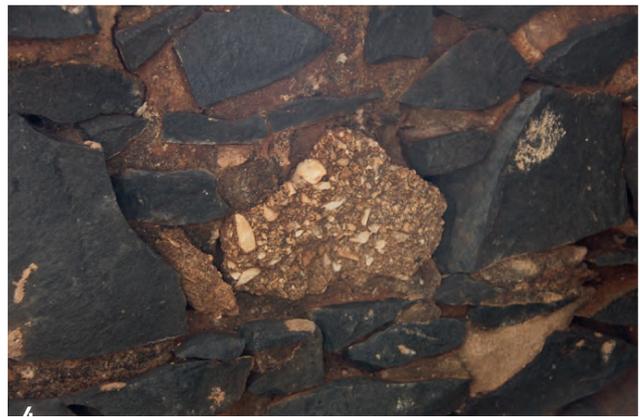
<i>The Outbuildings</i>	
External	
Roof	N/A
Battens	N/A
Rafters and Purlins	N/A
Gutters	N/A
Downpipes	N/A
Fascia's and Scotia	N/A
Bargeboards	N/A
Eaves	N/A
Soffits	N/A
Eaves Brackets	N/A
Ceiling Joists	N/A
Walls	Coursed bluestone approximately 1.5m in height, stabilised with cement and shell mortar. Remains of hold down in one wall
Openings	N/A
Ground	Cement brick
Electrics	N/A
Others	N/A
Internal	
Ceiling/Roof	N/A
Walls	Coursed bluestone approximately 1.5m in height, stabilised with cement and shell mortar. Remains of hold down in one wall
Openings	N/A
Floors	Cement foundation
Fixtures and Fittings	N/A
Electrics	N/A
Others	N/A
Condition	
<p>Generally, the place is in a fair condition. Areas that require attention include:</p> <ul style="list-style-type: none"> • Perform suggested maintenance works on Item 9 of CWS • Test existent mortar composition before repairs • Clean rubbish and maintain clean floors • All works to be performed accordingly to Section 11 of CWS <p>Note: Please refer to Conservation Works Schedule 2017</p>

Photographs	
<ol style="list-style-type: none"> 1 View of remains looking southwest 2 Detail of steel remains within wall 3 Evidence of stone foundation remains 4 Detail of cracking to northeast elevation

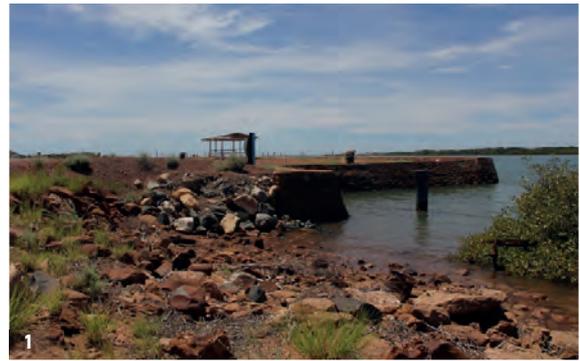
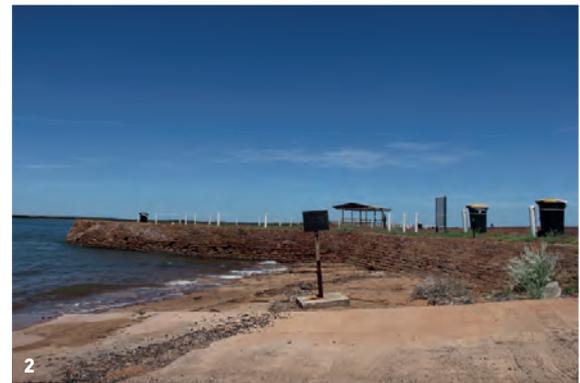
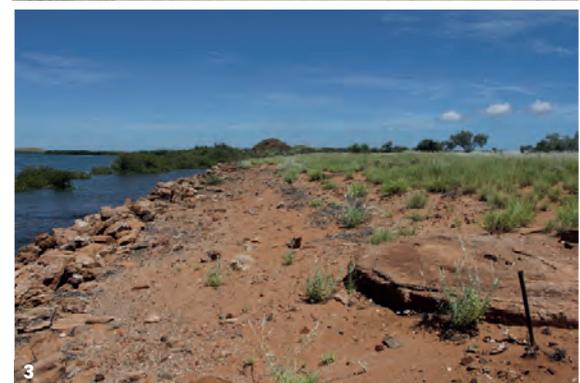
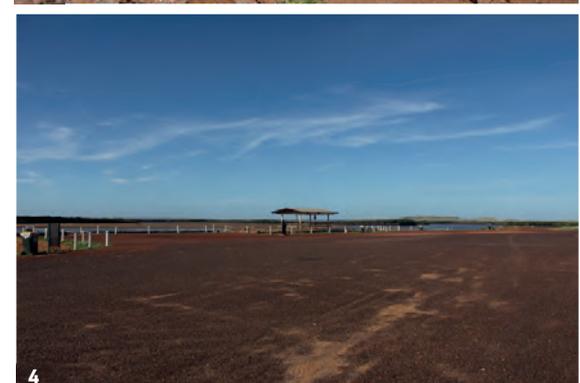
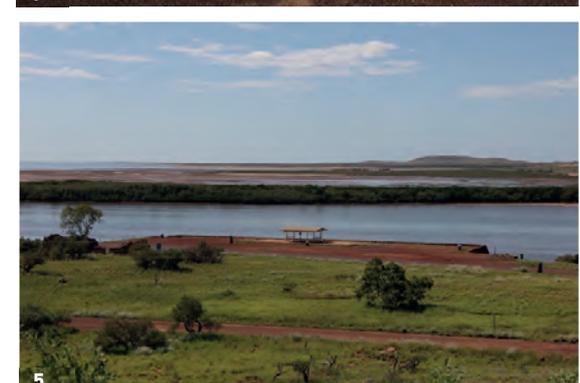
<i>Land Backed Wharf</i>	
External	
Roof Sheets and Flashing	N/A
Battens	N/A
Rafters and Purlins	N/A
Gutters	N/A
Downpipes	N/A
Fascia's and Scotia	N/A
Bargeboards	N/A
Eaves	N/A
Soffits	N/A
Eaves Brackets	N/A
Ceiling Joists	N/A
Walls	Stone and cement mortar
Openings	N/A
Ground	Gravel
Electrics	N/A
Others	N/A
Internal	
Ceiling/Roof	N/A
Walls	Stone and cement mortar
Openings	N/A
Floors	Gravel
Fixtures and Fittings	N/A
Electrics	N/A
Others	N/A
Condition	
<p>Generally, the place is in a fair condition. Areas that require attention include:</p> <ul style="list-style-type: none"> • Perform suggested maintenance works on Item 9 of CWS • Test existent mortar composition before repairs • Clean rubbish and maintain clean floors • All works to be performed accordingly to Section 11 of CWS <p>Note: Please refer to Conservation Works Schedule 2017</p>	
Photographs	
<ol style="list-style-type: none"> 1 View of northeastern side of wharf 2 View of southwestern side of wharf and boat ramp 3 Evidence of foundation 4 Car parking area to north of wharf 5 Aerial photograph of wharf looking southeast

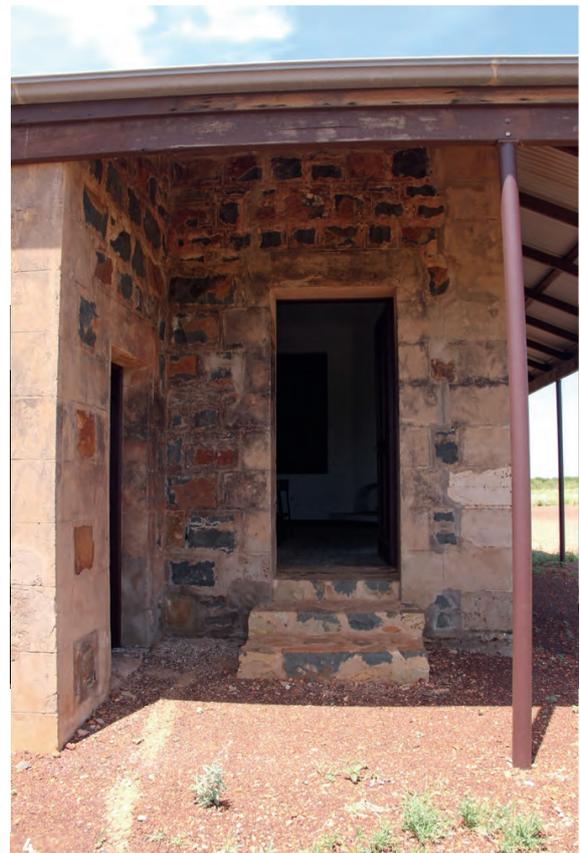
Cossack School	
External	
Roof	Corrugated metal roof with cyclonic fixings every fourth crest
Battens	N/A
Rafters and Purlins	Purlins connected to beam and hook over every second rafter
Gutters	Ovolo gutters with no downpipe
Downpipes	N/A
Fascia's and Scotia	Timber fascia
Bargeboards	N/A
Eaves	N/A
Soffits	N/A
Eaves Brackets	N/A
Ceiling Joists	Beam connected to post
Walls	Local bluestone, lime mortar, fretted way in parts. Quoining to corners, timber top plate subject to termite attack
Openings	Lintel over openings comprising timber pieces. Timber panel door with timber lintel
Ground	N/A
Electrics	N/A
Others	Reinstated brickface chimney with render and concrete banding. Reinstated verandah with circular verandah posts
Internal	
Ceiling/Roof	Corrugated metal roof sheeting. Scotia architrave and fixings. Boarded up skylight with timber panels
Walls	Considerable fretting to wall. Vents removed in each wall. Evidence of plastered finish to walls

Openings	Structural timber window frame remains. Opening fretted away, timber door head remains, PGI straps for door frame remain
Floors	Concrete floor
Fixtures and Fittings	N/A
Electrics	N/A
Others	Remains of fire place. No chimney remains
Condition	
<p>Generally, the place is in a fair condition. Areas that require attention include:</p> <ul style="list-style-type: none"> • Perform suggested maintenance works on Item 9 of CWS • Test existent mortar composition before repairs • Clean rubbish and maintain clean floors • All works to be performed accordingly to Section 11 of CWS <p>Note: Please refer to Conservation Works Schedule 2017</p>	
Photographs	
<ol style="list-style-type: none"> 1 View of southeast elevation looking northwest 2 Detail of mortar composition 3 Detail of ceiling damage 4 Detail of stonework to northwest elevation
