# COSSACK

**DRAFT** Volume 1: Conservation Management Plan  
February 2018

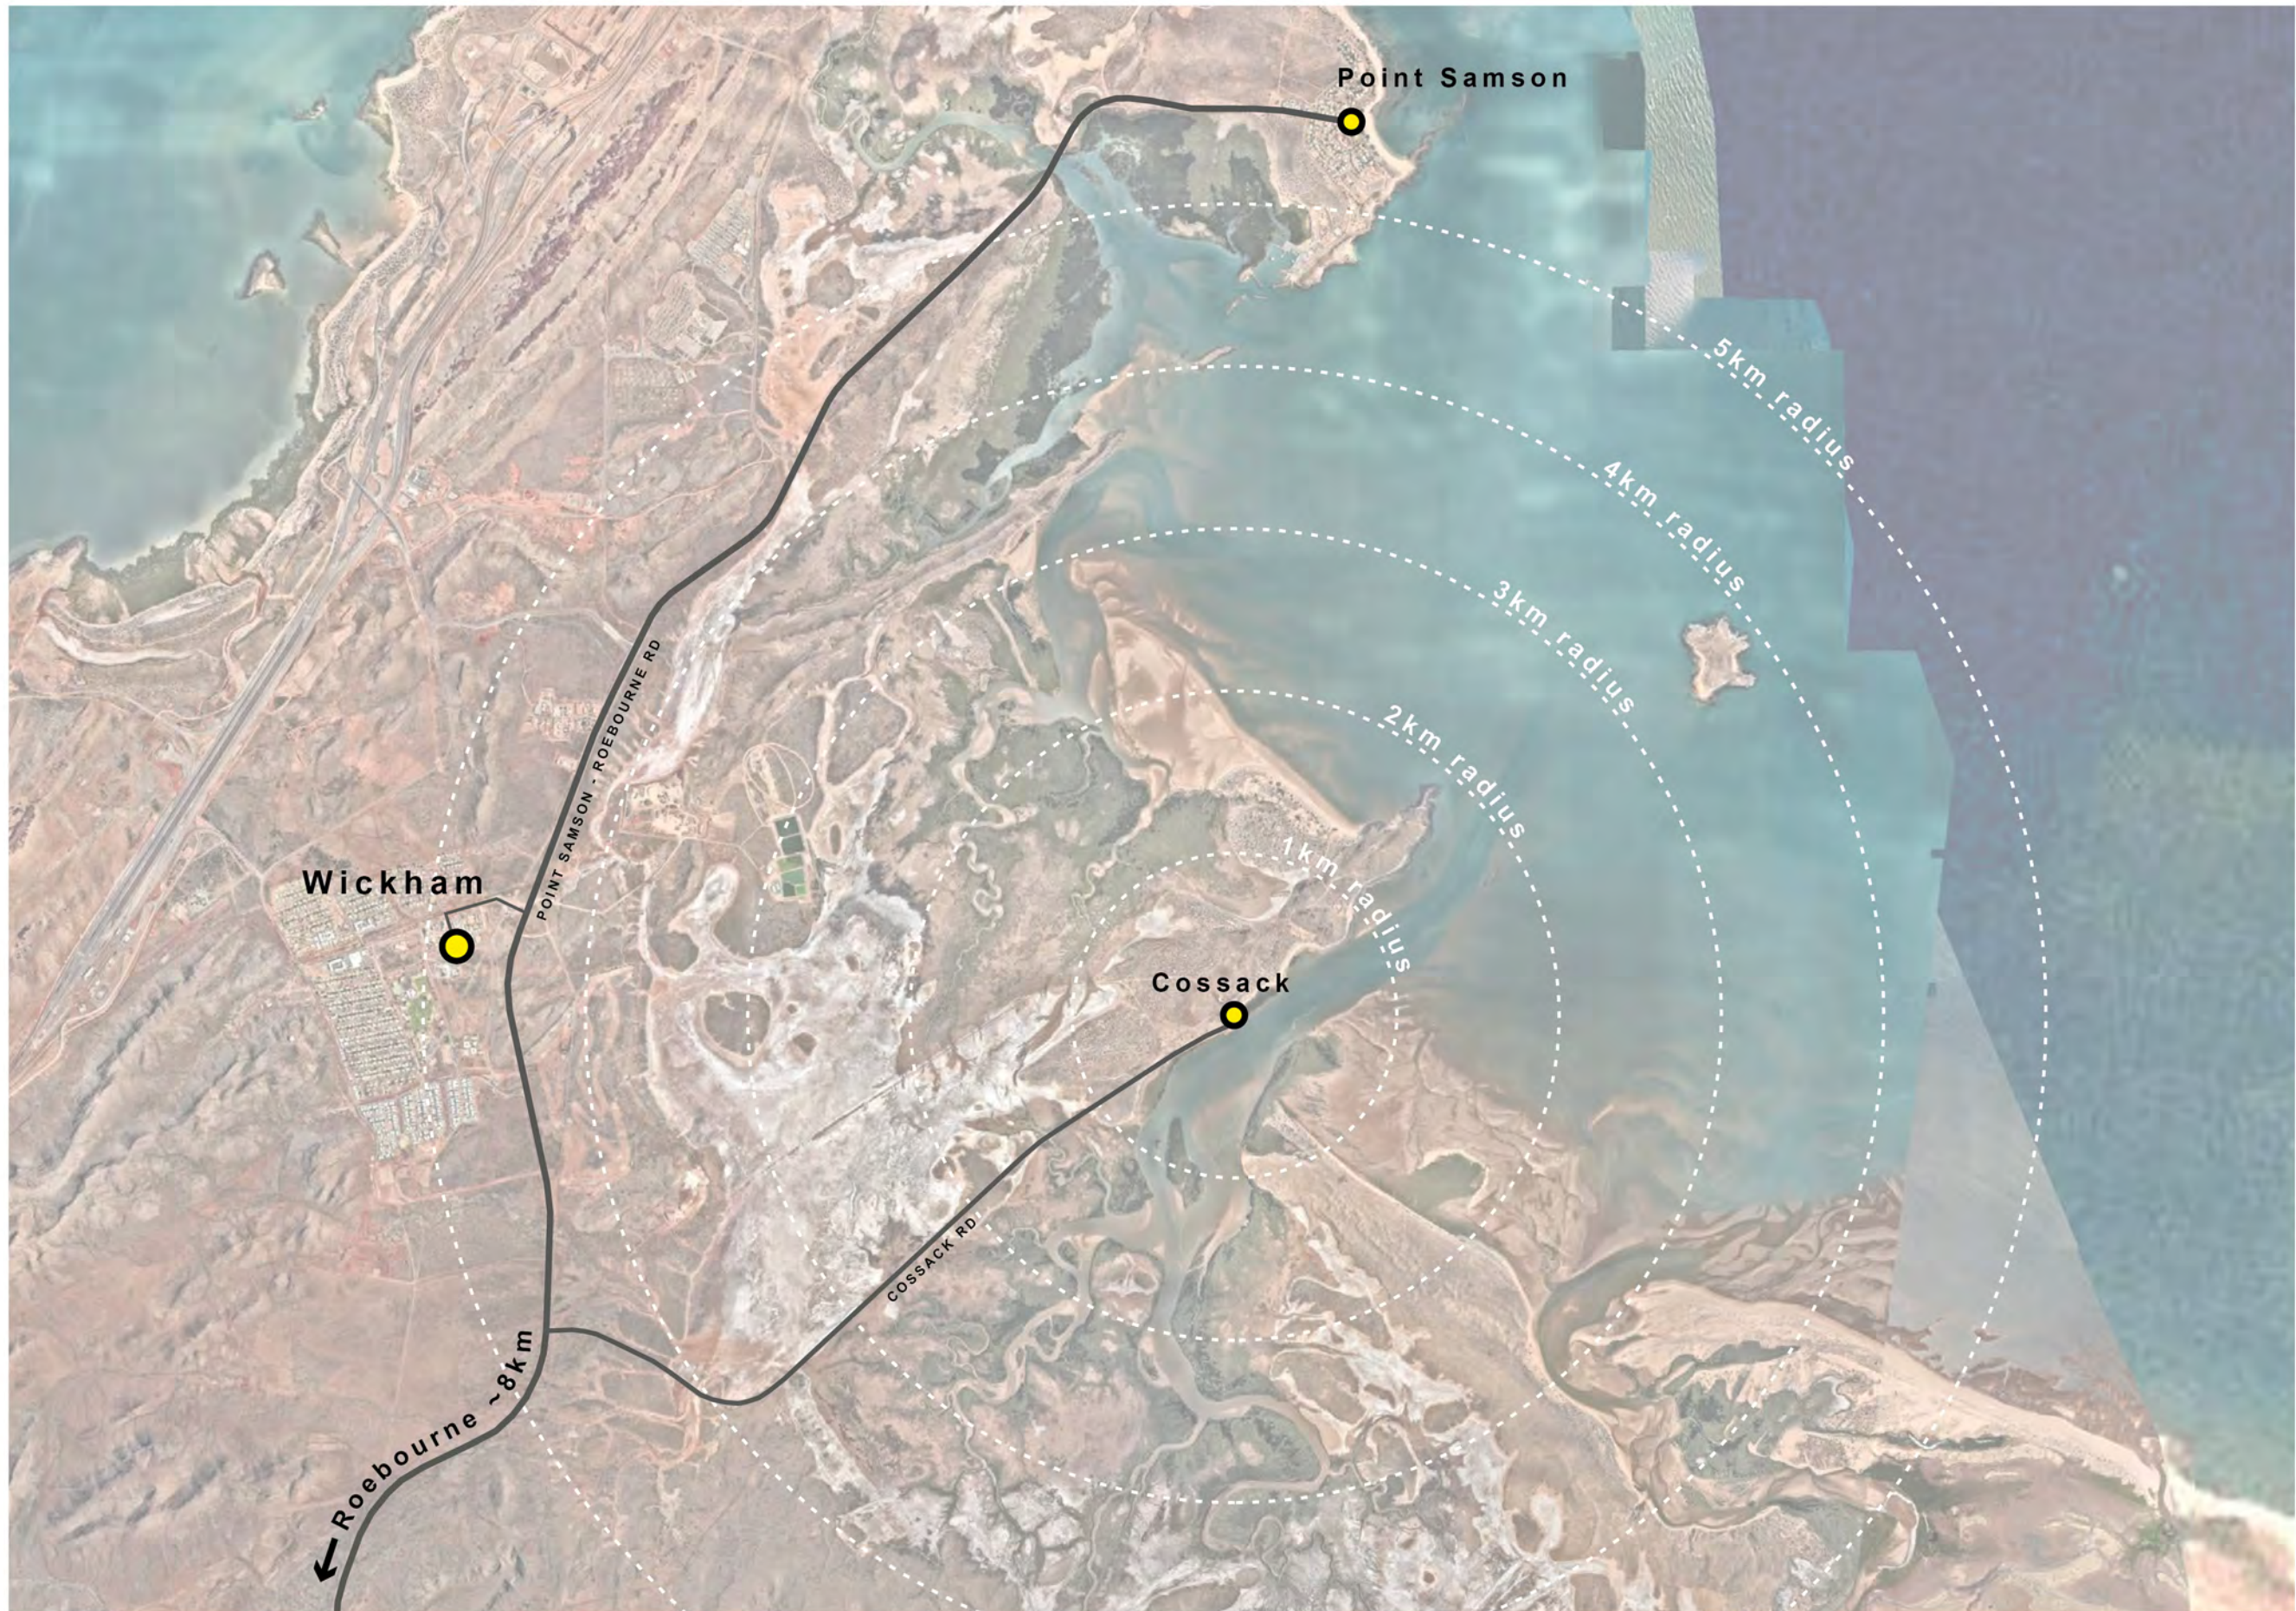
Figure 1. Location Plan The Department of Housing and Works, the Shire of Roebourne and the Heritage Council of WA, 2006, Draft Master Plan Concept Stage, page 29, available at: <[https://web.archive.org/web/20070829003312/http://heritage.wa.gov.au/pdfs/pubList/section1/cossack\\_concept\\_plan\\_report.pdf](https://web.archive.org/web/20070829003312/http://heritage.wa.gov.au/pdfs/pubList/section1/cossack_concept_plan_report.pdf)> [27.11.2017]

The area subject to this CMP encompasses the area of land identified within the HCWA's Cossack Town Site Precinct which is generally bound by Wickham Street, Dampier Street, Pearl Street, Ward Street, Pilot Street, Perseverance Street, Settlers Beach Road, Cossack Road to the Cemetery at Lots 422 and 433, and the foreshore to the high-water mark (including the Land Backed Wharf), as illustrated in Figure 1.

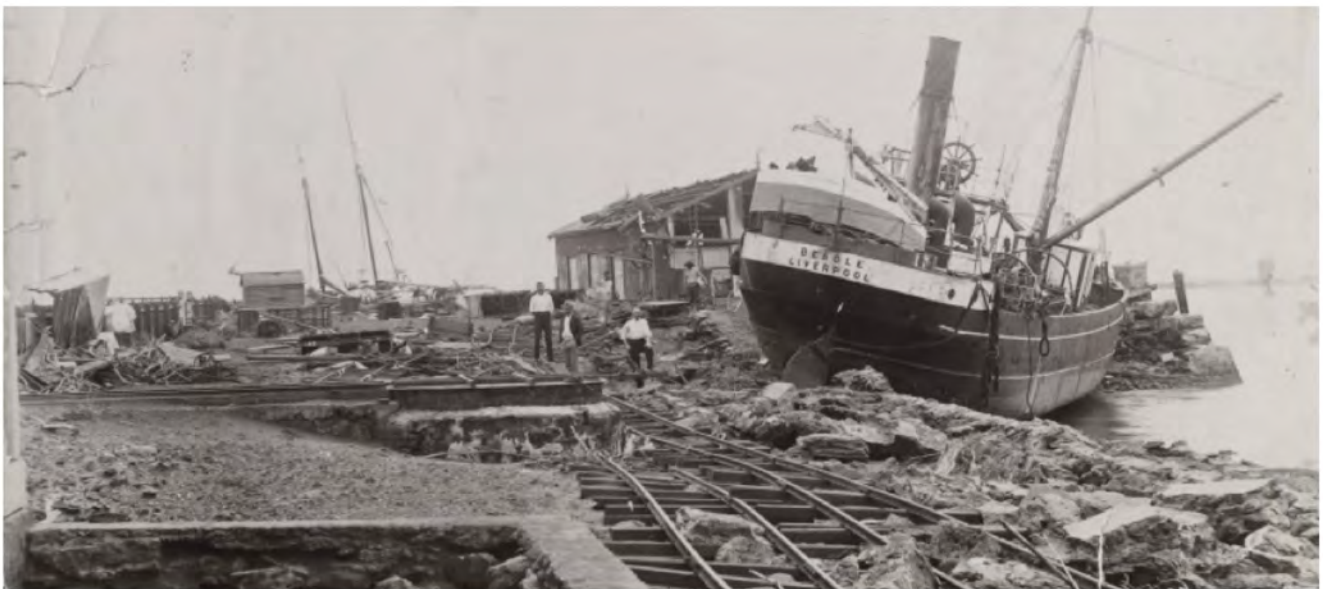
Figure 8. Cyclone damage at Cossack Wharf in 1898 (Source: State Library of Western Australia).

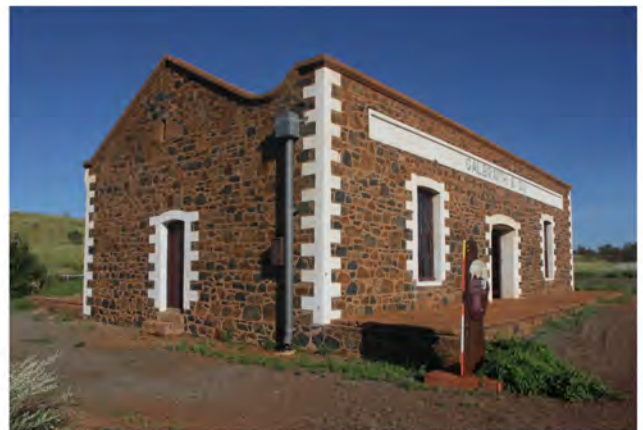
Figure 12. Galbraith's Store in 2017 (Source: TPG, 2017).

Galbraith's Store was constructed from local bluestone (ironstone) rock rubble walls with some bastard tuck pointing and rendered quoining at door and window openings, with a custom orb zincalume roof. The use of stone in solid foundations during this time was suggested to be an indication of status which was almost exclusive to the province of the pearling and trading elites, and the government that supported them.

Galbraith's Store is currently used for purposes of a shop and art gallery under a commercial lease and remains in poor to good condition.

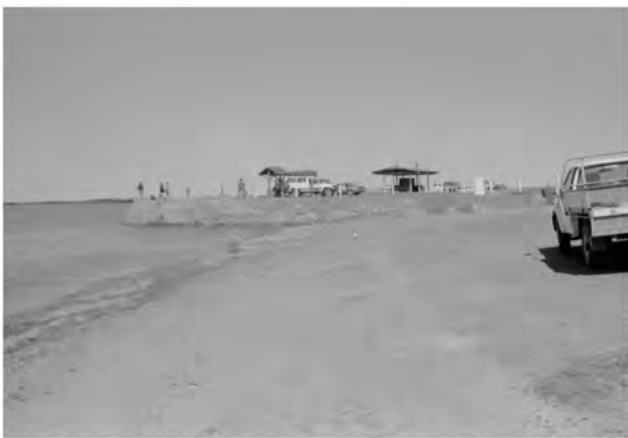
Figure 46. Northeast elevation of Wharf wall in 1994 (Source: State Library of Western Australia).t

The Landbacked Wharf was the centre of Cossack's port functions and is constructed of a stone and concrete wharf (originally with a timber deck) and covers the site of two former timber pile jetties. The wharf has a concrete face wall, with stone pitch end walls however has recently been damaged in 2017, presenting a settlement on the north-eastern corner.

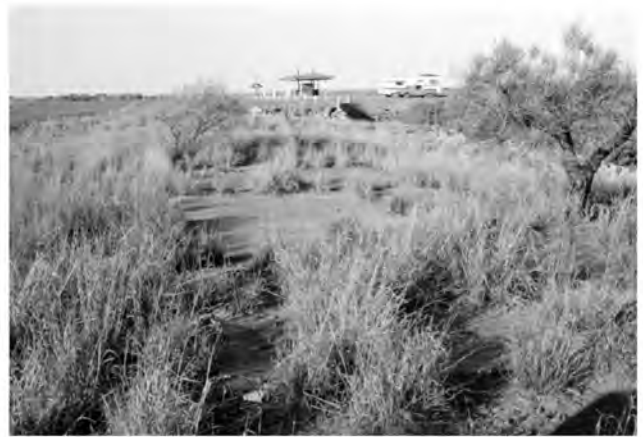
Figure 51. Floor slab and remains of Cossack Railway Station in 1994 (Source: State Library of Western Australia).

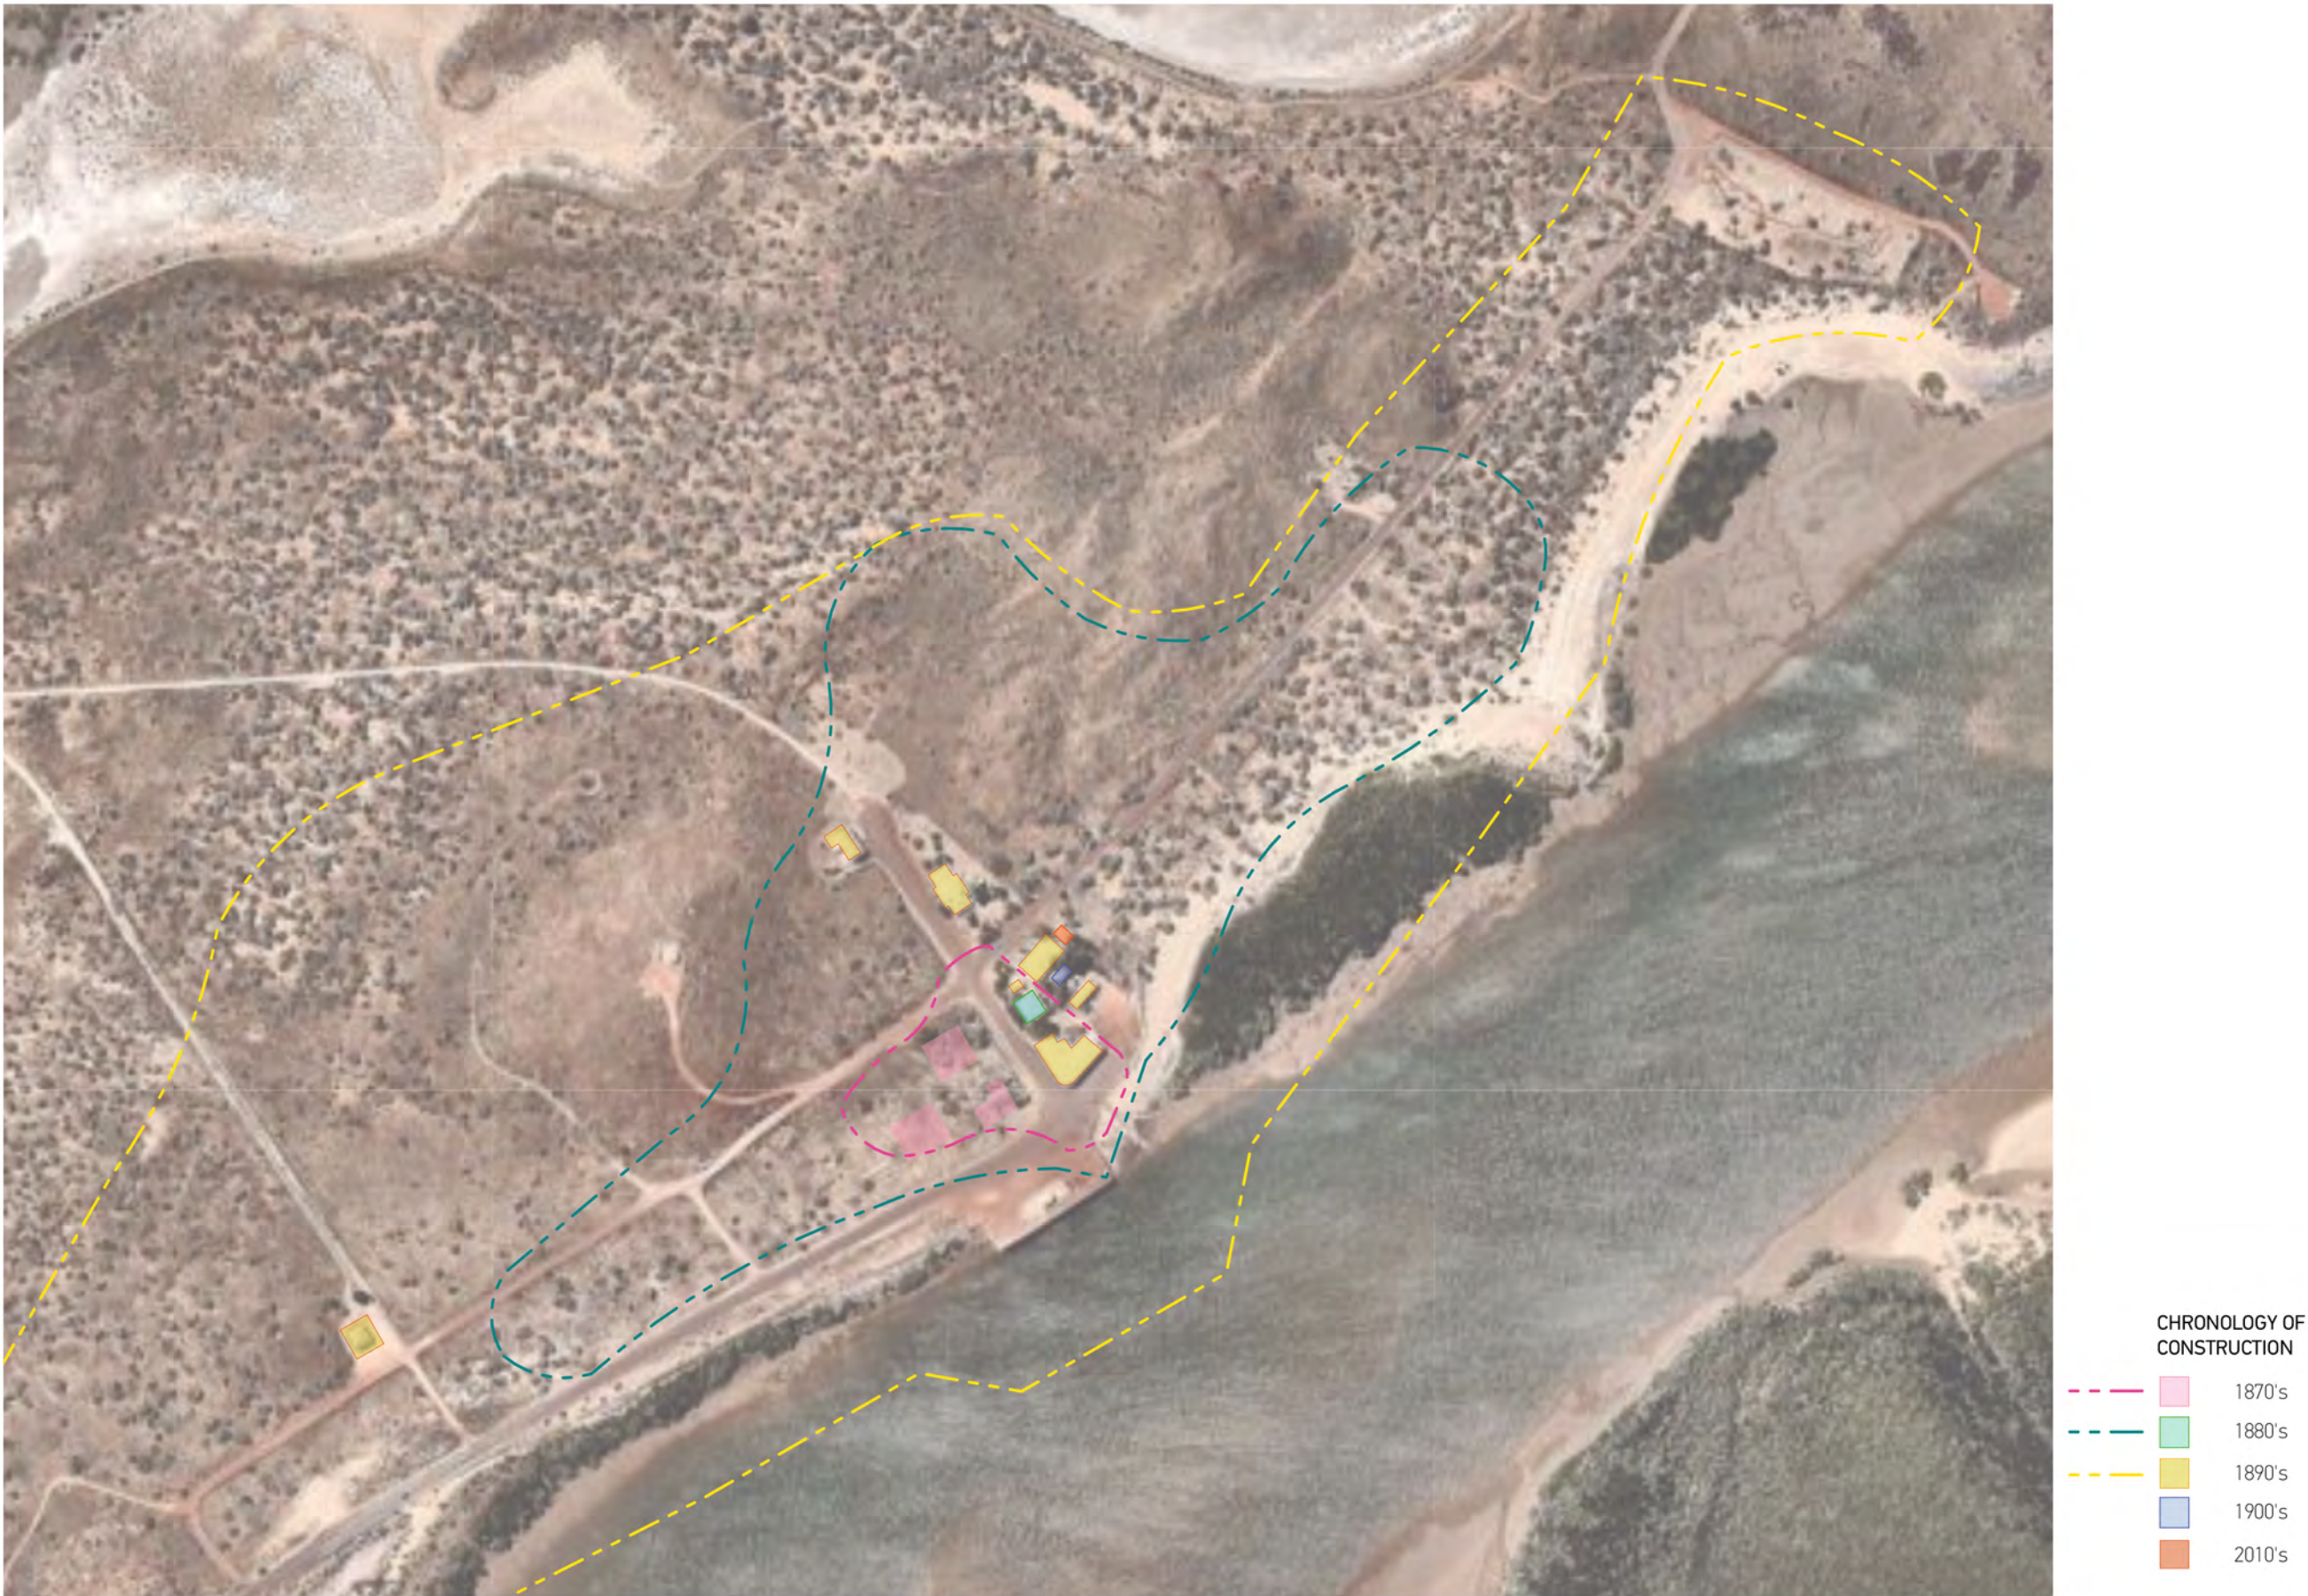
Figure 55. Chronological Sequence, according to Nayton, 1990 (TPG artwork over Nearmaps image, 2017).

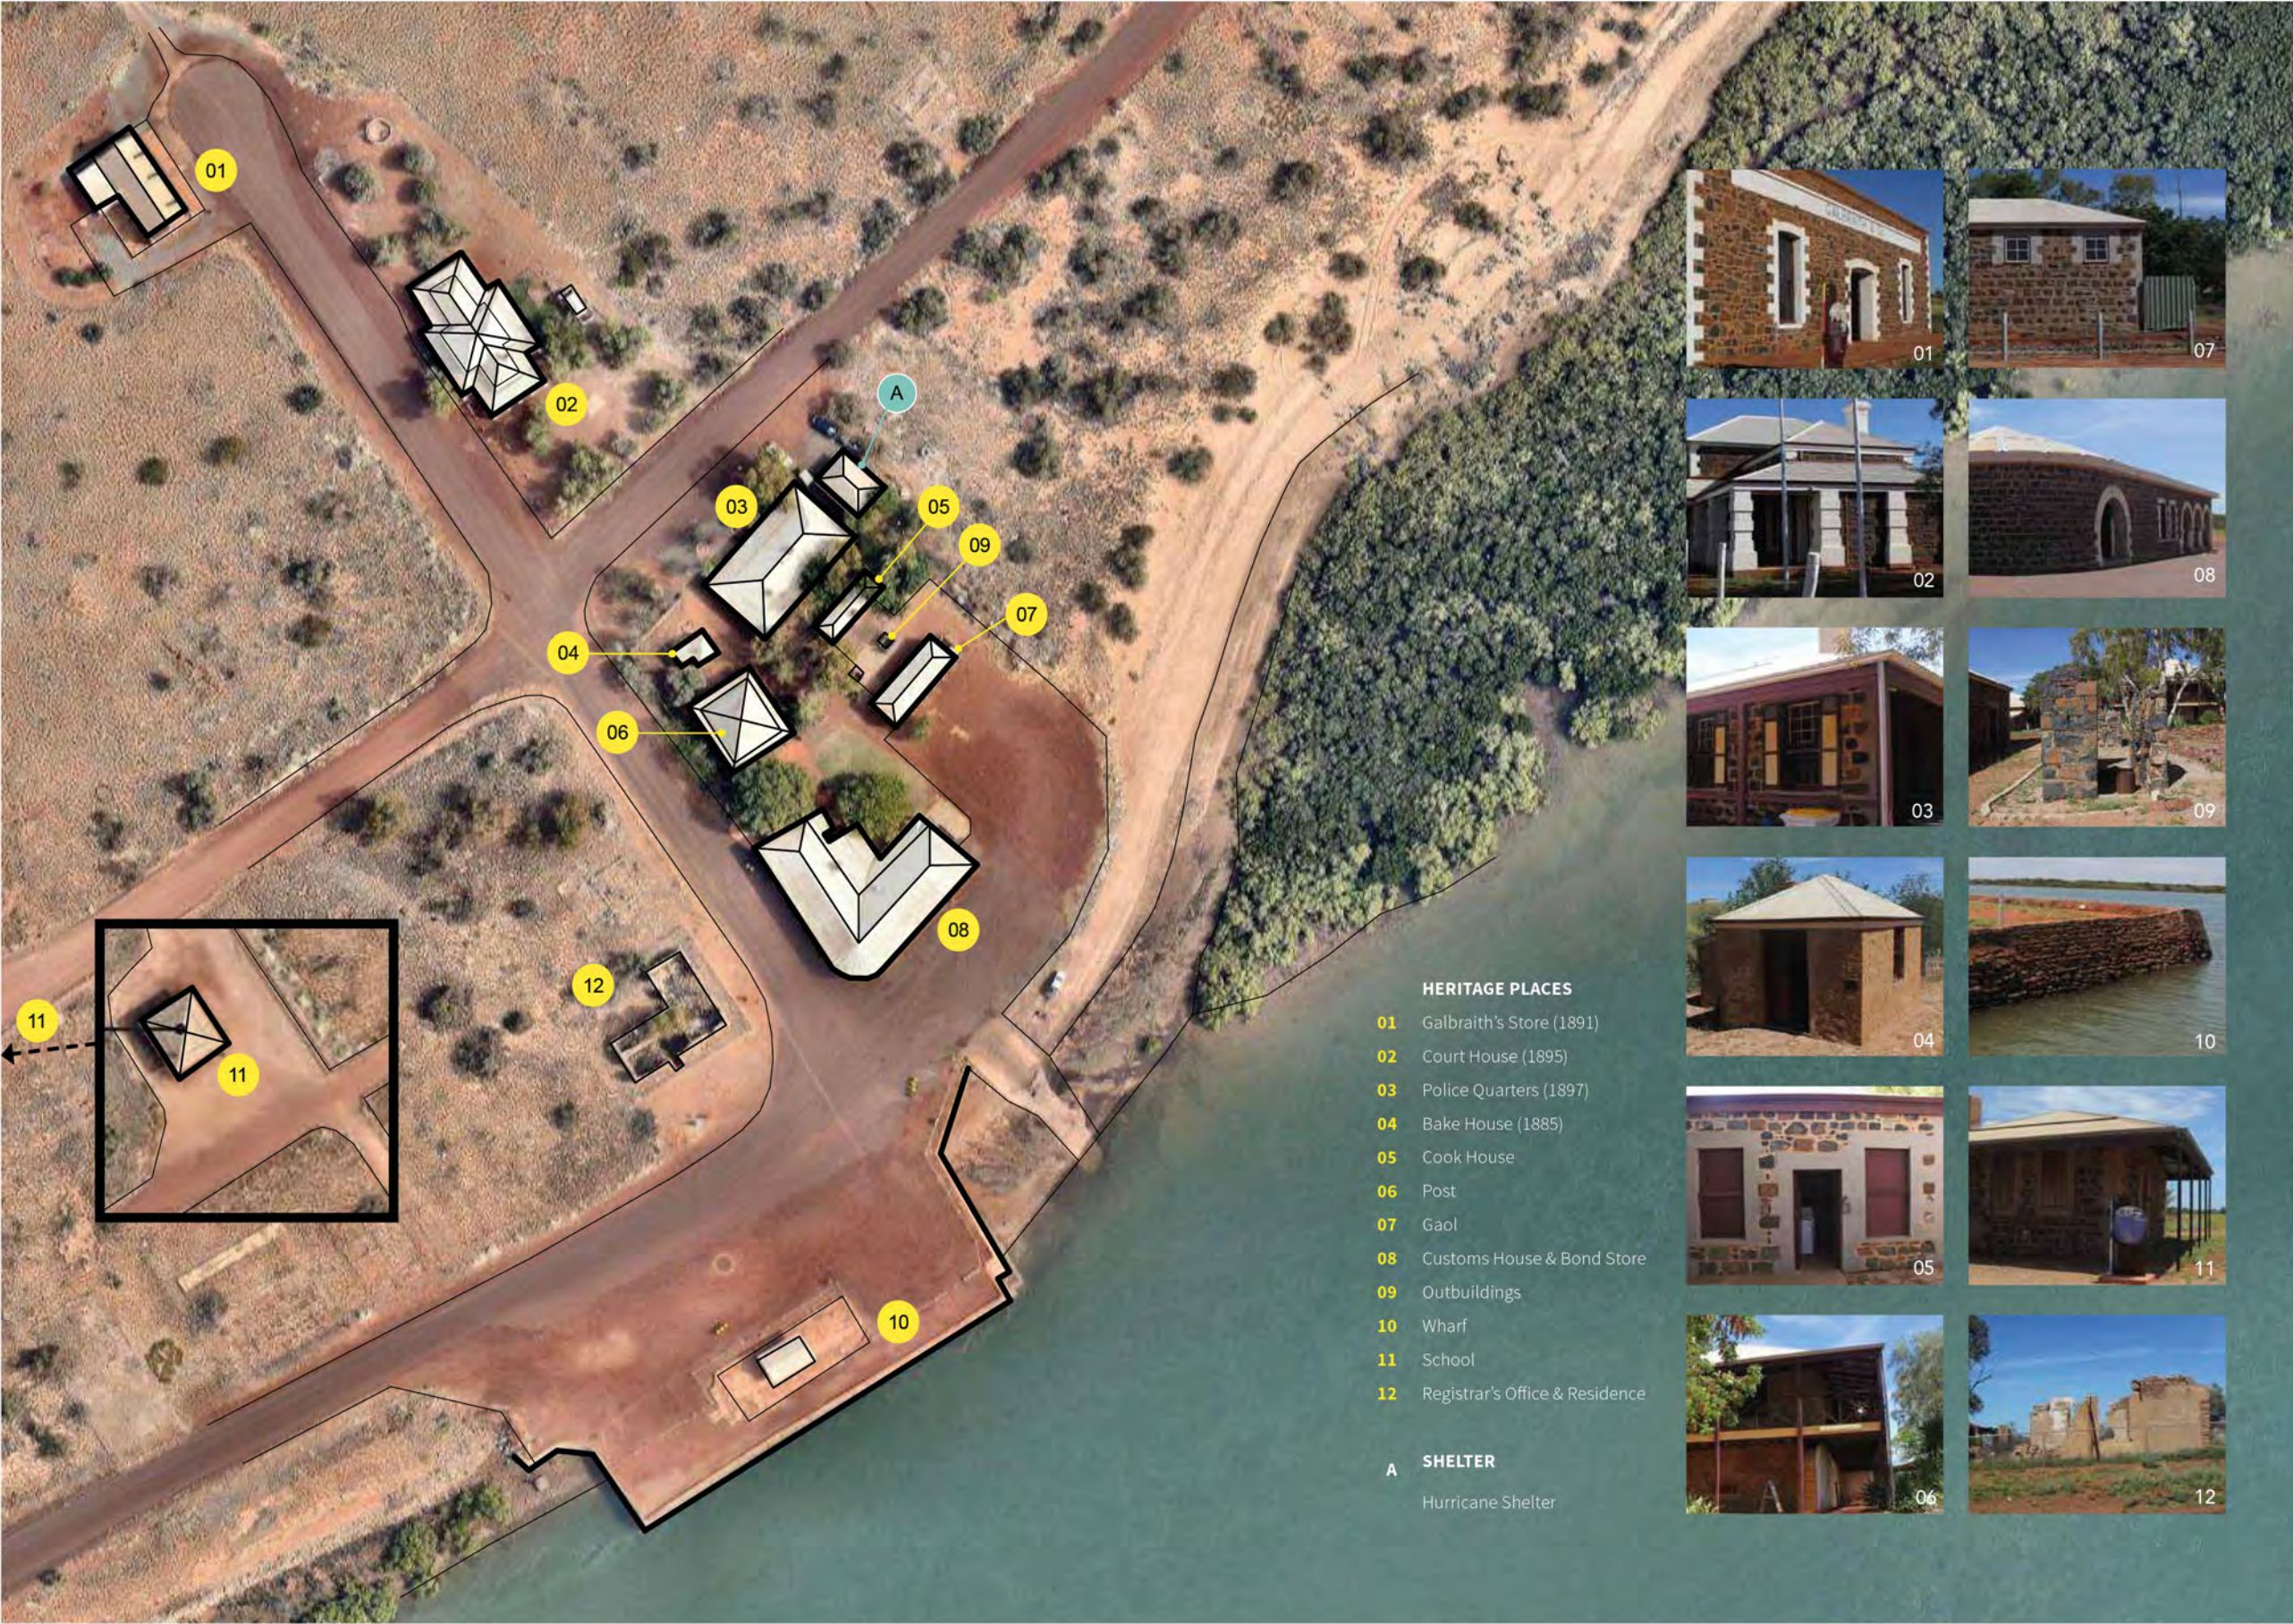
Figure 56. Individual Buildings Location (TPG artwork over Nearmaps image, 2017).
