## Place No. 04 Balmoral Station Homestead Group (fmr)

LOCATION	
Name of Place	<b>Balmoral Station Homestead Group (fmr)</b>
<b>Location/Address</b>	
Street Number	Great Northern Highway, 8km NW of station entrance
Street Name	
Suburb/Town	
Other Locational descriptor (text)	408547 mE, 7659948 mN Longitude 116.1191 Latitude -21.1591

DESCRIPTION	
Construction Date (1)	c.1945
Construction Date (2)	1860s
Site Type (Place Type)	Individual Building or Group Historic site
<b>Use(s) of Place</b>

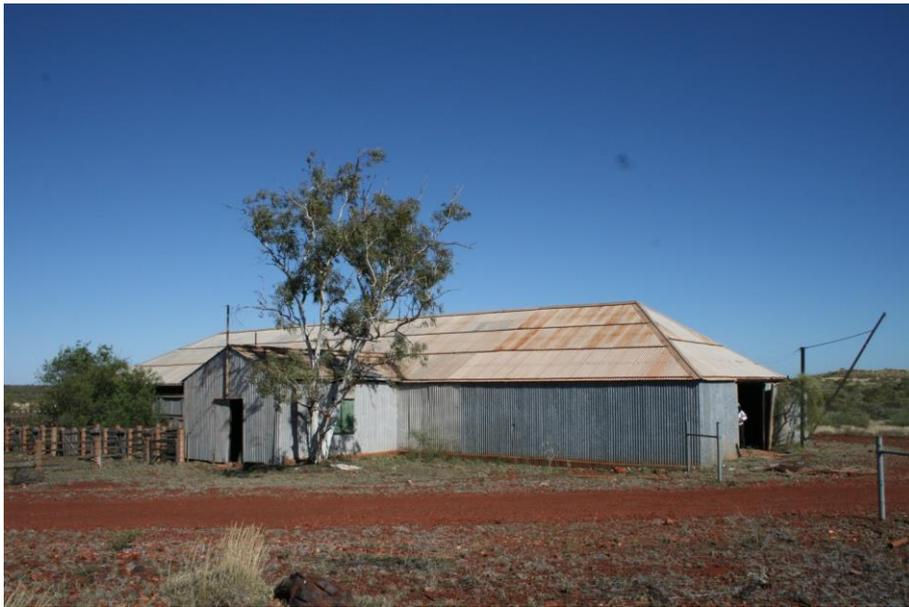
Shearing shed at Balmoral Station 2012

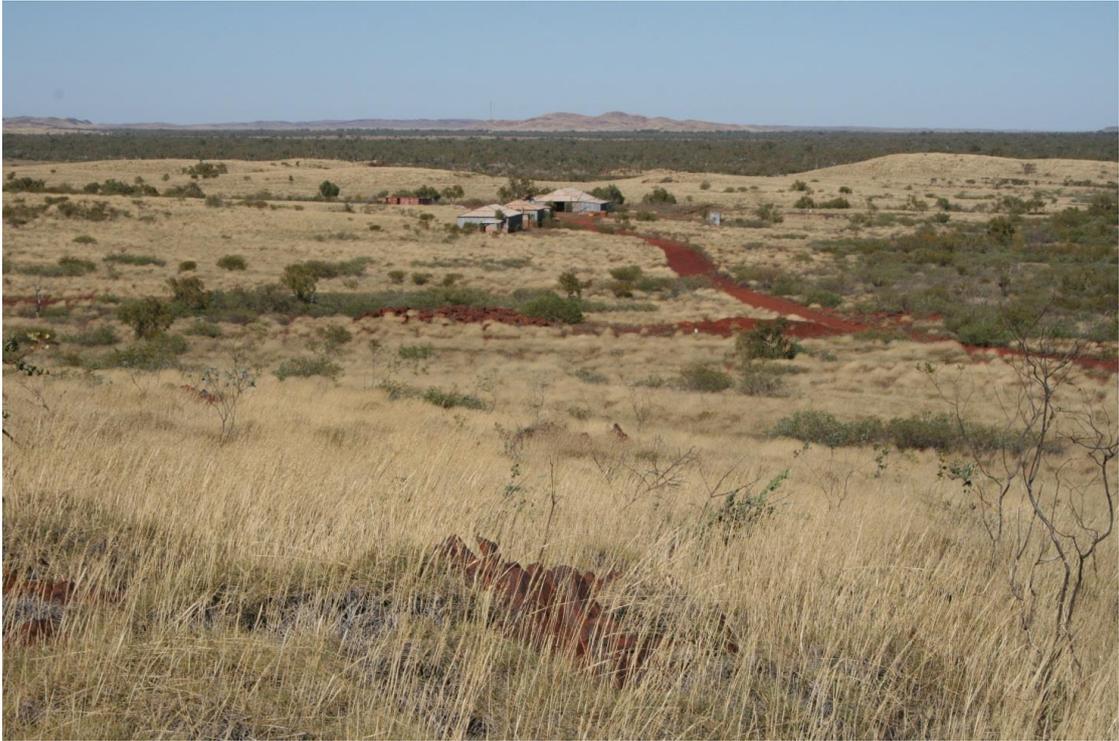
**View of Balmoral Station buildings: workers' quarters and shearing shed 2012**

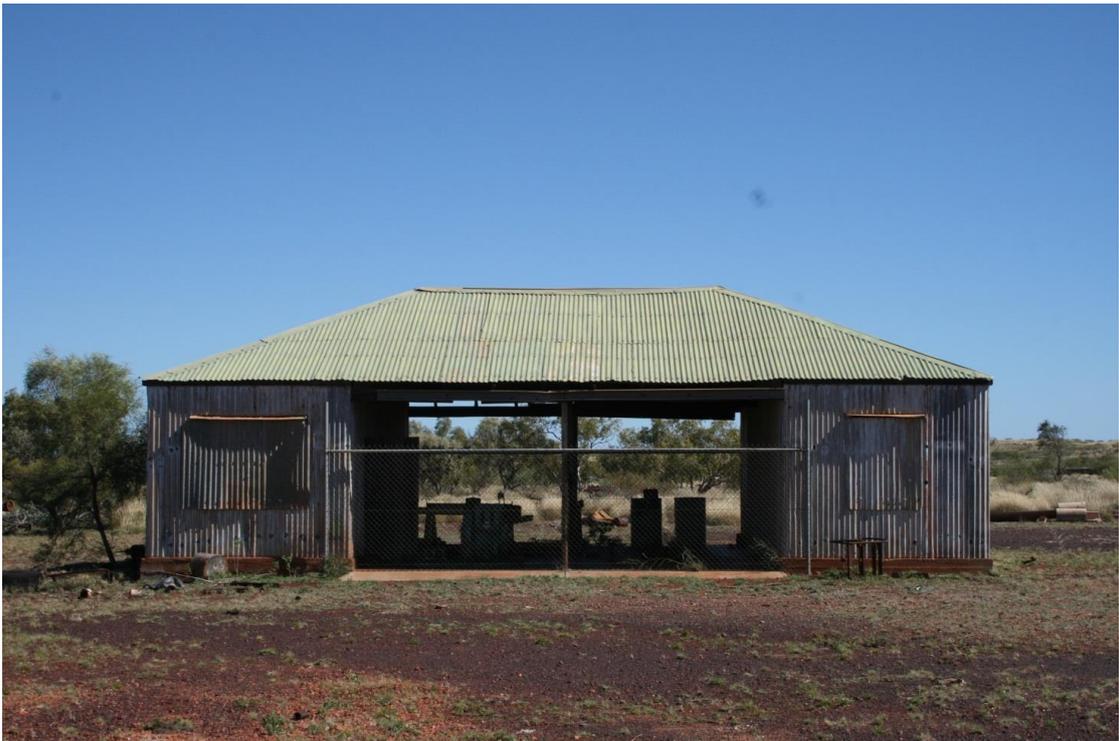
<i>Original</i>	FARMING/PASTORAL: Homestead Servants' Quarters/Shearers' Quarters Shed Kitchen Stockyard Other
<i>Present</i>	INDUSTRIAL/MANUFACTURING: Other - Iron Ore Mining Lease VACANT/UNUSED: Vacant/Unused
<b>Construction Materials:</b>	
<i>Walls</i>	1. ASBESTOS 199 Other Asbestos 7. PLASTER 701 Fibrous Plaster Sheet
<i>Roof</i>	6. METAL 606 Corrugated Iron
<i>Other</i>	11. TIMBER 1105 Weatherboard 1199 Other Timber
Condition	Sound
Integrity (how much of the original fabric is intact?):	Fairly intact
<b>Physical Description</b>	
<p>Balmoral station complex includes evidence of 16 identified buildings and structures dating from a range of periods and in various conditions. Many of the buildings date from post 1945, when a destructive cyclone devastated buildings at the site. Key historical structures are described below (Refer to the site plan for corresponding numbers):</p> <p>Washroom (1) – This serviced the shearers quarter's complex. It has a corrugated iron roof and open walls with metal posts and concrete floors.</p> <p>Worker's quarters (2) – This has a corrugated iron roof and iron walls above the dado, with a wooden frame and concrete floor and dado. The building has 12 workers bedrooms, with walls formed from corrugated iron and timber. The hallway has a concrete dado and timber truss frames in the open roof, with a bathroom and larger dormitory at the north end of the building. The three shower cubicles, constructed from corrugated iron and timber, remain in the bathroom, some with shower heads and pipes intact. A 44 gallon drum is rigged up on the exterior for the supply of water. There is a simple wooden shelf with four sinks. The building has wooden doors and wooden awning style windows.</p> <p>Kitchen and mess (3) – This is a smaller building with a corrugated iron roof and walls above a dado. It has a wooden frame and concrete floor and dado.</p> <p>Quarters (4) – These are smaller quarters, presumably an overseer's cottage. It is constructed of corrugated iron roof and walls above dado, with a wooden frame and concrete floor and dado. The interior has walls of fibro panels (probably asbestos).</p> <p>Toilet (5) – This structure has a corrugated iron roof and walls, wooden frame and concrete floors.</p> <p>Sheep yards (7) – Constructed from concrete posts and four wooden rails in fair condition.</p> <p>Shearing shed (6) – This structure is in a good condition and is constructed of the local cajuput timber resistant to termites, from the paperbark <i>Maleleuca leucadendra</i> and is very rare. The building has a corrugated iron roof and walls, with a concrete and timber floor. There are ten stands for shearing and the engine room is intact. The shearing shed and shearers quarters remain one of the most intact and complete examples of a disused shearing complex in the Shire.</p> <p>Work shed and garage (12) – This structure has a corrugated iron roof and walls, wooden frame and concrete floor.</p>

**Work shed and garage at Balmoral Station 2012**

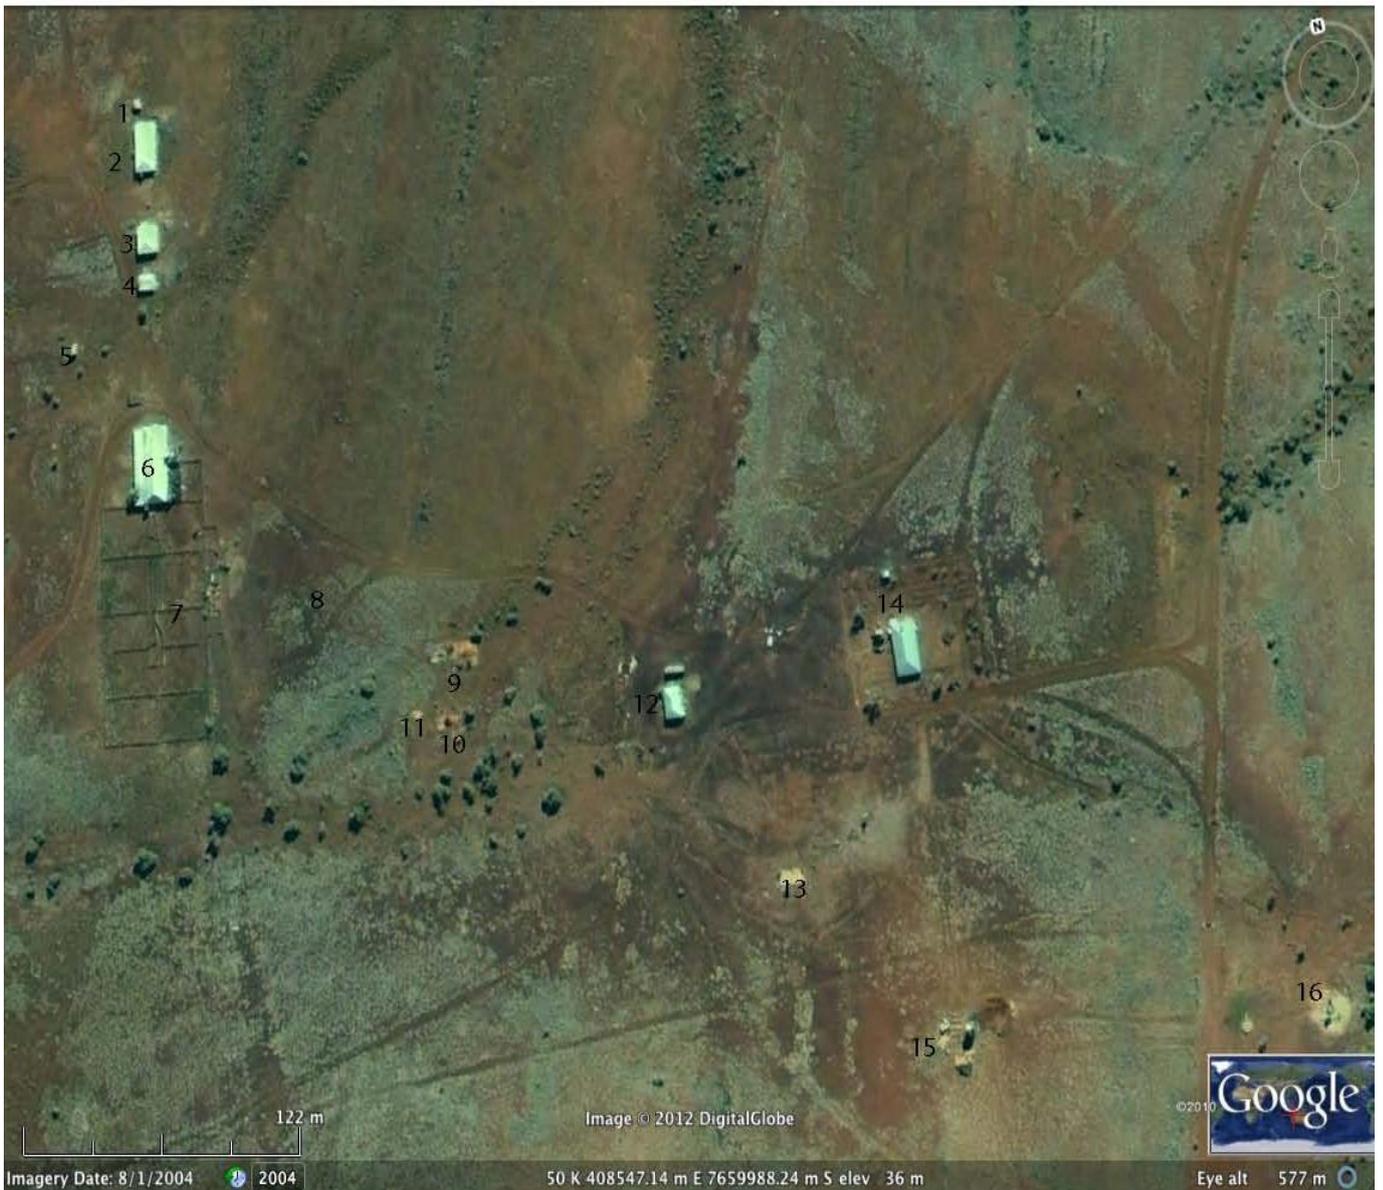
### BALMORAL STATION HOMESTEAD

1. Washroom (CI roof; open walls; metal posts; concrete floors)
2. Workers' quarters (CI roof and walls above dado; wooden frame; concrete floor and dado)

3. Kitchen and Mess (CI roof and walls above dado; wooden frame; concrete floor and dado)
4. Quarters (CI roof and walls above dado; wooden frame; concrete floor and dado)

5. Toilet (CI roof and walls; concrete floor and wall footing)
6. Shearing shed (CI roof and walls; wooden frame; concrete floor)
7. Sheep yards (concrete posts and 4 wooden rails)

8. June 2012: site of shipping containers
9. Building floor (concrete, possible wooden frame and CI walls and roof)
10. Building floor (concrete, possible wooden frame and CI walls and roof)

11. Building floor (concrete, possible wooden frame and CI walls and roof)
12. Work shed and garage (CI roof and walls; wooden frame; concrete floor)
13. House floor (concrete)

14. Homestead (CI roof; fibro panels above dado, weatherboard walls below dado; wooden frame, metal verandah posts; concrete floor: S end enclosed as modern bathroom; N end enclosed as kitchen). Metal shed to N.

15. Water tank (some derelict)
16. Bore (windmill remains; replaced by solar pump; concrete tank base; modern tank at 15)
