**EXTENSION OF APPROVAL PERIOD - LOT 500 MADIGAN ROAD DEVELOPMENT PLAN**  
**WAPC REFERENCE: SPN/0244M-1**

**REVISED STRUCTURE PLAN AMENDMENT – MADIGAN ROAD, KARRATHA  
IMPACT OF PROPOSED SCHOOL SITE IN STAGE 3 ON THE LOCAL WATER MANAGEMENT STRATEGY**

## **Madigan Road Urban Development, Karratha Local Water Management Strategy**

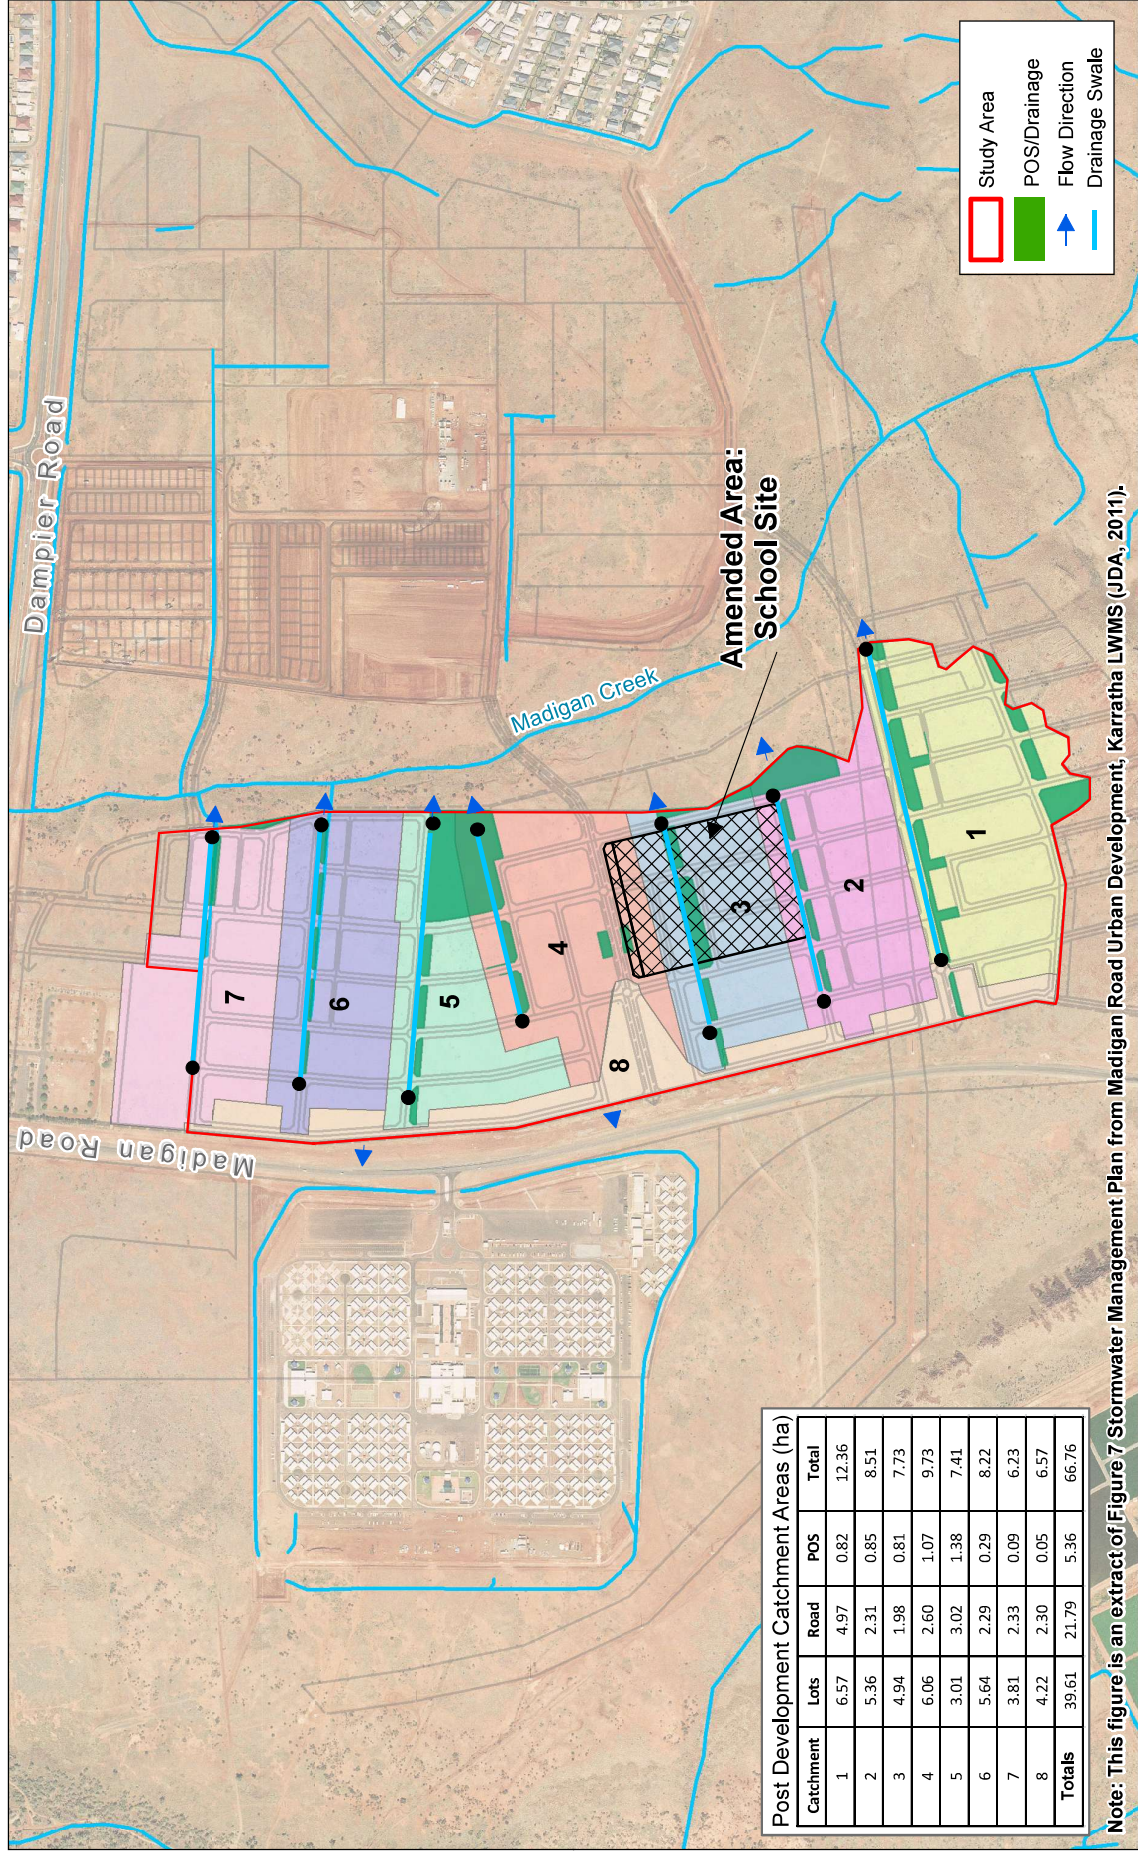
**Figure 1: Madigan Road Revised Structure Plan Amendment**

JDA previously prepared a Local Water Management Strategy (LWMS) to support the Madigan Road Structure Plan. A revised structure plan amendment is now proposed to include a School in Stage 3 (see Plan 1 attached).

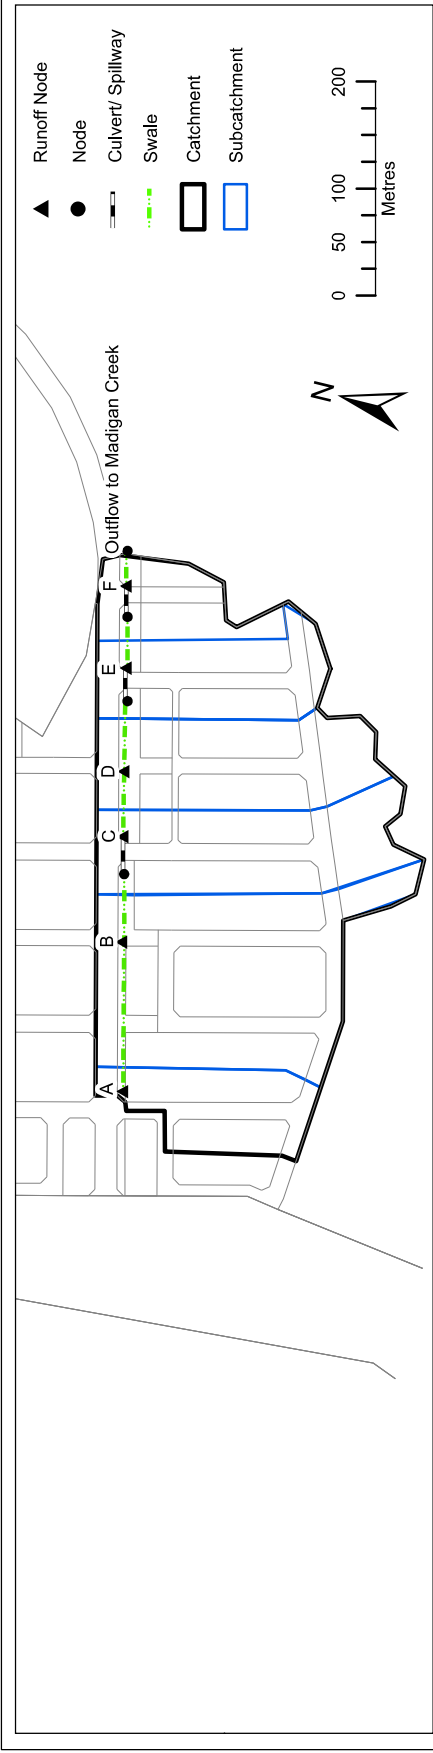
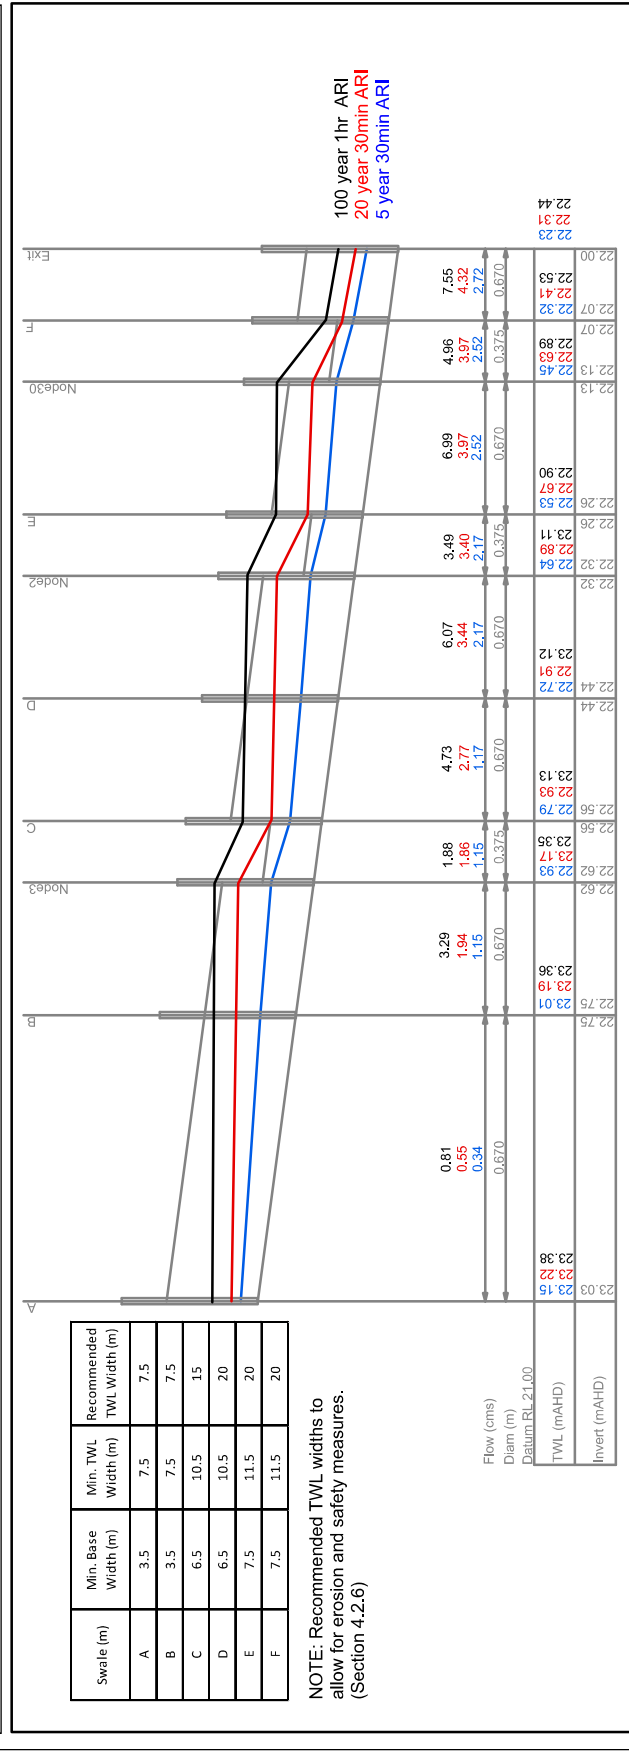
**Figure 8: Madigan Creek Flood Study, Post-Development Flood Levels**

For Catchments 1 to 7, the drainage swales will have a minimum longitudinal grade of 1 in 500 with the downstream invert set at the current existing natural surface at the boundary of the Study Area. The elevations at these locations are approximately 0.5m above the adjacent invert of Madigan Creek. A free outfall condition into Madigan Creek was adopted for this modelling as these inverts are above the modelled post development flood levels of Madigan Creek (Figure 8).

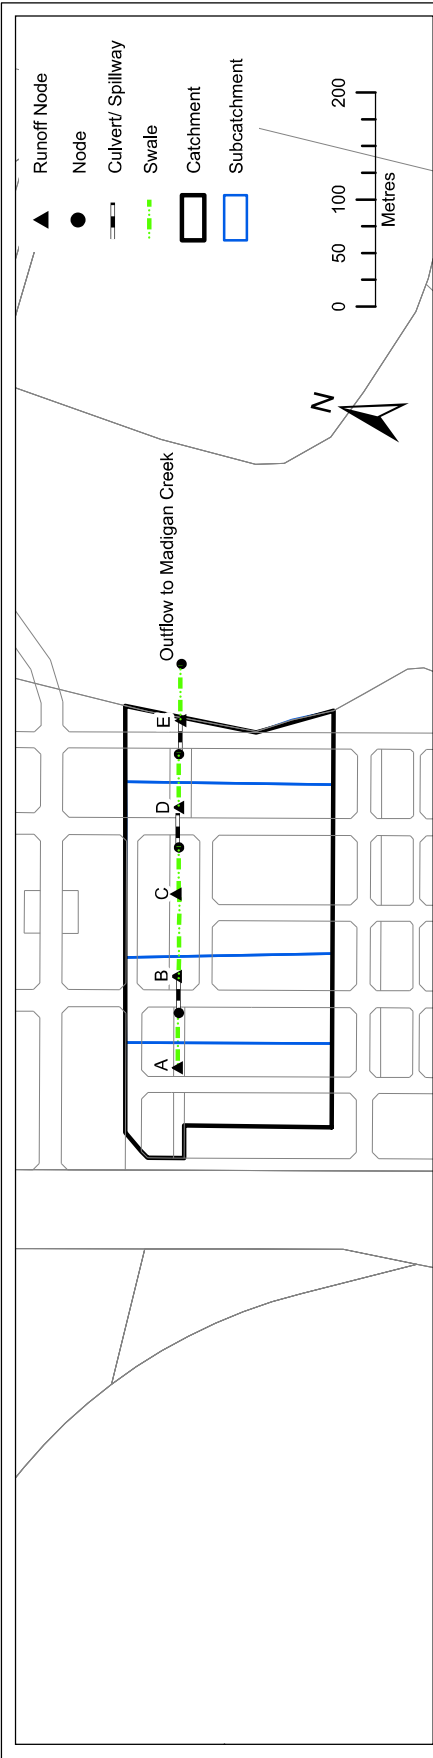
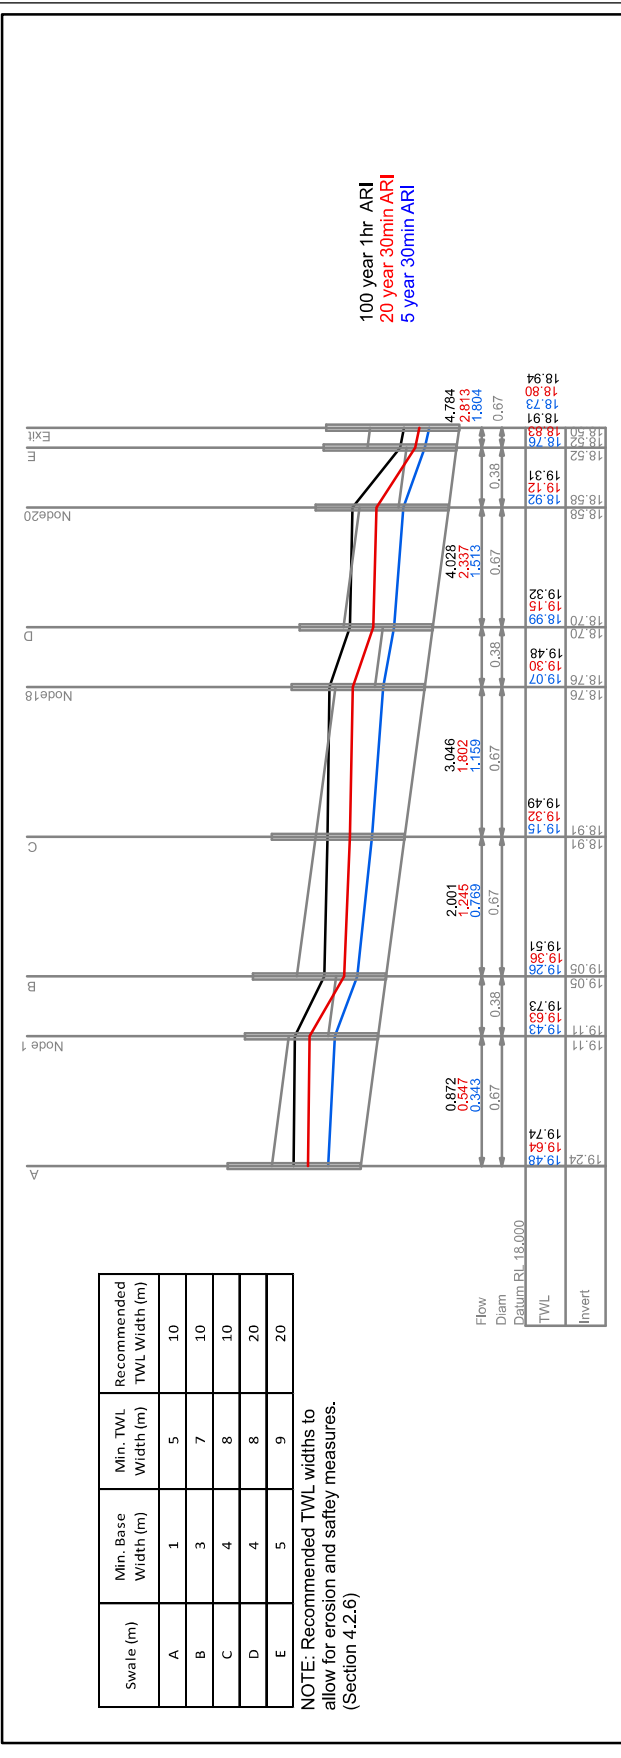
LandCorp  
Madigan Road Urban Development, Karratha - LVMS  
Figure 10: Catchment 2 Profile Plot for 5yr, 20yr & 100yr ARI

Stormwater modelling results for the drainage swale in each catchment for the critical rainfall duration (ranging between 30min and 1hr) for the 5yr, 20yr and 100yr ARI are presented in Figures 9 to 16. These figures show flood level and flows as longitudinal sections together with the modelled minimum swale widths. Recommended swale widths have also been presented on these figures to ensure erosion and velocity reducing measures, sedimentation areas and any landscaping treatments can be accommodated during detailed design.

Maximum velocity modelled within one section of a drainage swale is 1.8m/s, exceeding the recommended maximum design velocity of 1.1m/s to protect against scouring and erosion of in-situ material. However it is considered that refinement of the drainage swale dimensions (widening base width), modelling parameters and inclusion of engineering structures (where appropriate) during detail design will reduce velocity within the recommended design limit and be presented in the UWMP.

From a safety perspective, the product of velocity and flood depth should not exceed 0.4m<sup>2</sup>/s. Although this applies to stormwater flow on the road system, it has also been conservatively applied to the drainage swales within the POS. A maximum of 0.6m<sup>2</sup>/s has been modelled within a section of a drainage swale. As described above, refinement of the drainage swale during detailed design will reduce this factor to within recommended design limits.

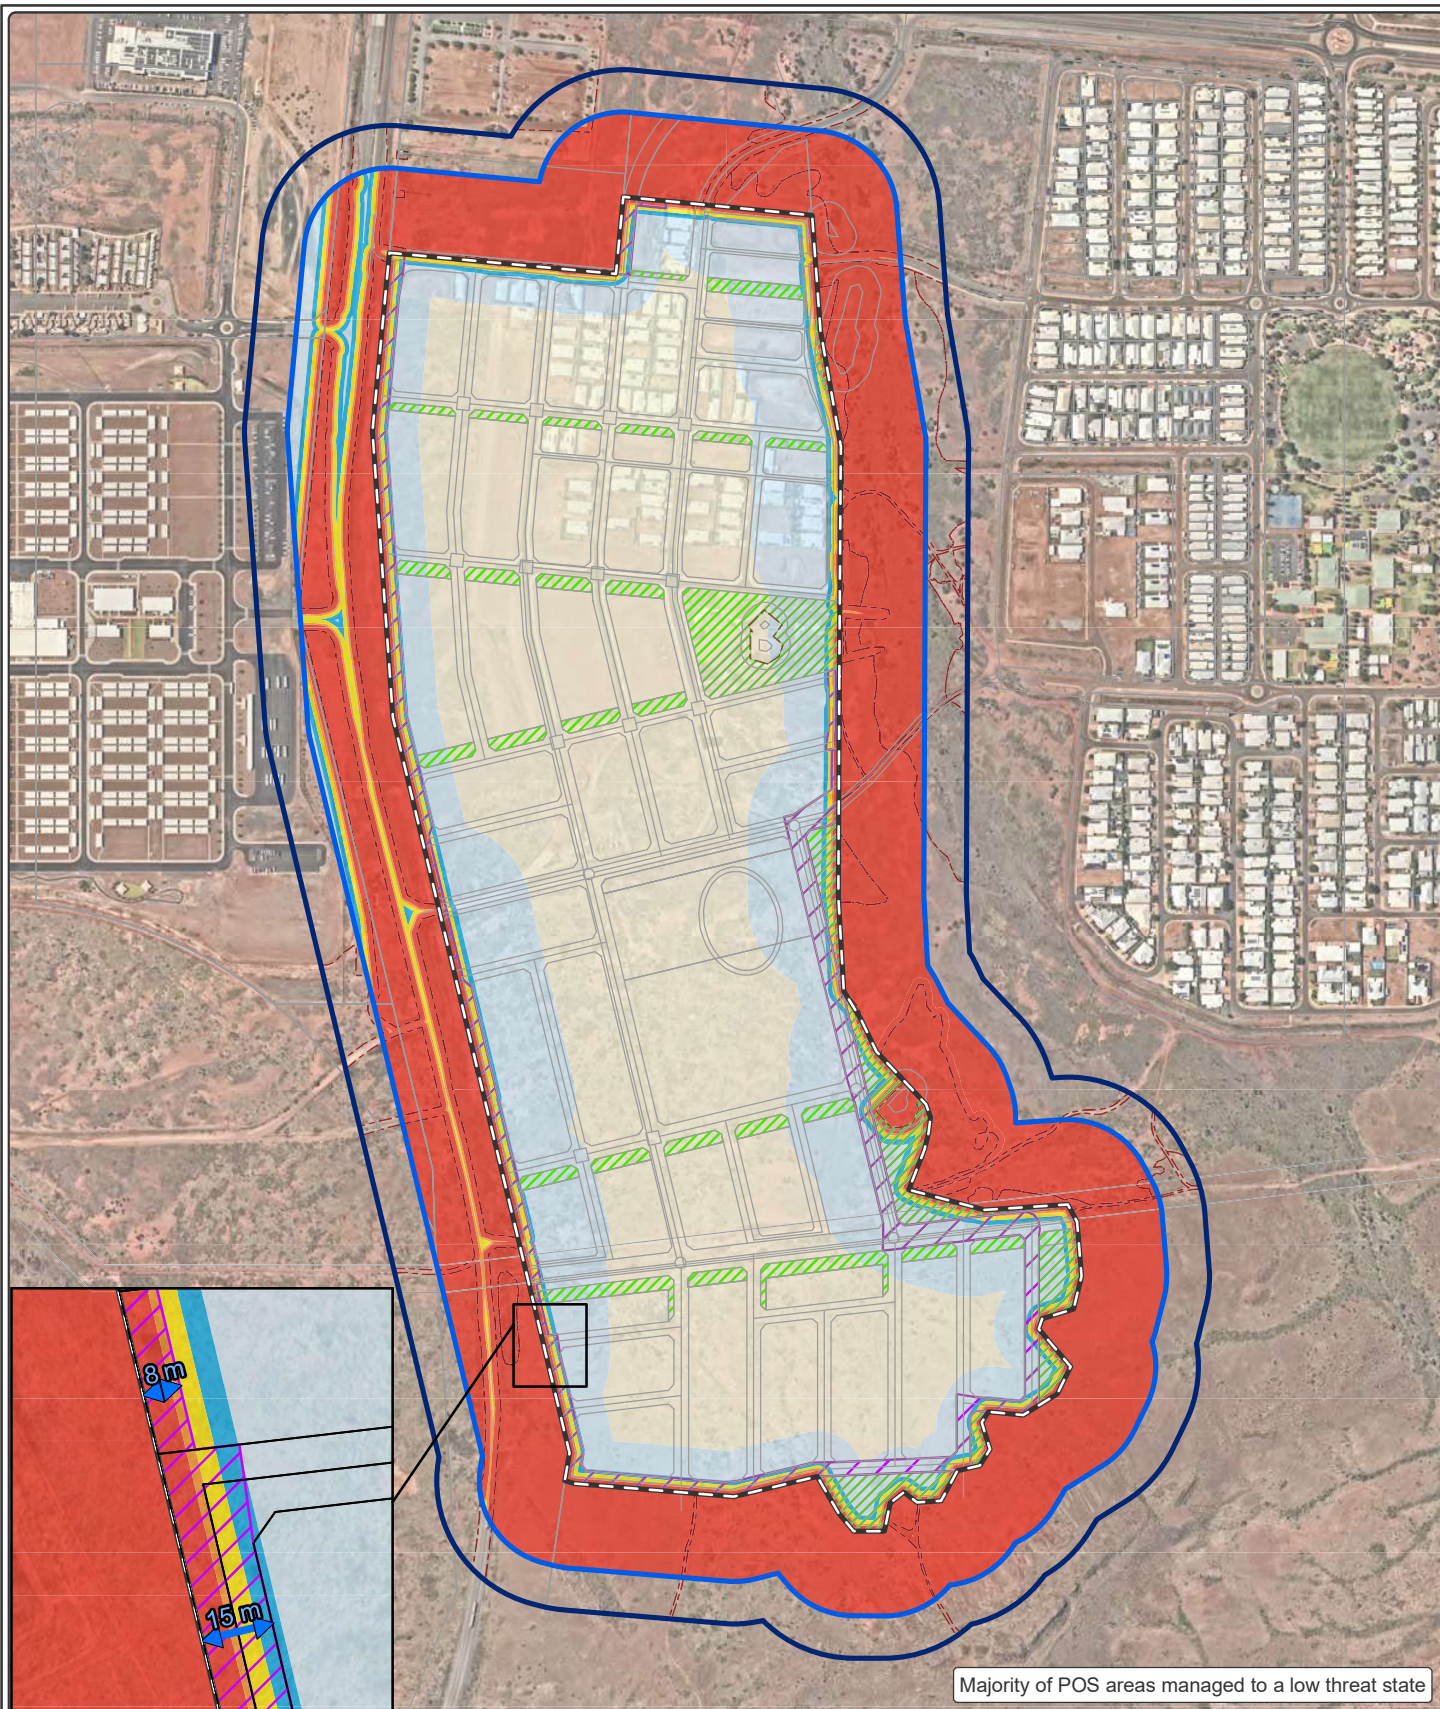
**Figure 7: Bushfire Attack Level (BAL) Contours - (Post-development)**

Should there be any changes in development design or vegetation/hazard extent that requires a modified bushfire management response, then the above BAL ratings will need to be reassessed for the affected areas and documented in a brief addendum to this BMP.

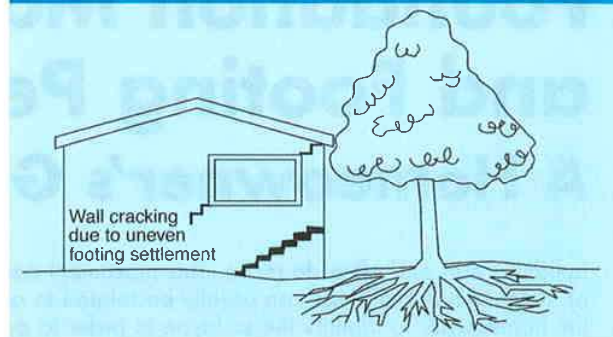
### Trees can cause shrinkage and damage

As the weather pattern changes and the soil begins to dry out, the external footings will be first affected, beginning with the locations where the sun's effect is strongest. This has the effect of lowering the external footings. The doming is accentuated and cracking reduces or disappears where it occurred because of dishing, but other cracks open up. The roof lines may become convex.

Doming and dishing are also affected by weather in other ways. In areas where warm, wet summers and cooler dry winters prevail, water migration tends to be toward the interior and doming will be accentuated, whereas where summers are dry and winters are cold and wet, migration tends to be toward the exterior and the underlying propensity is toward dishing.

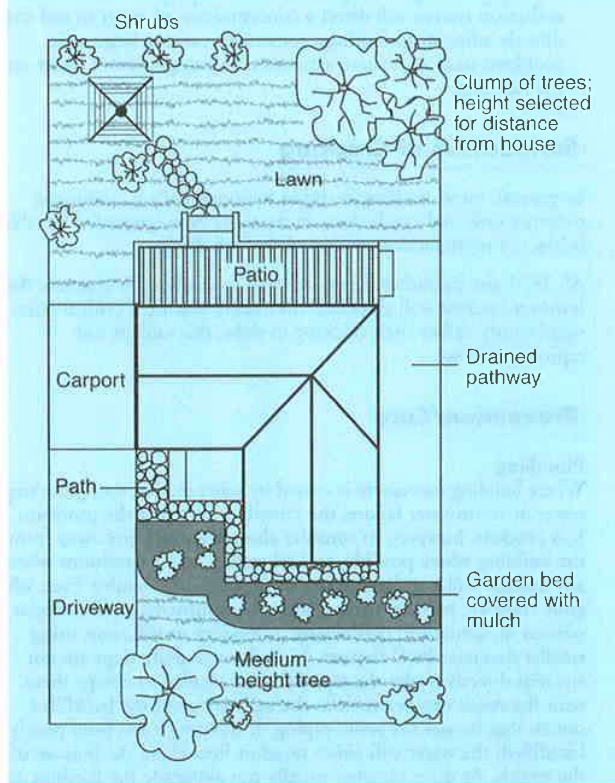
#### Gardens for a reactive site

should extend outwards a minimum of 900 mm (more in highly reactive soil) and should have a minimum fall away from the building of 1:60. The finished paving should be no less than 100 mm below brick vent bases.

It is prudent to relocate drainage pipes away from this paving, if possible, to avoid complications from future leakage. If this is not practical, earthenware pipes should be replaced by PVC and backfilling should be of the same soil type as the surrounding soil and compacted to the same density.

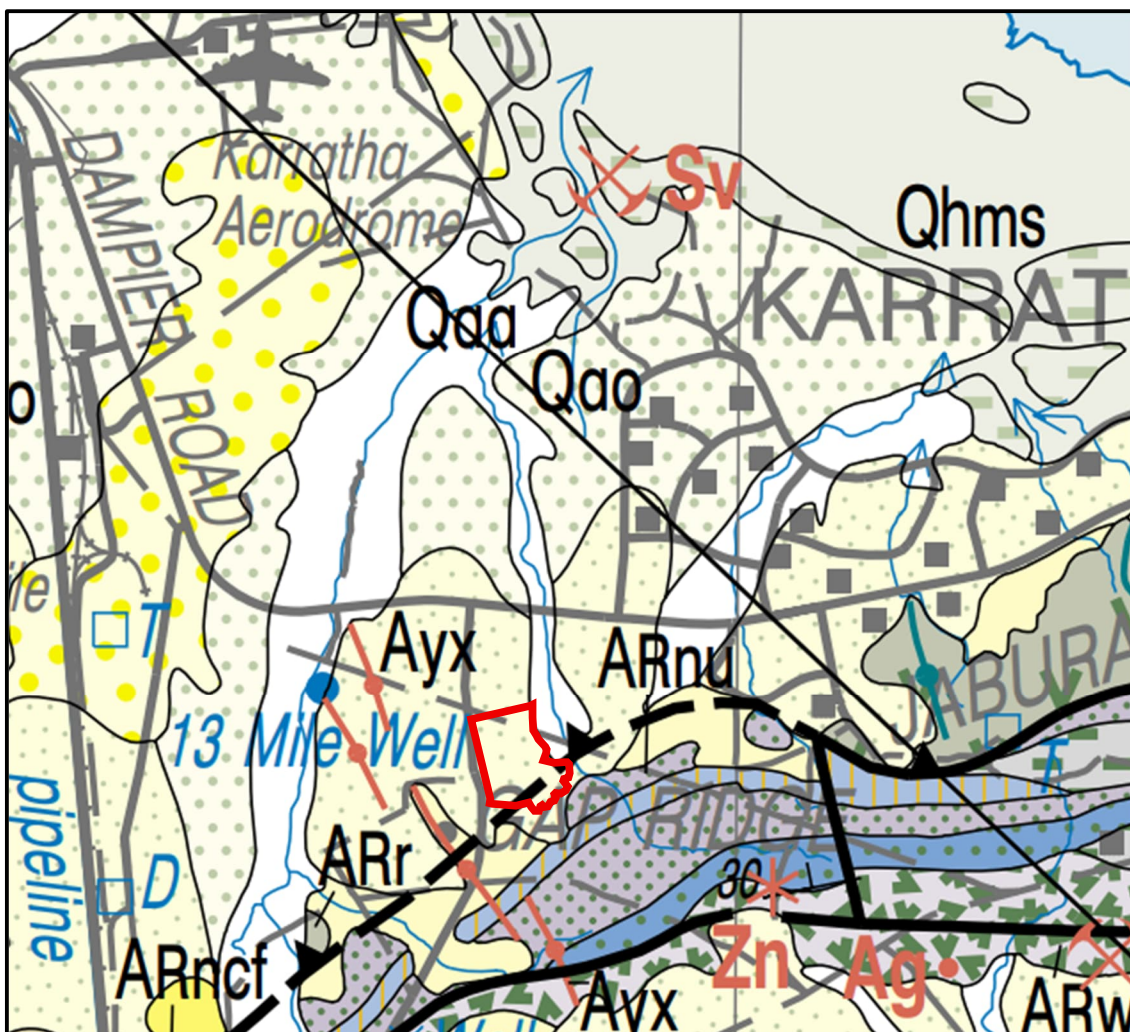
Figure 5 – Geological Survey of Western Australia (Dampier-Barrow Island)

The geology of the Site is consistent with conditions encountered in previous stages 1 and 2 of the development, and with other nearby developments in the region and is suitable for residential development.
