**COSSACK**

**DRAFT** Conservation Management Plan

Volume 2: Appendices

## **Building Condition Assessments Report**

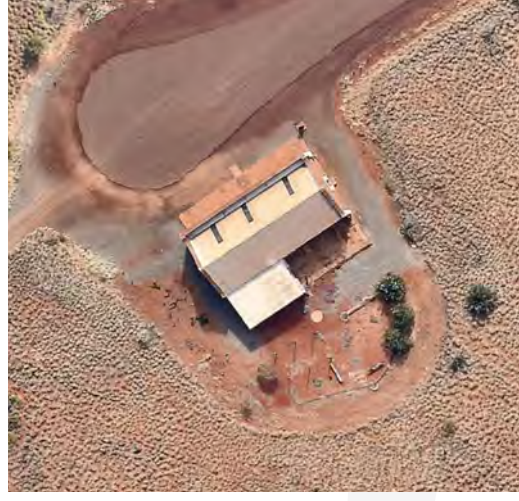
*Efflorescence of salts due to cement mortar and the use of concrete to tie beams. Source: TPG+PM 2017*

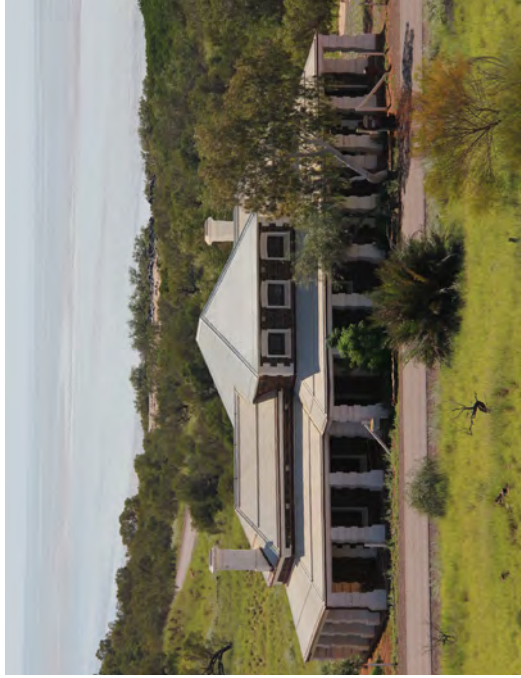
Rainwater system is collapsing, with dismantled downpipes. Source: TPG+PM 2017

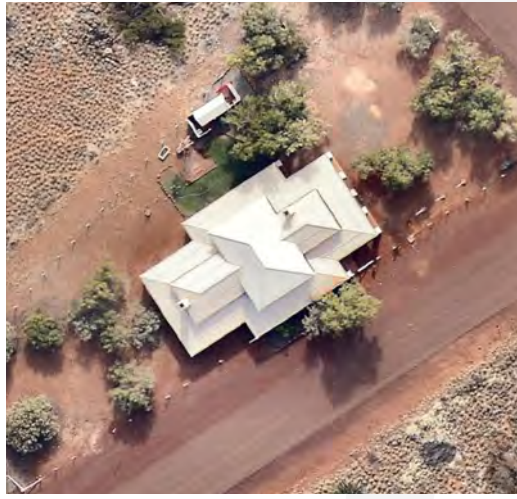
General rust on metal roof sheets. Source: TPG+PM 2017

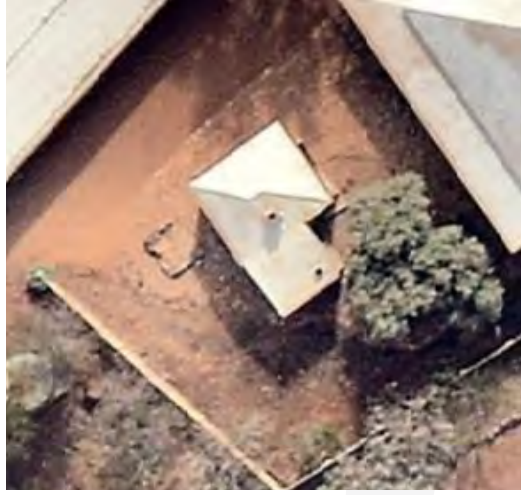
Efflorescence of salts due to cement mortar. Source: TPG+PM 2017

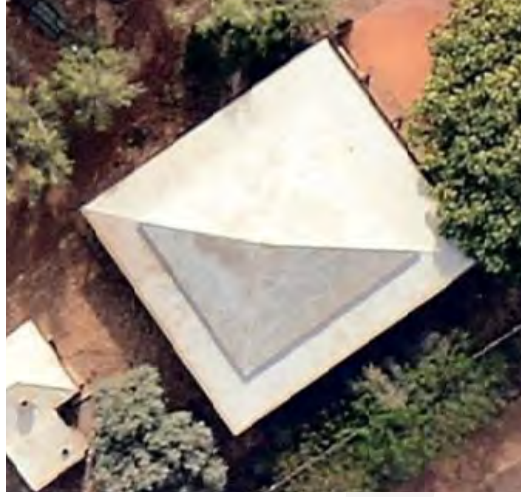
Efflorescence of salts due to cement render and rising damp. Source: TPG+PM 2017

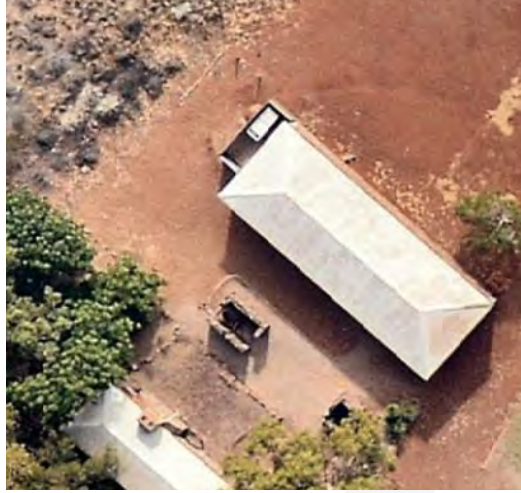
Hairline cracks throughout. Source: TPG+PM 2017

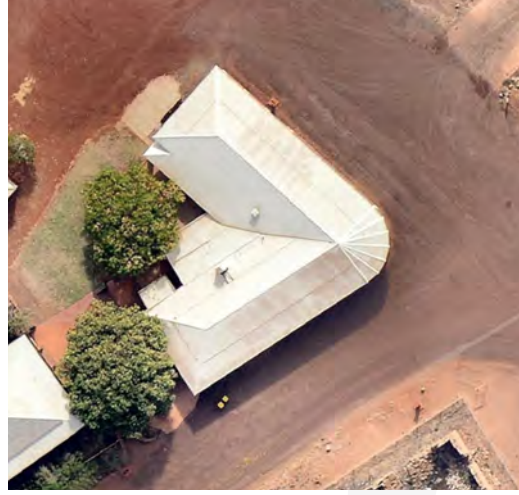
Damaged eaves and soffit. Source: TPG+PM 2017

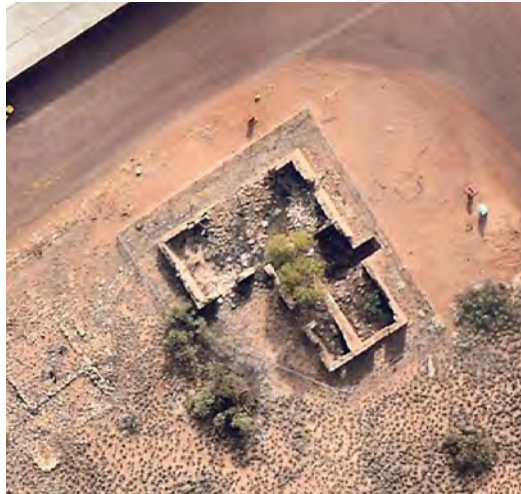
Major vertical crack. Source: TPG+PM 2017

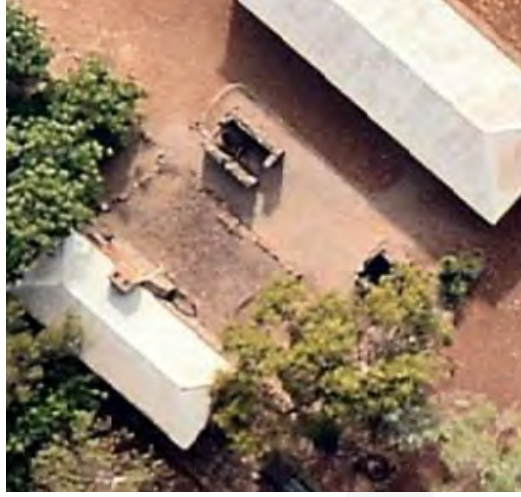
Rubbish inside Outbuildings. Source: TPG+PM 2017
